## IMCA Safety Flash 01/12

January 2012

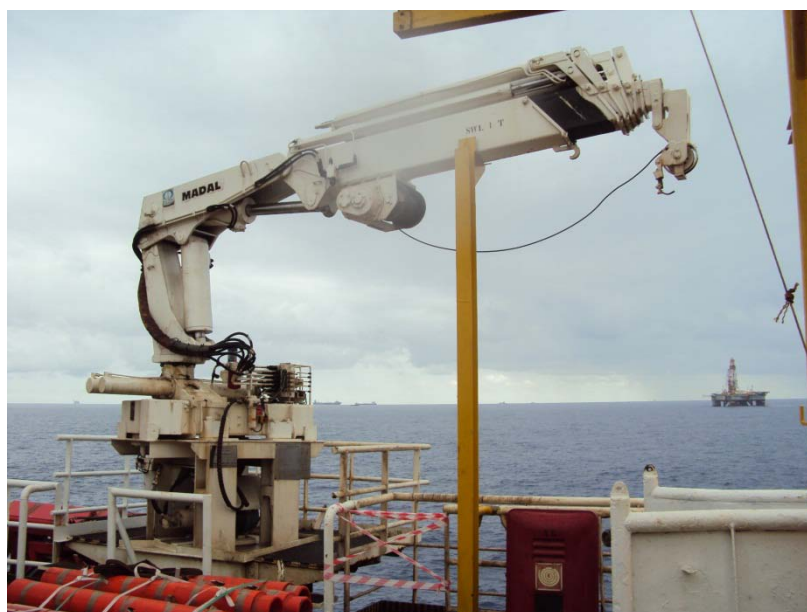
A member has reported an incident in which a crane winch wire parted and the hook block was dropped to deck. The incident occurred when the crane operator began to extend the jib of the crane without letting out the winch wire at the same time. The extending jib caught the hook block and caused the crane winch wire to part. The hook block, which weighed 30kg, dropped 10 metres (m) to the deck. There were no injuries.

*Crane following incident*

- ◆ The crane operator was not paying proper attention to the extending jib;
- ◆ The crane operator had not informed his supervisor that this work was taking place;
- ◆ The crane operator was effectively working alone: there was no-one else watching the crane whilst it was being operated;
- ◆ There was no locking or warning mechanism fitted to the crane to prevent this from happening.

- ◆ Review training of persons operating cranes and winches;
- ◆ Review of risk assessment for this job;
- ◆ Investigate installation of lock protection sensors for this kind of crane.

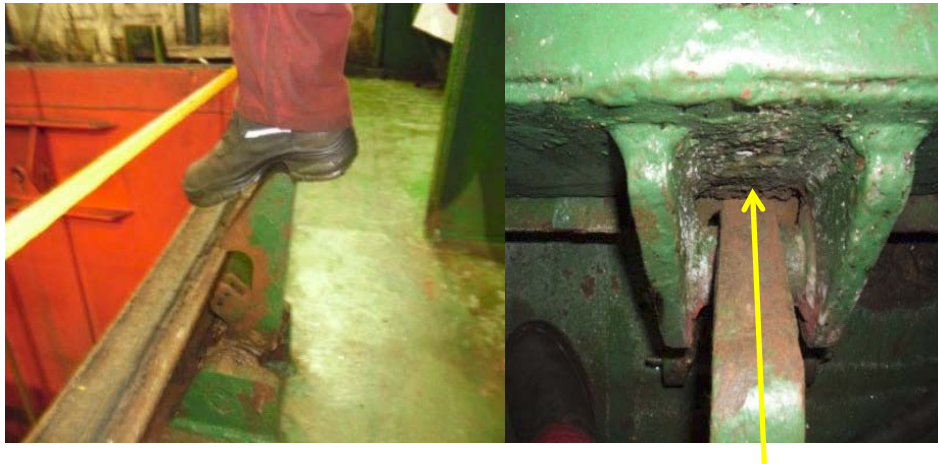
*Spring-loaded latch operated by foot*

*Fingers were trapped here*

- ◆ The immediate cause of the incident was that the securing hook was too stiff to be held open by foot;
- ◆ The root cause was that the old spring had recently been changed out and a new one fitted to the securing hook, which made it too stiff to operate. The potential problems this change introduced were not noticed, highlighted or addressed before operations restarted.

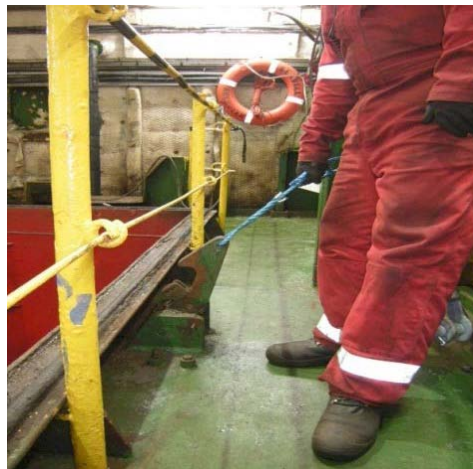
*Showing rope tail in use (making manual handling unnecessary)*

- ◆ The hook was modified to remove the need for hands to be in close proximity of the locking clamp. A hole was drilled in the clamp and rope attached to facilitate safe operation. Future operators will pull to release the hatch to open, thereby encouraging a hands free approach.
