IMCA Safety Flash 01/14

January 2014

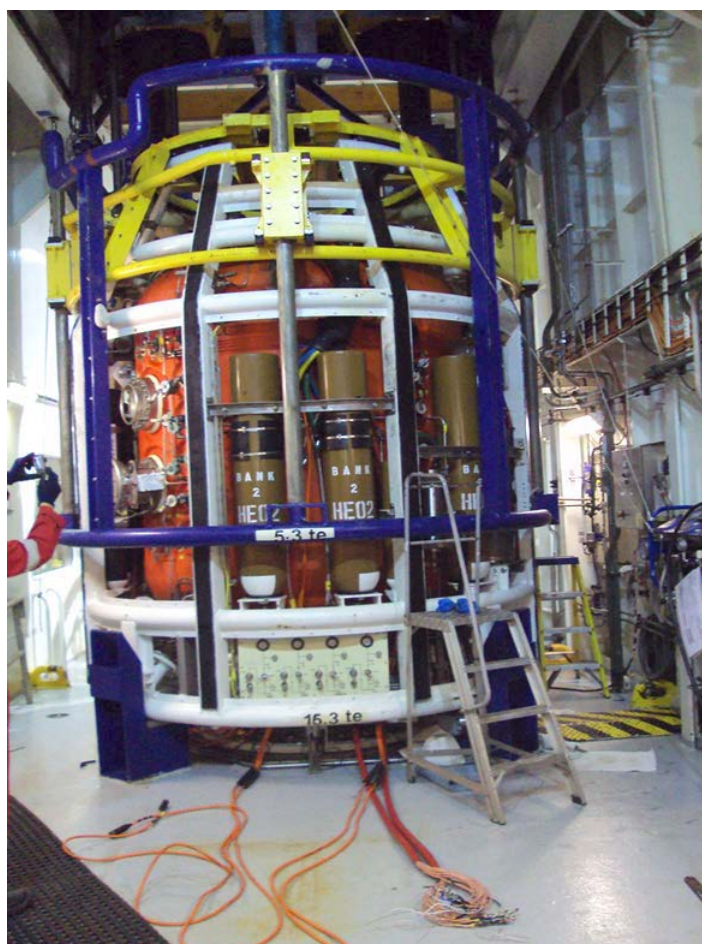
As the diving bell was being lowered into the moonpool, two uncontrolled descents were experienced. During the second uncontrolled descent, the bell's umbilical was damaged leading to a loss of bell pressure. Investigations have shown that the system had been placed in an unsafe condition following operator error and that the programmable logic controller (PLC) had failed to safeguard against these errors. Several layers of additional barriers and backups constrained the actual consequences of the incident to material damage only.

The investigation revealed the following:

- ◆ The implications of introducing PLC technology in to the diving industry may not have been fully understood, and the related roles, responsibilities and competencies of both the technical and operational personnel were not sufficiently clarified;
- ◆ Although the risk management documentation was advanced for a DSV, there was evidence that it lacked continuity and integrity – operator error was not considered;

- ◆ Emergency response to reasonably foreseeable hazardous conditions was not sufficiently defined; for the most effective use, the ergonomic layout, checklists, training and drills requires optimisation. Emergency related processes were not audited for effectiveness or for feedback to improve the related technical, procedural or competency systems;

- ◆ There was insufficient supervisory understanding of both the bell launch and recovery control system. A lack of situational awareness was needed to understand and control the human and equipment response to a complex and hazardous situation;

- ◆ During the development or construction phases, the bell launch control systems were not assigned a SIL rating and consequently, lacked the correct level of safety scrutiny as that given to other, more highly rated, systems;

Members' attention is drawn to the IMCA document AODC 009 *Emergency Isolation of Gas Circuits in the Event of a Ruptured Bell Umbilical*

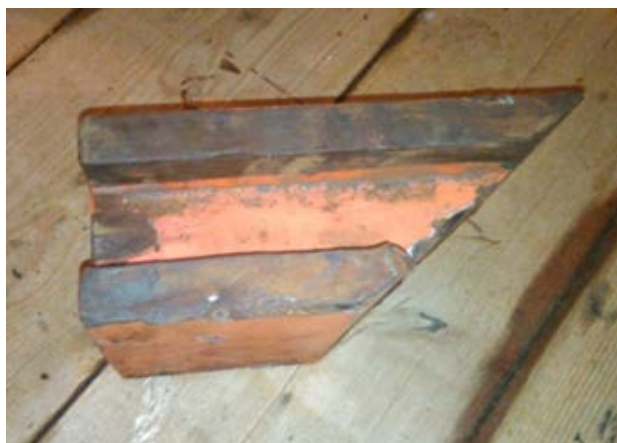
Chain guide

- ◆ The steel chain guide was part of the spooling mechanism (see photographs) and fell to the deck along with two sheared securing bolts;

- ◆ One of the two bolts appeared to have fractured this and had the potential to cause misalignment of the chain guide, during normal operations. This misalignment appears to have caused the chain guide to catch on the chain, causing it to shear the second bolt and thus fall off;
- ◆ The injured person should not have been in the area during this operation;
- ◆ Using the “DROPS Calculator” as a benchmark in the classification of the potential consequences of a dropped object, the outcome of this incident could have been a fatality.

- ◆ The worksite was made secure, and other securing bolts within the winch house area were checked;
- ◆ Planning and procedural control of tasks should consider the position of personnel and potential dangers as part of procedure development;
- ◆ Vessel and onshore management to reiterate the need for personnel to remain clear of hazardous areas and equipment;
- ◆ Ensure access points to all hazardous areas and equipment have adequate barriers and signage.

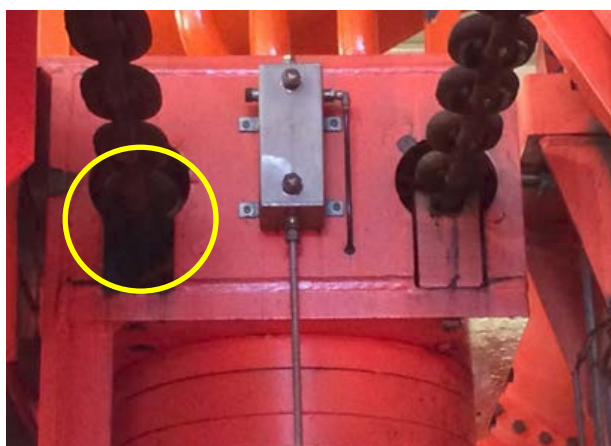
(L) missing chain guide (R) Chain guide in original location

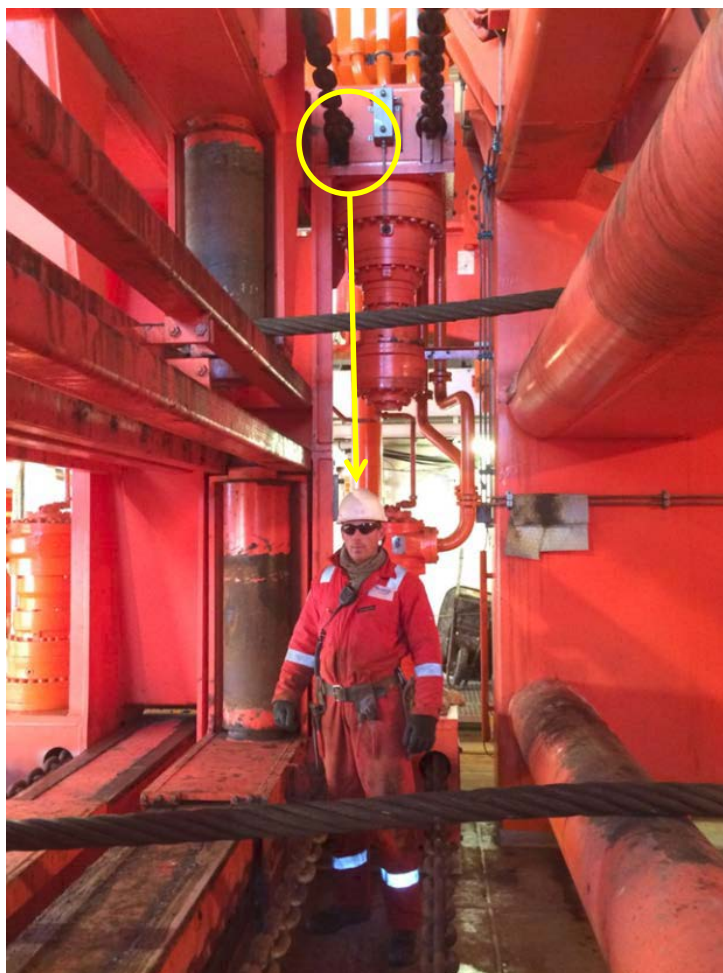
Position of the injured person and the place from which object fell

- ◆ Access to hazardous areas should be properly controlled through effective planning, procedural controls and risk assessment of tasks;
- ◆ The crew should maintain a continued focus on situational awareness and hazard perception in what may be considered ‘routine’ operations.

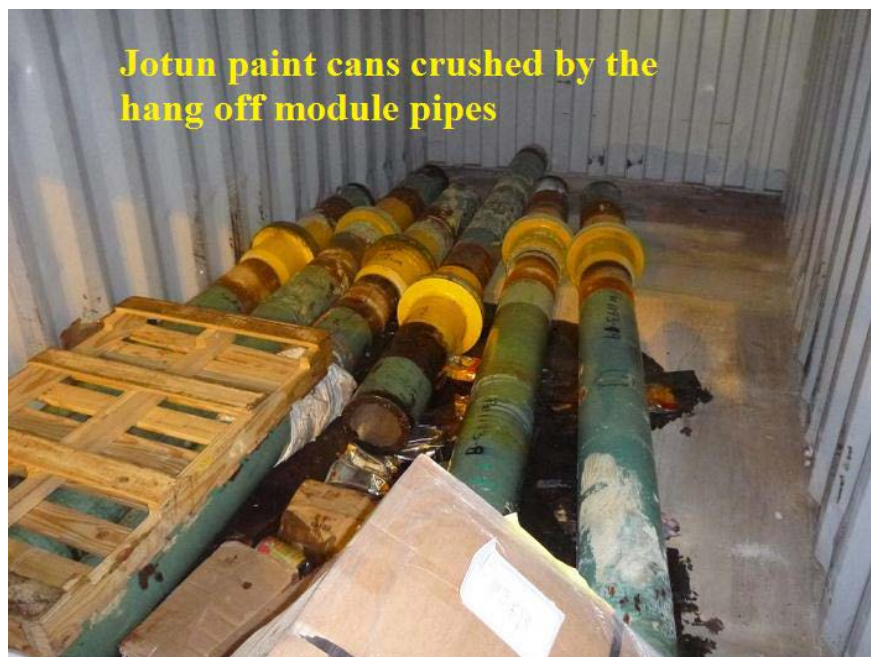
A member has reported an incident in which a freight container was delivered offshore with damaged internal contents, owing to poor stowage. When the doors of the container were opened, there was a strong smell of paint. It was discovered that heavy pipes had been loaded into the container but had not been stowed properly or lashed down. The pipes had moved during transit and had crushed part of the other cargo, including a number of cans of paint and some welding consumables.

Photograph: showing inside of freight container and damaged cargo.

Our member notes that this is a good example of the need for proper stowage and lashing. Cargo in a freight container that is not lashed down properly can easily shift during transit and damage itself or other cargo. In this example it is cans of paint, but it could easily cause a much more serious hazard of dropped or falling objects when the doors are opened, as well as a potential spill to the environment.

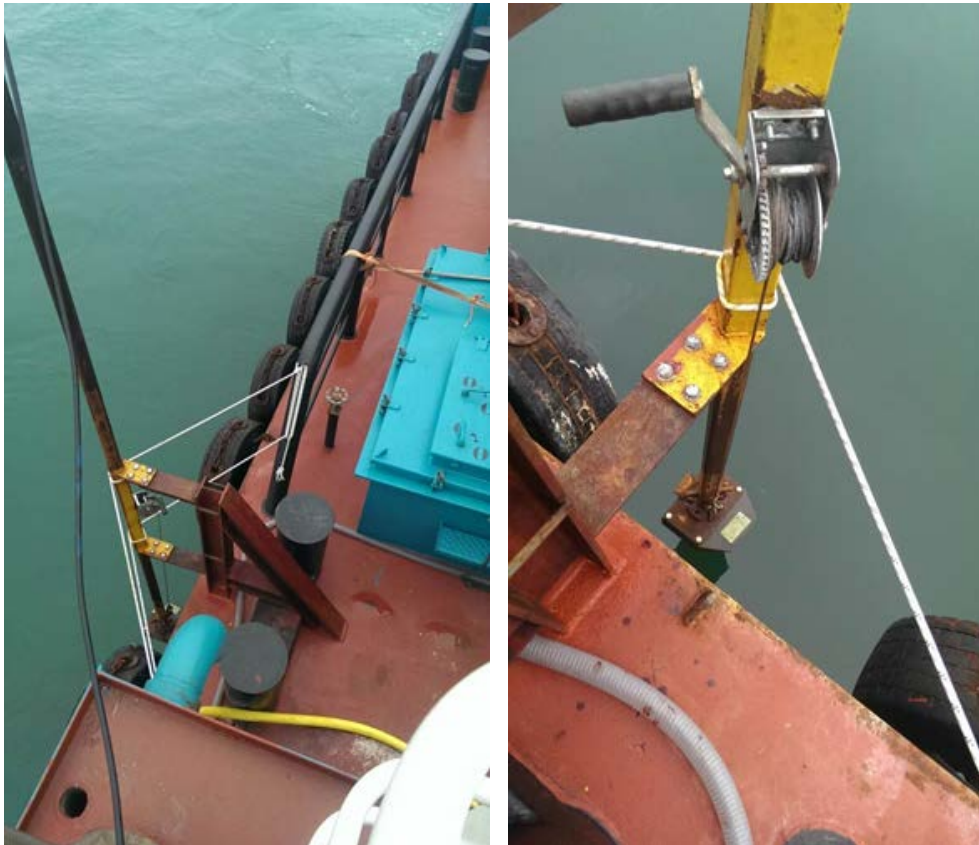
A member has reported an incident in which a crewman was struck and injured by an out-of-control rotating handle. The incident occurred on a small vessel during the deployment of a stand-alone echosounder. This required the use of an over the side pole to deploy the echo sounder. The crewman was lowering the echosounder pole by means of a small winch when the handle slipped from his grasp and started to rotate quickly. As he tried to grab the handle to regain control over the winch, the edge of the handle struck his forearm causing a deep cut which subsequently required seven stitches.

Photographs showing pole and winch

- ◆ The requirement for an over the side pole arose due to a necessary change of vessel, only one week before mobilisation;
- ◆ There was no detailed specification in place for the required pole and winch mechanism;
- ◆ Responsibilities for the design, manufacture, installation and acceptance of the pole and winch were not clearly allocated;
- ◆ The installed winch was not suitable as it had no safety mechanism to prevent free fall when lowering;
- ◆ This hazard was not identified, as existing robust risk management procedures were not followed.

- ◆ Standard specifications were developed and distributed for this form of over the side pole and winch mechanism;
- ◆ Written instructions to be provided to project managers and field crew covering;
 - Requirement for completion of task risk assessment and any associated method statements before project mobilisation
 - Need for clear understanding and documentation of responsibilities associated with projects
 - Involvement in pre-project meetings, hazard id and risk assessment (HIRA) and kick-off meetings
 - Requirement for formal documented project briefing for operational personnel
 - Requirement for better formal documentation of project communications
 - Requirement for adherence to management of change process
 - Requirement for formal documented handovers when personnel changed out
 - Requirement to stop the job in the event of an unsafe condition.
