I Fatality – Fall from Height

2 Vertical Lay System Dropped During Quayside Mobilisation

3 Fire at Sea

4 Securing of Loads

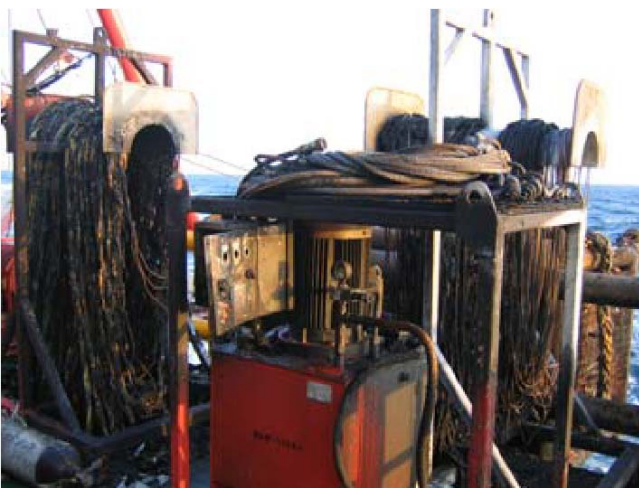
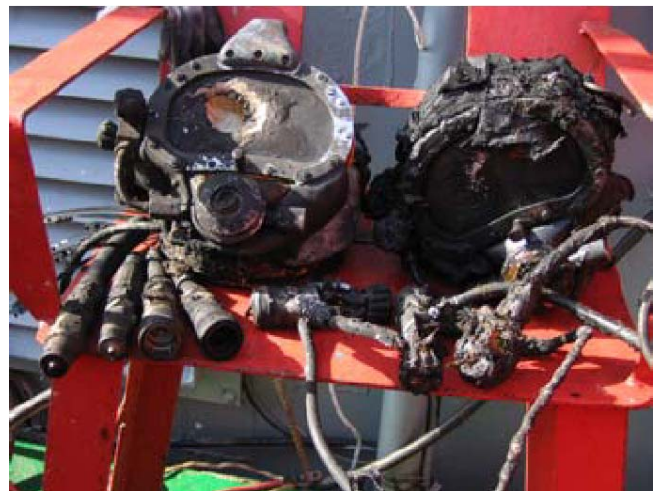
The photographs demonstrate the level of heat generated in a short time frame, but are quoted as not demonstrating the real potential this incident had to have developed into a major disaster. A 50l air cylinder was exposed to the heat and several 40 gallon oil drums were stored within meters of the scene. It is not difficult to imagine the conflagration which may have ensued had the fire not been contained in time.

According to the incident report, the fire, which began in a rubbish basket (approx 2m x 2m), was extinguished in 15 minutes. It is not certain what the ignition source was, but either a hot welding rod or a cigarette butt is suspected. Contributing factors have been noted and include an overflow of rubbish and strong prevailing winds. Congestion in the area is apparent by the evidence of the photo on the left.

Recommendations by the vessel safety department are:

- ◆ the basket be modified into a burn basket;
- ◆ no overflow of the basket contents and immediate incineration of combustible waste;
- ◆ electrodes to be disposed of in metal containers, not in the rubbish basket;
- ◆ no throwing of cigarette butts into the basket.

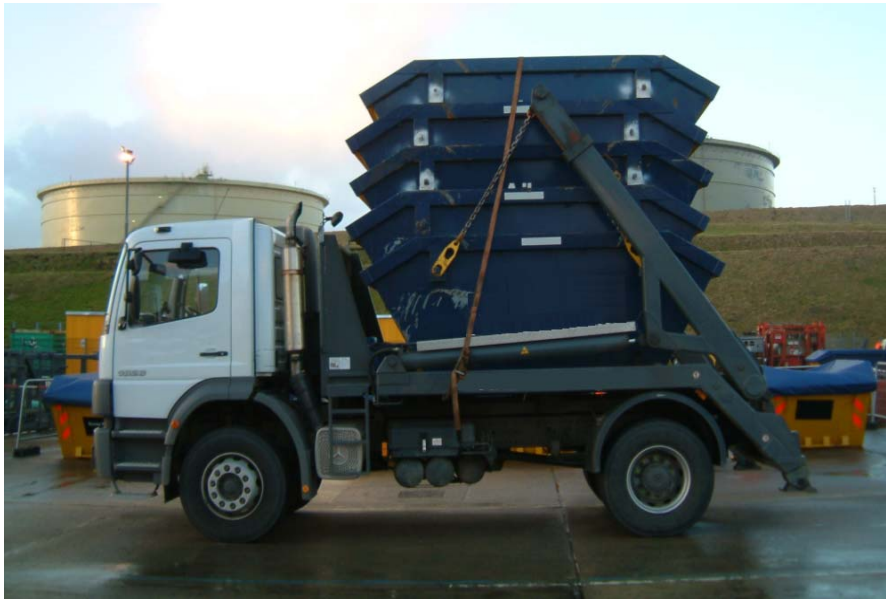
During transportation of five empty skips between a shore base and terminal, the top-most skip was blown from the top of the stack and landed on the road. No injuries occurred and no vehicles were damaged, but evasive action appears to have been taken by third party vehicles on the road to avoid the skip. There was the potential for multiple permanent injuries or fatalities and for damage to property.

- ◆ The skips were stacked five high, one on top of the other, significantly above the height of the truck cabin;
- ◆ There was high wind loading – the wind increased during the journey to approximately gale force, with gusting;
- ◆ The skips had been inadequately secured to the truck, with no strops used.
