1 Falling Object – Failure of Lifting Appliance

2 Fatal Fall in Shipyard

3 Worker Sustained Severe Facial Injuries During Vessel Maintenance

4 Hand Injury Sustained by Diver

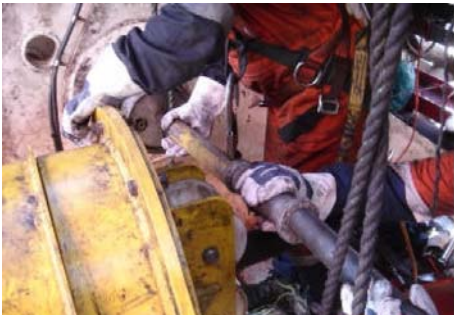
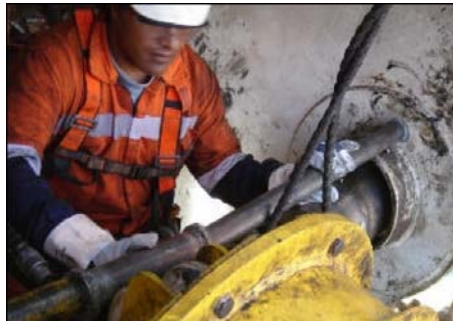
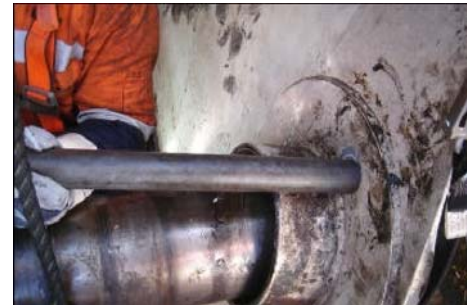
IMCA has received a report on an accident wherein a worker on a pipelay vessel sustained serious injuries to his face. Whilst the vessel was alongside, routine inspection and maintenance work was being carried out on sheaves, bearings and clamps on a J-lay tower. The main pin and sheaves had been dismantled successfully. Later, during re-installation, the main pin was inserted by hand, halfway inside its path, in order to facilitate its final positioning. It was decided to use a hydraulic jack to push the pin in further. To this end, an additional pipe was introduced to the job. This pipe was held by hand and the hydraulic jack positioned at the other end of it. The jack was then put under pressure to start pushing the pin into its final position. Whilst under pressure, the pipe slipped out from under the jack and hit a worker in the face.

Appropriate first aid was applied. The casualty was then transferred to hospital where severe facial injuries were diagnosed.

- ◆ A job safety analysis (JSA) was used that had been developed for a similar operation carried out for work on another piece of equipment. However, the additional tools and equipment being used were not mentioned on this JSA;
- ◆ This work had not been documented at a safety briefing held earlier that day;
- ◆ The 'tool used for the job', i.e. the pipe, was not of a manufactured design and hence was not fit for purpose;
- ◆ the supervisor/workgroup leader was unable to offer continual support/supervision due to heavy work load and could only visit the work site periodically.

- ◆ Existing and/or generic job safety analyses should be rigorously examined when being reviewed in order to take specific work environment conditions into account;
- ◆ Permit to work requirements need to be applied at all times;
- ◆ Pre-job safety briefings are essential and should cover all planned and possible or likely work;
- ◆ Personnel need to be clear that in case of doubt, they should avoid shortcuts and ask their supervisor.

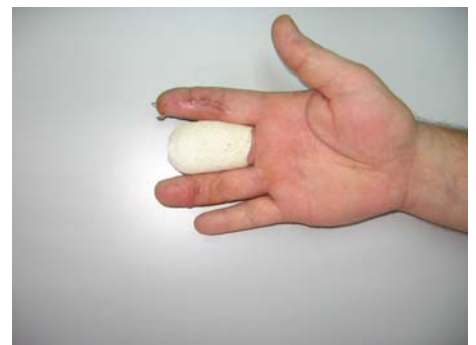
On the advice of the diver medic, the diver's wound was treated during decompression, which took four days. The wound was dressed at regular intervals and successfully kept uninfected until the diver could be hospitalised. In subsequent surgery, two injured fingers were saved, but part of the diver's middle finger had to be amputated. The diver would be able to carry out normal diving activities in future and pursue a career in diving.

Post surgery and top phalange amputation
