## IMCA Safety Flash 02/08

February 2008

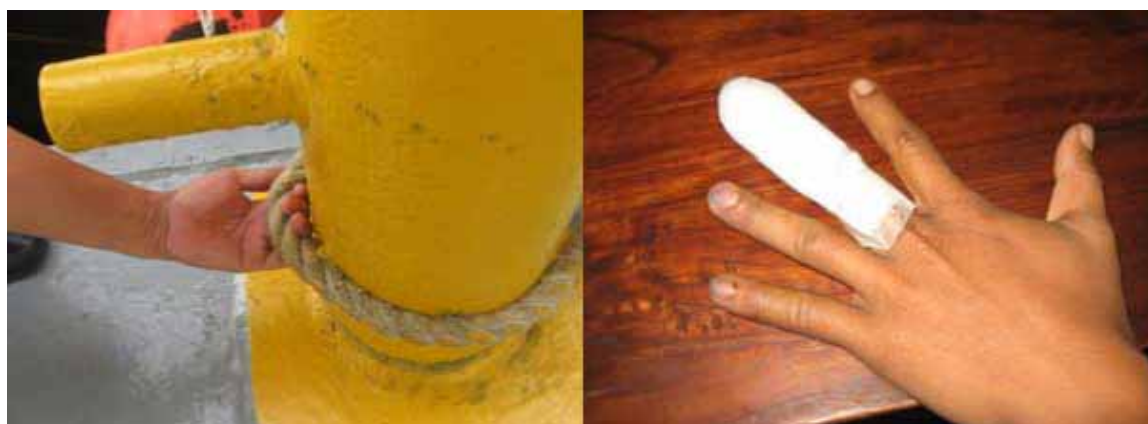
A member has reported an incident in which a crew member sustained a finger injury whilst trying to cast off a towing line. The crew member was asked to cast the line off from a bollard on the forecastle deck of the vessel. The towing line was slackened sufficiently to allow the line to be removed from the bollard. When the crew person tried to lift the eye of the towing line, a sudden high swell pushed the vessel astern and the tow line came under tension. The fingers of the crew person's left hand were trapped between the towing line and the bollard. The master responded immediately and caused the vessel to move ahead, causing the towing line tension to be released and releasing the trapped hand. The crew person suffered the loss of the middle finger nail and slight swelling on two fingers and was given first aid.

*Mooring rope and bollard*

*Injured finger*

- ◆ Weather and sea conditions should be taken into account when undertaking a risk assessment;
- ◆ Good seamanship techniques should be followed: in this case the warping drum could have been used to take off the tension from the towing line. If a warping drum is not available for use then rope/chain stoppers should always be used while casting off mooring lines and towing lines.

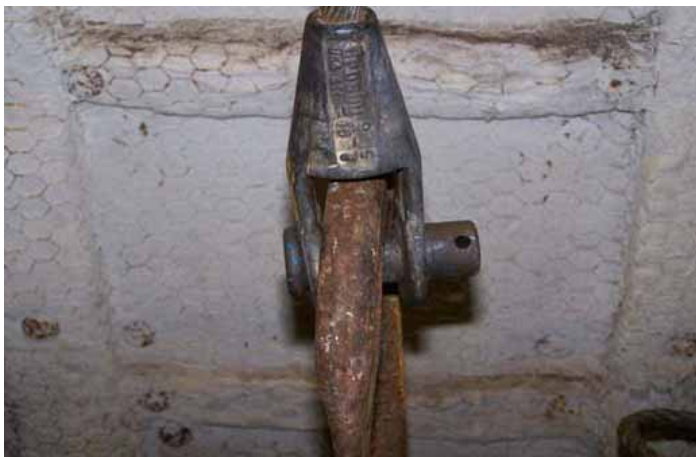
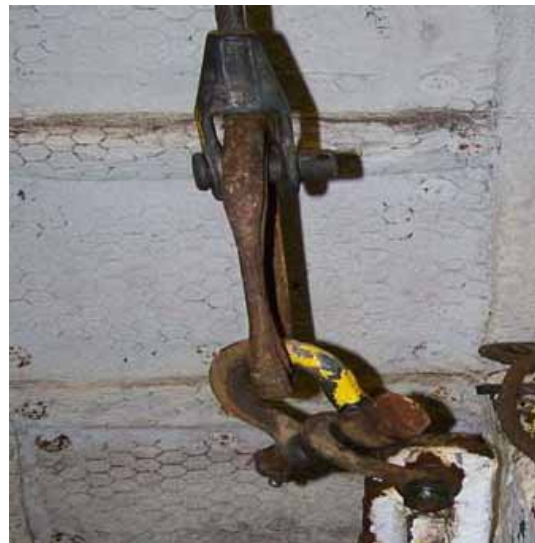
- ◆ The disconnection occurred between the spelter socket and the master link and the spelter socket load pin was secured in position by the use of a split cotter pin only;

- ◆ It is not known how the spelter socket load pin became detached from the body of the socket. However, galvanic corrosion of the split cotter pin, incorrect fitting of the split cotter pin or side impact to the spelter socket load pin could have contributed to the failure. British Standard BS 463 states that the use of a “plain pin with split cotter pin” is an “acceptable wire rope termination”, although this type of termination may not have been suitable for the purpose for which it was being employed;

- ◆ Open spelter sockets with ‘plain load pins’ are more suited to static connections. However, where it is necessary to make/break connections more frequently then closed spelter sockets should be used with an interfacing shackle, as these lifting accessories are commonplace and easy to change out or replace.

*Actual rigging setup in use at time of incident*

- ◆ Companies are encouraged to assess their use of spelter sockets and where possible use the closed type and suitable interface shackle;
- ◆ Where open spelter sockets must be used their suitability for the task should be assessed. If the spelter socket is to be used in a subsea lifting arrangement or experience any side impact (however minor) then the ‘screwed load pin with nut and split cotter pin’ securing type should be used.

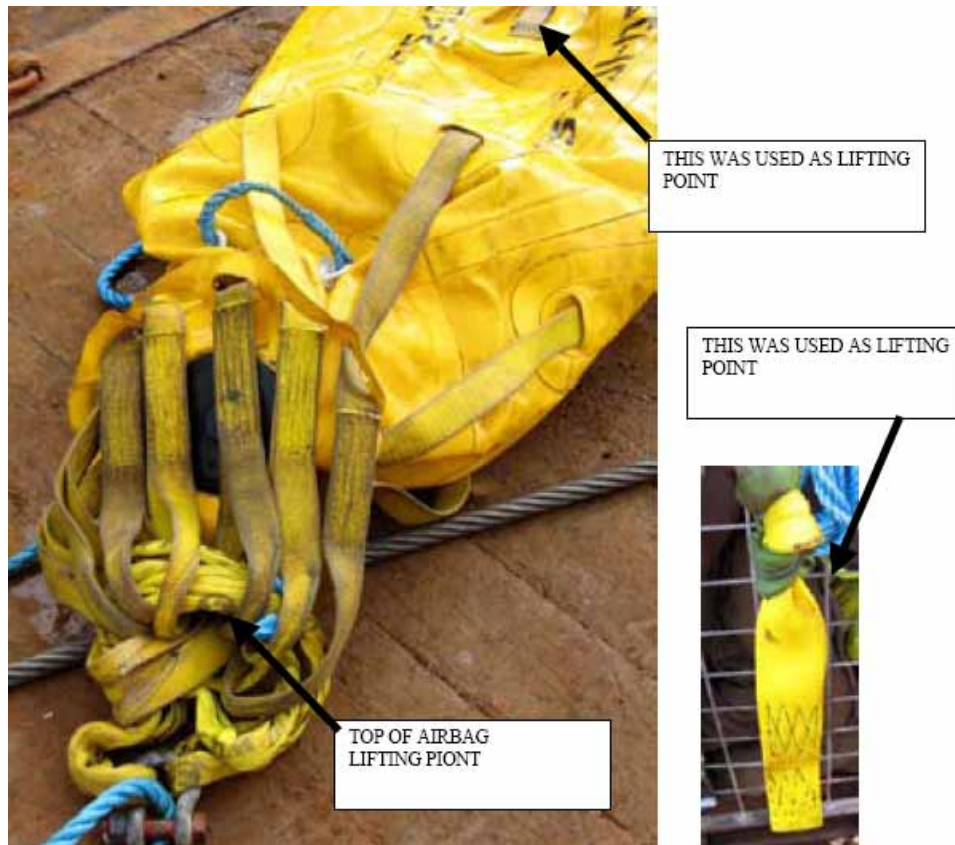
Investigation revealed that the points used for lifting the bags were not appropriate certified lifting points but only user handling points. Subsequent tests demonstrated that these user handling points were insufficiently strong to carry the weight of the lift bag.

*Lifting bag similar to that involved in incident*

- ◆ Only use appropriate lifting points, do not use unidentified lifting points.
- ◆ Lifting points on lift bags should be clearly marked. Suppliers should be made aware of this requirement.
- ◆ Remove or stitch together the man-handling straps, to prevent the possibility of mistakenly using these for lifting the bag during installation and recovery.
