## IMCA Safety Flash 02/09

February 2009

### 2 Schat Harding Product Awareness Notice – Free-Fall Lifeboat Hooks

Members are alerted to the attached 'Product awareness notice' issued by Schat Harding in relation to its free-fall hook, type FFH13.

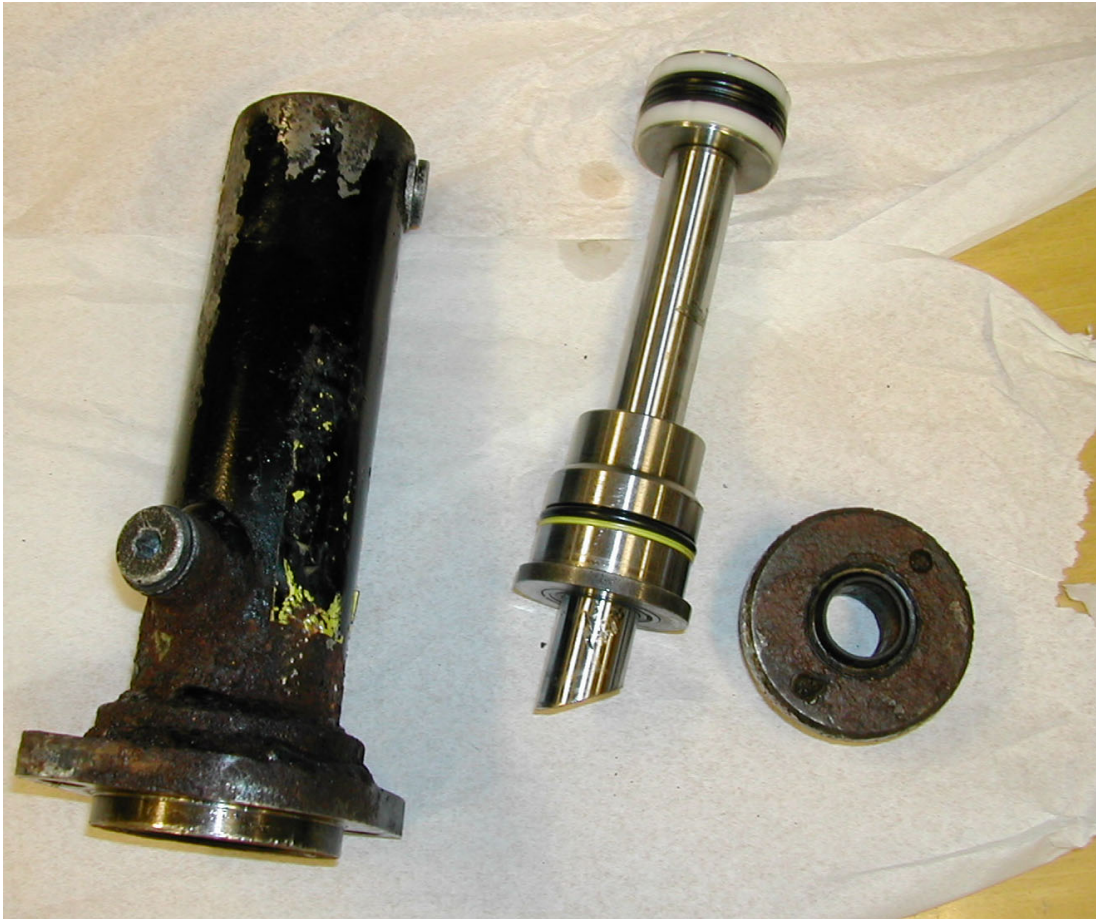
Picture 1.

The hydraulic cylinder was changed and further examination revealed that the piston rod was stuck to the cylinder end piece by corrosion. The cylinder end piece is of normal steel, and as the enclosed pictures shows that the outside is clearly corroded due to that the applied painting is not sufficient to protect this part. On the inside one we also see corrosion and a damaged area on the piston rod which we believe is where the rod was stuck to the end piece. To avoid this situation there should be hydraulic oil inside in the cylinder both in the high pressure side and in the low pressure side, but it seems that there has not been oil or that some water has entered the seal in the cylinder end piece.

The piston rod was cut in order to manage to disassemble the hook. Cylinder to the left and the end piece to the right.

A mock training freefall should be carried out as soon as possible (according to given instructions) in order to verify that the cylinder and the hook is operating as it should. The hydraulic cylinder should then be inspected that it moves when pressure is applied. If the cylinder is not operating, please contact our Aftersales and Service Department for assistance. The hook arrangement including the hydraulic cylinder should be operated and tested according to given instructions at a regular time interval.

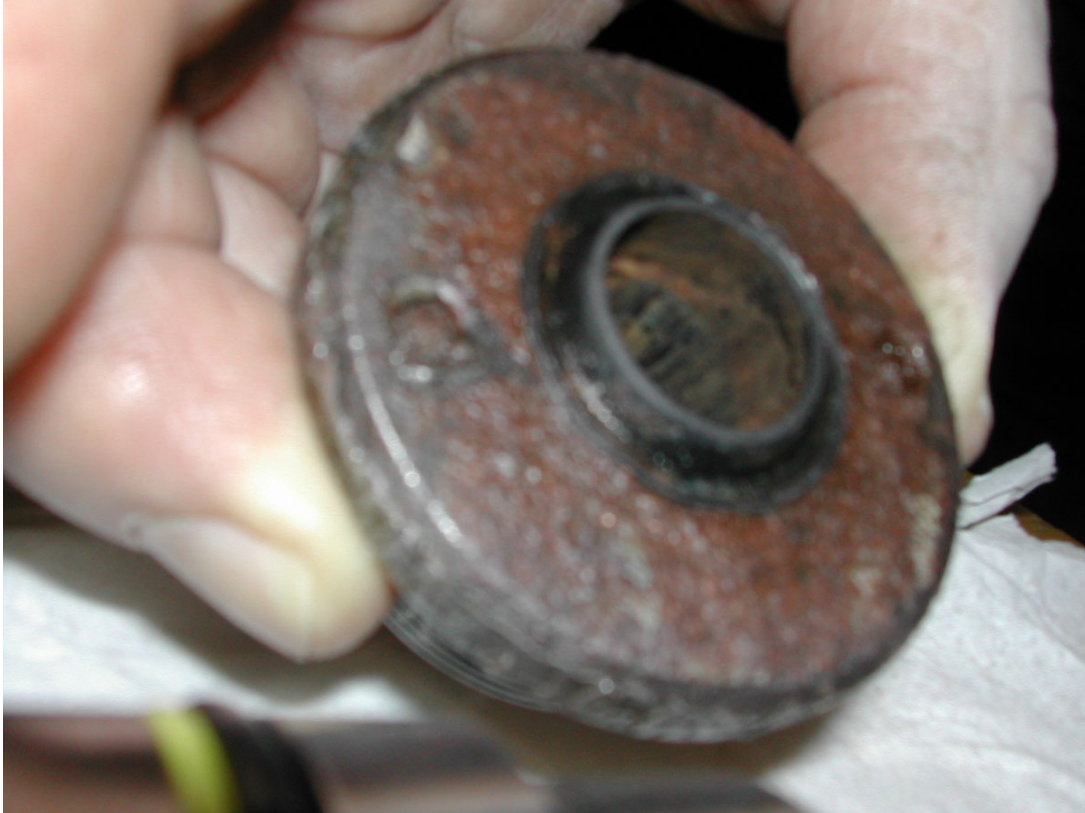
Picture 2.  
The end piece is corroded, also on the inside.

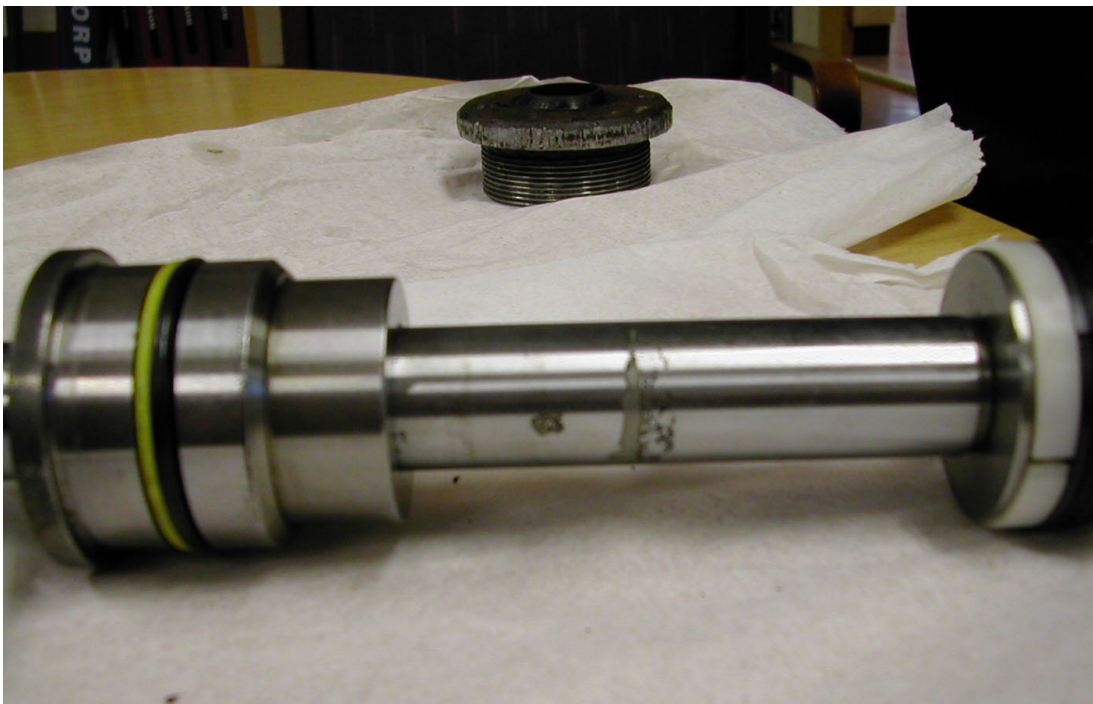
Picture 3.  
Piston rod has clearly a damaged area.

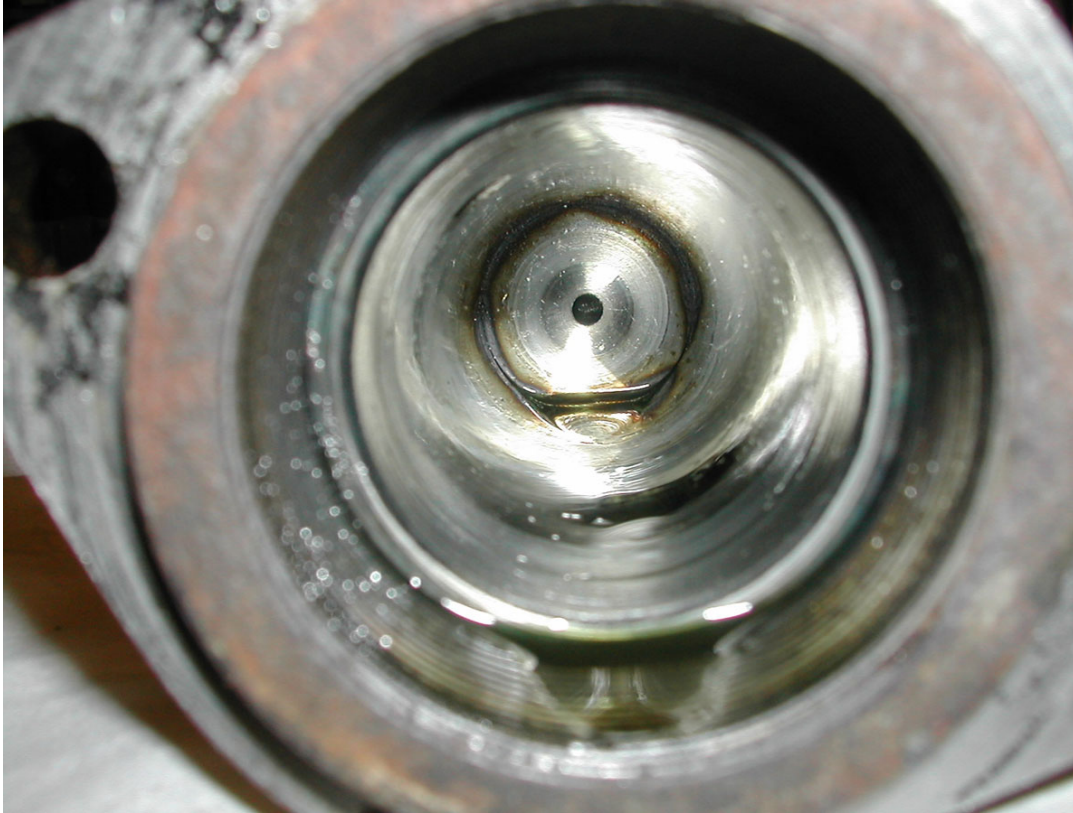
Picture 4.  
Seen inside the cylinder, does not show corrosion on the inside.

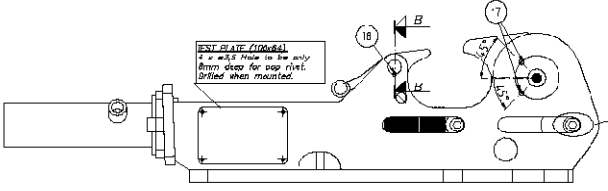
<p>Hook FFH13.</p>

The findings consists of that the side plates in the hook frame has been made of plain steel (S355J2G3 similar to NVE36) instead of WELDOX 900 (or XABO 890) that is a high tensile steel. This is a production mistake that has not been discovered by our Quality Control system before the hooks left our factory.

The wrong steel type used reduces the overall safe working load of the hook so that the required safety factor is reduced from 6 which is required by Solas down to 4 (this

applies only to the hooks with the above serial numbers). The reduction in safety factor has been verified by an actual strength test of a hook with wrong material used.

Schat-Harding has checked production data (material certificates) for all hooks produced and found that the hooks with the following serial numbers must be replaced:

- 1002/04
- 1003/04
- 1004/04
- 1005/04
- 1006/04

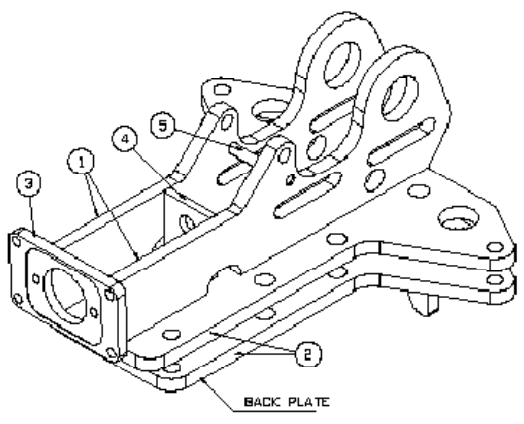
<p>Side plates shown by item no 1.</p>
