I Crewman Received 440V Electric Shock

2 Near Miss: Improper Use of Fall-Arrest Equipment Leads to Fall

3 Failure of Hose Reel Bearing Housing

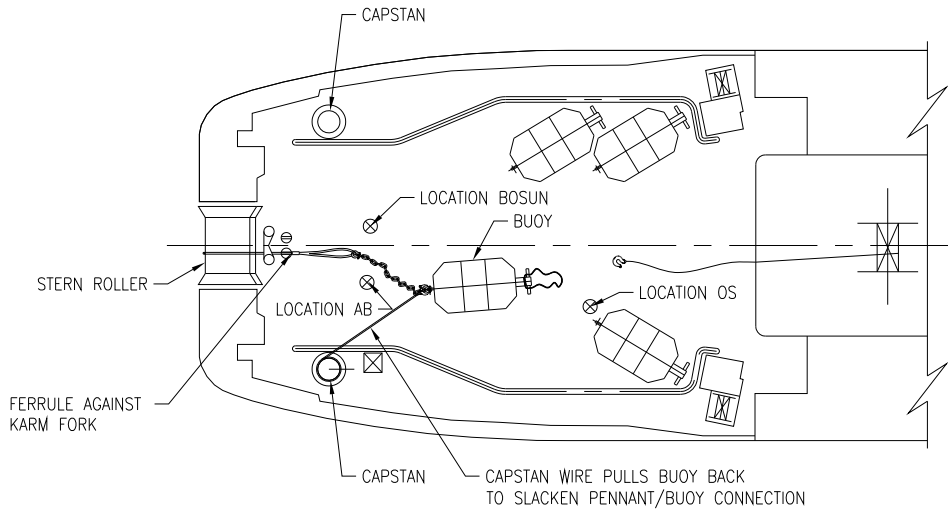
Fig. 1 Schematic diagrams of incident

The anchor buoy was winched onto the deck of the AHT until the pennant was in the wire stopper used to prevent the buoy from being pulled back towards the stern by sudden tension on the pennant wire. (See Fig. 1 Step 1.) Two crew members were disconnecting a shackle between the pennant wire connected to an anchor on the seabed and the buoy on deck (See Fig. 1 Step 2), when suddenly the pennant wire came under tension. The wire stopper failed to stop the pennant wire effectively and the sudden tension on the pennant wire jerked the buoy towards the stern of the vessel. The two crew members who were busy disconnecting the shackle were struck by the moving buoy. (See Fig. 1 Step 3). One crew member died instantly, the other suffered a minor injury.

STEP 2. START DISCONNECTING

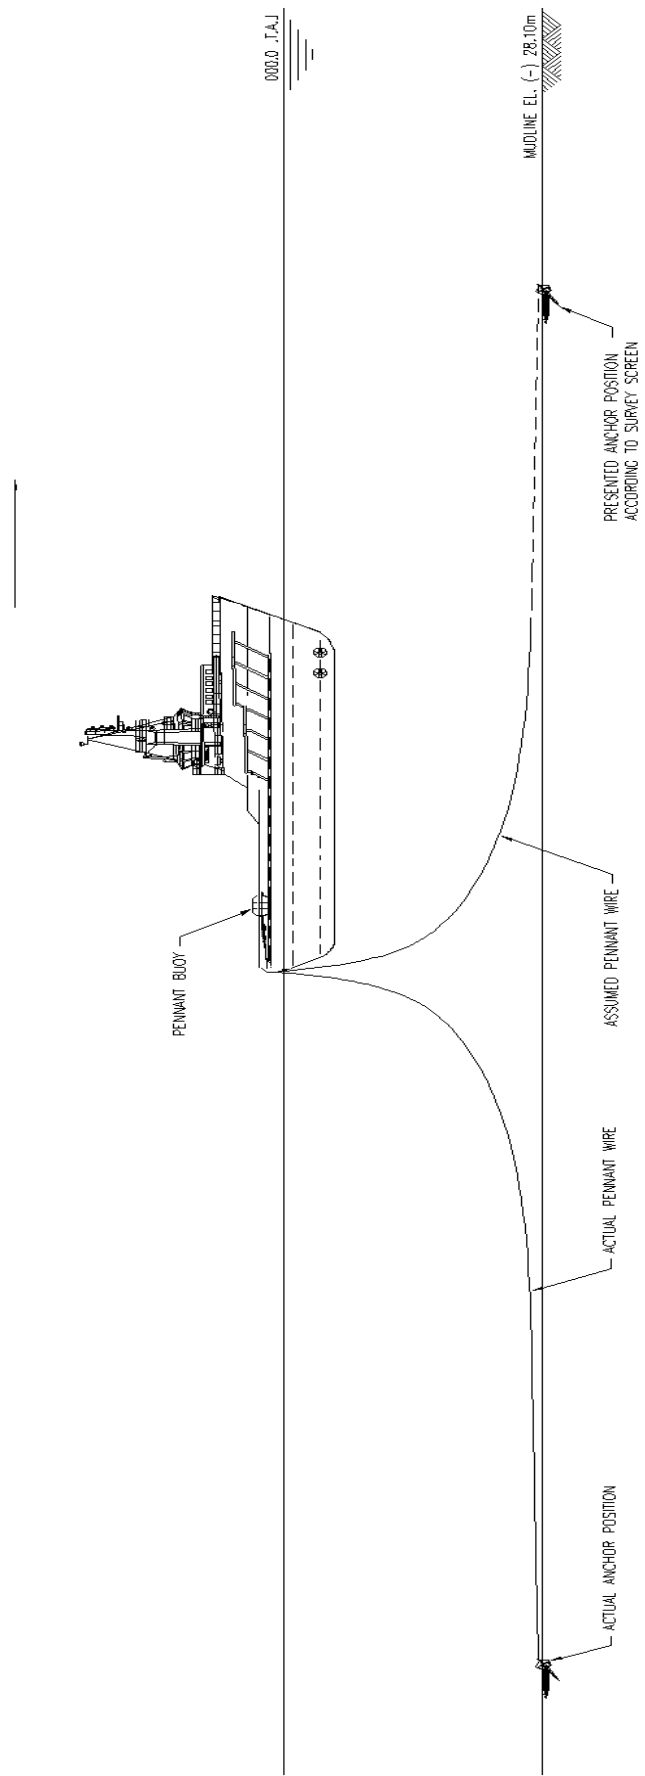
The sudden tension on the pennant wire came about because the survey screen on the bridge of the AHT displayed a 'design anchor position' instead of the 'as laid' anchor position. Based on the information presented by the survey screen, it was assumed that there was sailing slack in the pennant wire when in fact, it was being tensioned. (See Figure 2)

AHT MOVES FORWARD ASSUMING TO SLACKEN PENNANT WIRE BUT IN FACT TENSIONING IT

Fig. 2 Actual and design anchor positions

- ◆ A monthly inspection and check on wear and tear of the wire stopper equipment should be added to the vessel's planned maintenance system
- ◆ The 'as laid' information of the anchor should be provided by the positioning subcontractor and displayed on the survey screen

- ◆ The survey screen provided by the positioning subcontractor should be considered an additional tool to provide an assumed anchor location to the AHT, but this location should never be interpreted as representing the actual anchor position. A warning message to this effect should be displayed on the survey screen
