IMCA Safety Flash 02/11

February 2011

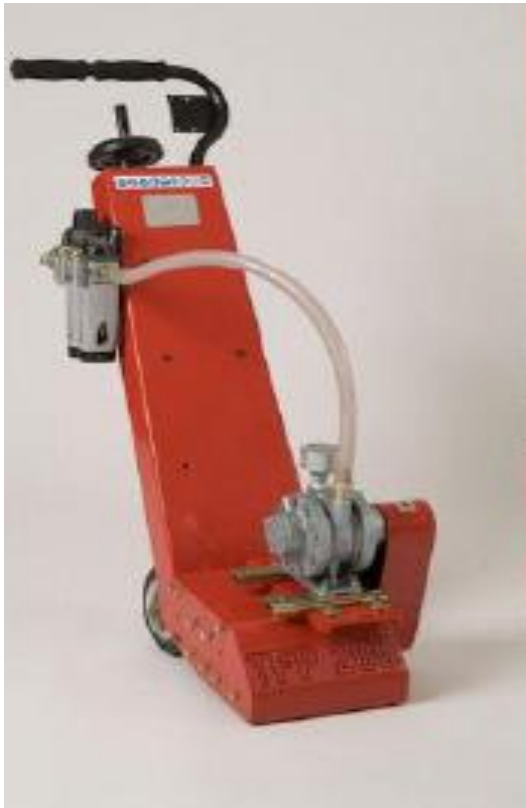
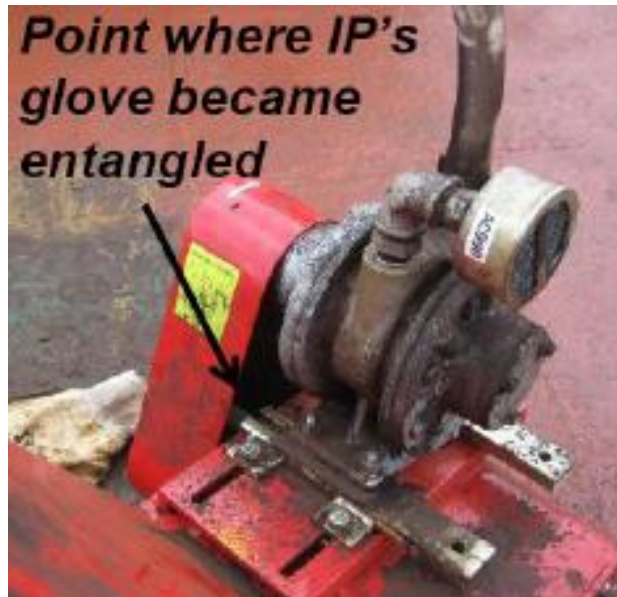
A member has reported an incident in which a crew member sustained a serious hand injury while using an air driven deck scaler during maintenance operations on deck. The crew member was wiping clean an area on the scaler to the rear of the motor when his glove became entangled in the drive belt and his fingers were subsequently trapped. The crewman sustained crush injuries to the tips of two fingers, and was medevaced for treatment and subsequent surgery. Fortunately no amputation resulted.

Figures – Deck scaling machine showing where person's glove was caught

- ◆ The deck scaling machine had no 'dead man' type control;
- ◆ The physical barrier to injury offered by the installed guards on the deck scaler was defeated;
- ◆ Existing company procedures for the use of this air-driven device clearly state 'disconnect airline before any trouble shooting or maintenance'.

- ◆ A design deficiency in the deck scaling machine;
- ◆ Failure to follow basic safe working practices.

- ◆ Further use of machines of this type was prevented until the suitability of appropriate control measures could be demonstrated. These included 'hard' barriers such as guarding and a dead man switch, and 'soft' barriers such as risk assessment and operating instructions;
- ◆ Further equipment was identified which may present a similar risk (guarding/dead man switch) i.e. drilling machines, lathes, bench grinders, etc. and actions identified which would appropriately manage the risk.

The manufacturer of the deck scaler was contacted to feedback concerns and highlight the lack of a 'dead man' switch on the device, and a swift and positive response was received from the manufacturer.

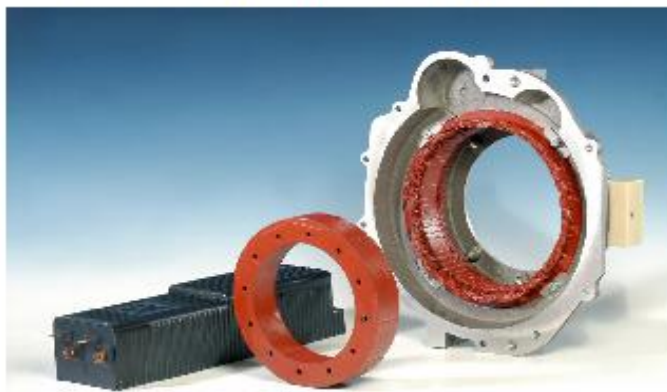
Image 1: main IFG parts

All STEYR MOTORS Integrated Flywheel Generators (IFG) are equipped with an electronic governor called the CCU. This CCU is 3 phase linked with the -bell housing containing- alternator which is generating an alternating current (AC). The CCU's positive and negative output sockets are twin galvanic separated terminals which should be singly or joint connected with a 24V battery group.

The main components are:
a) CCU (regulator)
b) permanent magnetic rotor
c) 3 phase coil

Due our policy to strive to let you deal with product improving modifications we recommend to exchange all 'old' type regulators. Swapping the previous ones for new types can be done without adaptations because of its compatibleness.

- Observe your aboard installation and check if your system is equipped with a previous (*image 1*) regulator or the modified (*image 4*) CCU.
- When equipped with a former (*image 1*) version: inform your supplier
- Refer in all communication -preferable in written- to this Service Bulletin under mention of this Service Bulletin number.

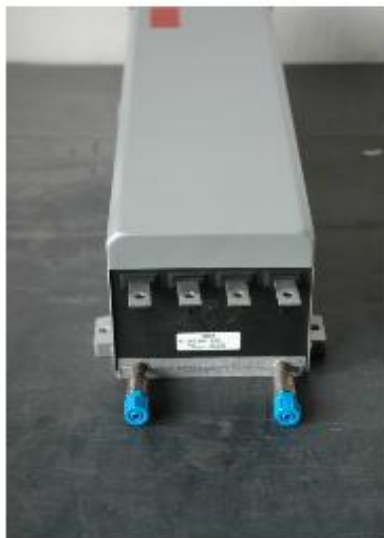
Image 2: new CCU (DC output)

The CCU, as shown in image 1, has been modified to meet nowadays requirements. For these are basically all terminals altered, the DC output into more robust terminals (see: image 2) and the input covered with a hood. (see: image 3)

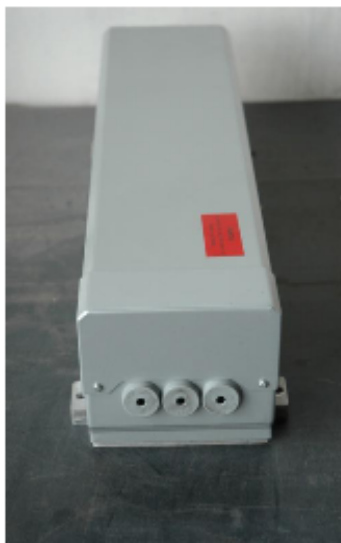
Image 4: new CCU

Another visible modify is the material and color the cover is made of, this has been changed from black/anthracite synthetic (*image 1*) into metal with a light grey coating (*image 2, 3 & 4*).
