IMCA Safety Flash 02/14

February 2014

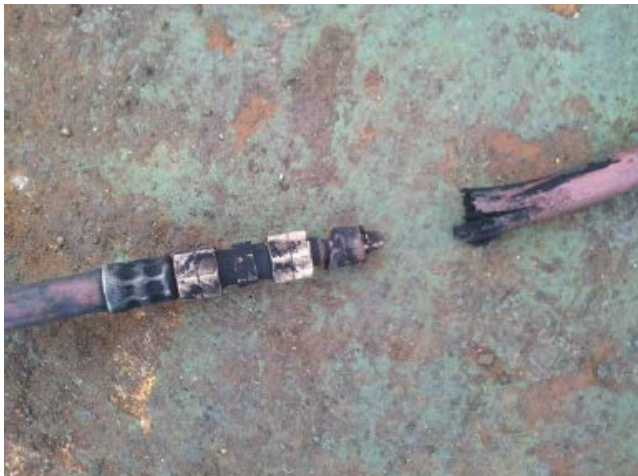
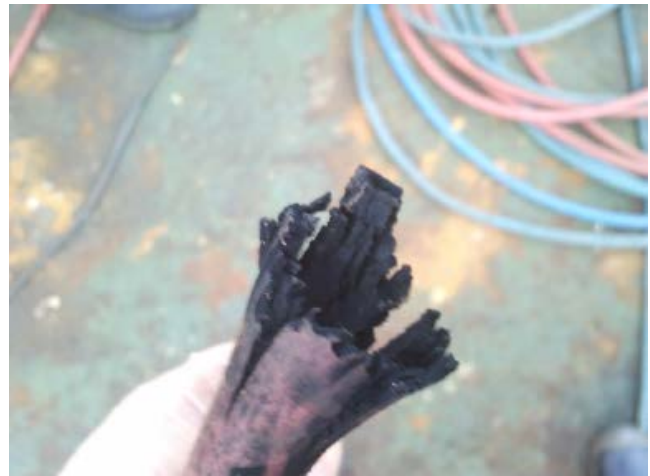
A member has reported an incident in which a sub-contractor's oxygen and acetylene cutting hose burst and caught fire. The incident occurred when the welder was ready to ignite the cutting torch head. The acetylene valve on the quad was slowly opened; the welder then opened up the oxygen and acetylene valves on the cutting head and ignited the tip. Instantly, there was a bang and flames were seen coming from a coil of oxygen and acetylene hoses on the deck. The burst created sufficient ignition and force to cause the hose to split in three separate places. The splits were located at the in-line hose connection points. The fire was immediately extinguished by the fire watcher who was able to fold over the two hoses thus preventing further gas flow. The gas supply was isolated at the cylinder and the hoses were vented. There were no injuries.

Figure: Showing damaged hoses after fire

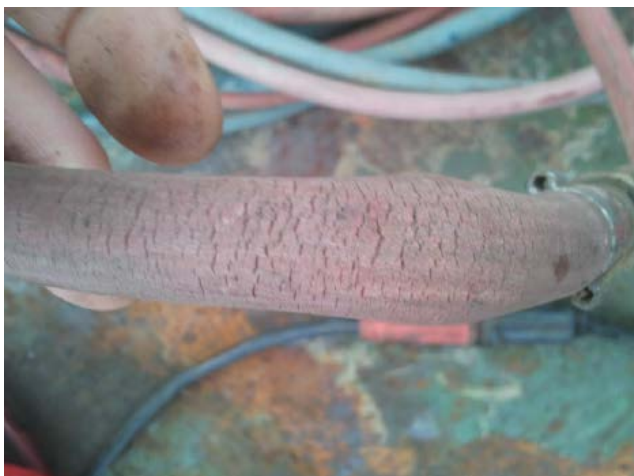
Work-hardened and perished hose

- ◆ The primary safety condition breached in this incident was: ***always use the correct tool safely to carry out the job***;
- ◆ Following the incident an inspection of the hoses revealed brittle and perished sections along the whole hose;
- ◆ It was suspected that the non-return valve on the cutting torch was inoperative, allowing a 'flashback' to take place within the hoses;
- ◆ Pre-use checks by the welders revealed that they set up the equipment without leak checking connections prior to using the equipment;
- ◆ The sub-contractor had a suitable leak detection substance but none was available at the incident site, and therefore the leak testing of cylinders and connectors had not been carried out.

- ◆ All welding and cutting equipment should be inspected prior to use, including:
 - Condition of hoses any perished hoses should be replaced immediately

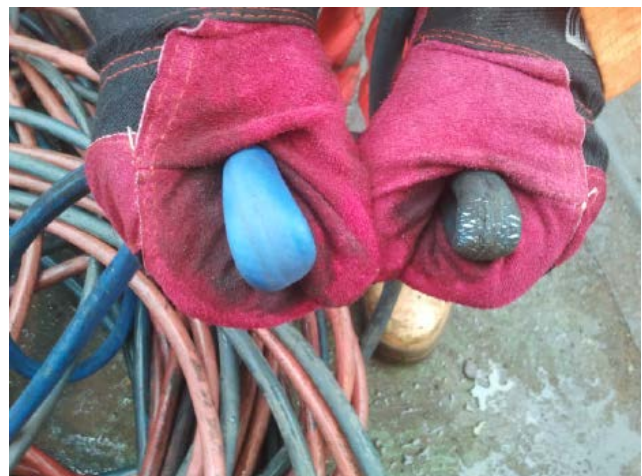
New (L) and old (R) hoses

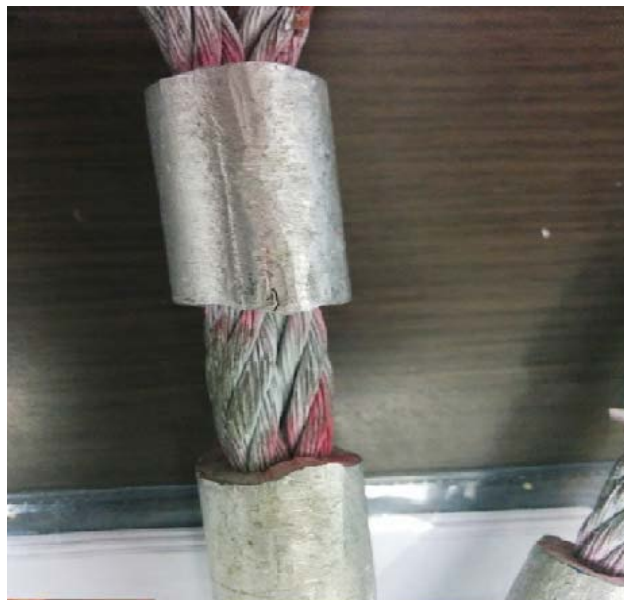
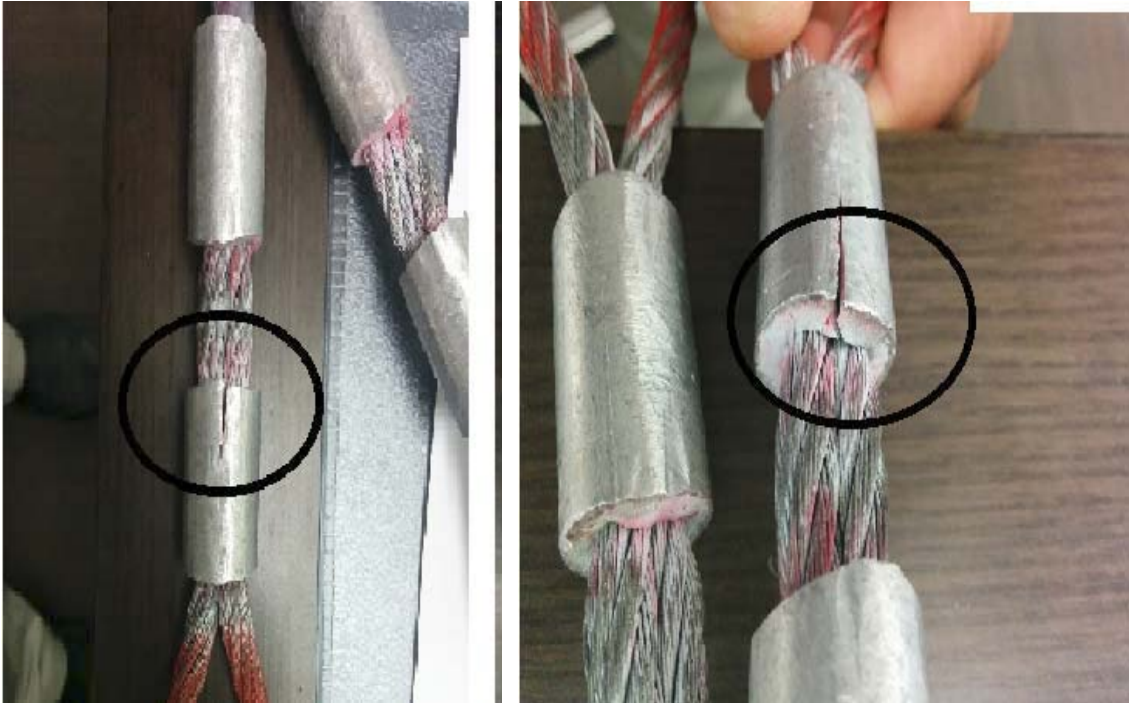
A member has reported an incident in which rope access personnel were found to be using damaged wire rope slings, which could have led to a dangerous situation and/or accidents.

Showing damage to wire rope slings

- ◆ All wire rope slings were inspected and checked before use at site (visual inspection) for deformities and wear and tear;
- ◆ Test certificates to be inspected before slings are used at site/yard;
- ◆ Ensured personnel were fully aware of this issue;
- ◆ Proper personal protective equipment (PPE) should be worn while lifting/handling slings;
- ◆ Manufacturer of the slings notified in regard to any defects/cuts/kinks in wire rope slings;
- ◆ Damaged wire ropes and slings should be removed from service immediately.
