IMCA Safety Flash 02/18

January 2018

1 LTI: Feet Trapped in Motion Compensated Telescopic Gangway

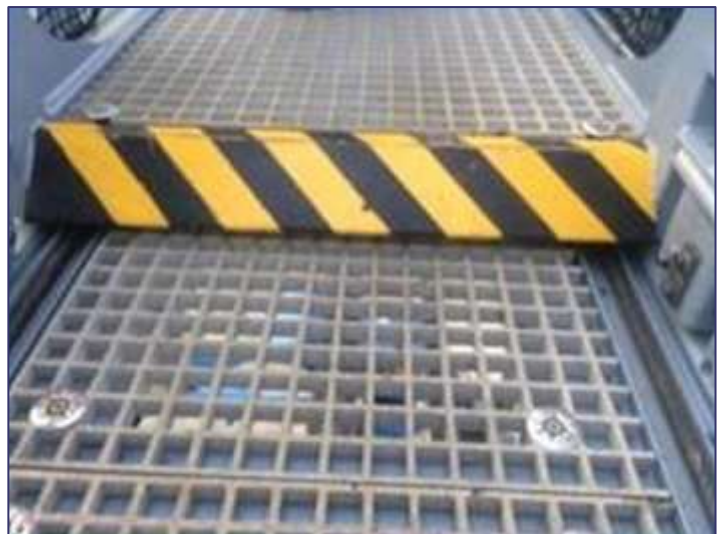
- ◆ The gap between the sliding step and the fixed part of the gangway on this particular system was sufficiently large to trap the steel toecap of a regularly sized safety shoe/boot.

- ◆ There was no specific design criteria for the gap between the sliding step and the fixed part of the gangway, nor was there an absolute norm for the monitoring of the gap;
- ◆ There was insufficient lighting on the gangway which resulted in a lack of awareness of the location and movement of the sliding step;
- ◆ The gangway induction video did not generate sufficient awareness regarding the potential hazard of the movement of the sliding step and its associated pinch points.

- ◆ Immediate check of the gap has been conducted on all Ampelmann gangways of this sort, and where required, corrective action taken;
- ◆ Reassessment of engineering specification of the gap in production, and implement maintenance procedure for regular monitoring of gap;
- ◆ Improve the existing safety video by increasing the emphasis on the sliding step and the associated pinch points;
- ◆ Increase the night-time visibility of the sliding step on both existing and future systems:
 - retrofit gangway lighting to the existing fleet
 - include gangway lighting on future gangway designs.

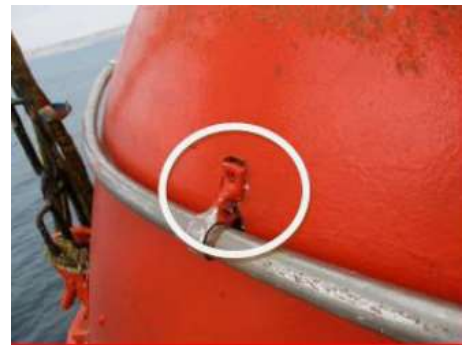
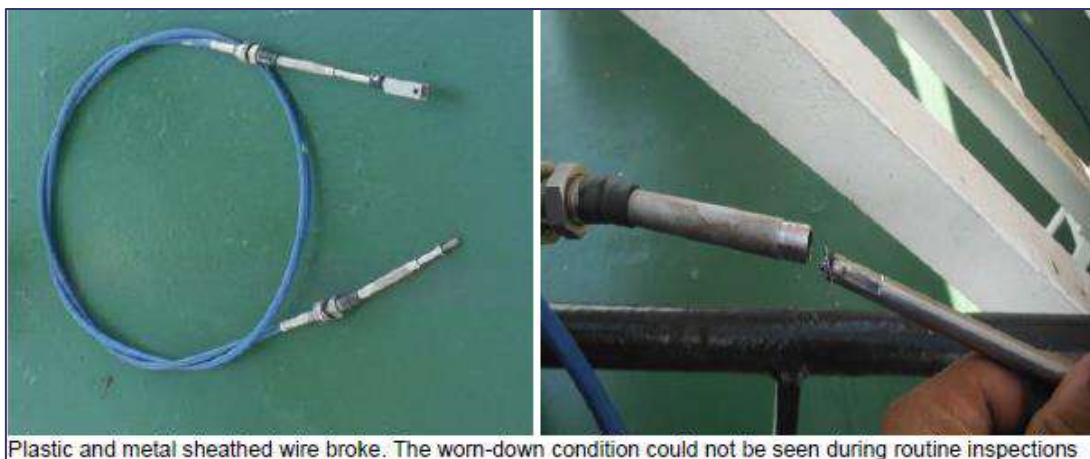
Plastic and metal sheathed wire broke. The worn-down condition could not be seen during routine inspections

- ◆ The release wire was broken inside the sheathing and this was not visible to the crew;
- ◆ The on-load release mechanism hook could not be locked in the shut position and the locking piece for the forward hook froze, delayed the hoisting;
- ◆ A **causal factor** was that the release wire was not inspected or checked by the maker during the 5 yearly tests of lifeboat in the dry dock which had been completed two months prior to this incident;

- ◆ **Root causes** identified included:
 - there were no clear instructions in the maker’s manual regarding renewal intervals of sheathed wires;
 - inadequate compliance/risk seen as tolerable – the service technician certified the condition of the boats and its equipment as good based on the test conducted at a recent drydocking.

- ◆ Deeper awareness needed of the risks involved with hidden or difficult to access failure or corrosion;
- ◆ Instructions on renewing the release wires as per maker’s recommendation to be placed on board;
- ◆ Use portable fenders if available when work is being carried out on boats while at water level and the sea state demands it.

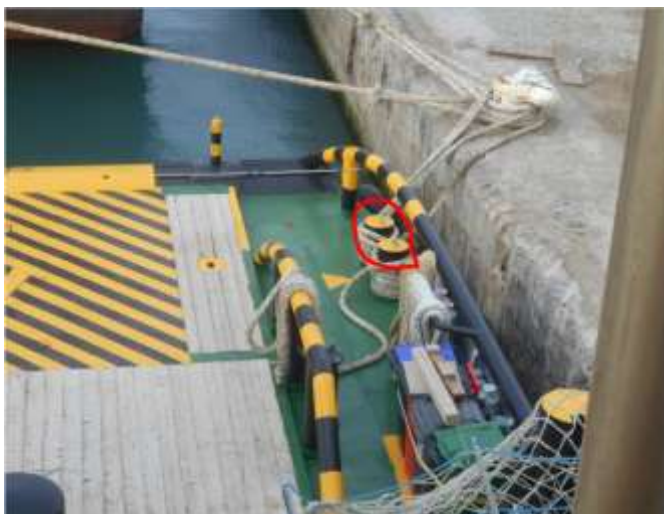
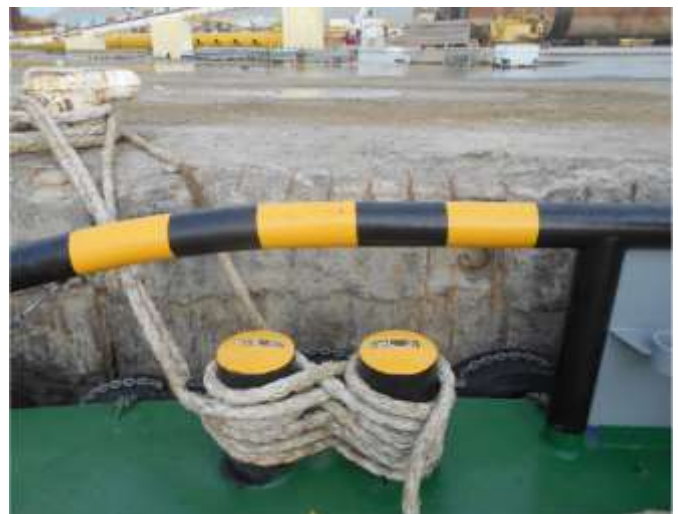
During mooring operations, an Able Seaman (AB) jumped from the vessel to the quayside to receive the mooring ropes. In doing so he slipped over the bulwark and fell over the side into the sea from a height of 1.75m. At that time, the gap between the vessel and the quay was 0.5-0.6 m.

- ◆ **Procedures not followed:** By jumping from the vessel to the quay, the crewman violated existing written procedures. All other persons present were aware that this practice was forbidden, and were aware of the possible consequences, but no-one stopped him;
- ◆ **Shortcuts:** The vessel Master did not ask the Port Authority for assistance due to alleged issues experienced in past, where this assistance was either not provided or was provided with a significant time delays. As a result, a shortcut was taken by the vessel crew, which resulted in the incident;
- ◆ **Routine acceptance of risk/complacency:** It was concluded by the investigation team that the unsafe practice of jumping from the vessel to the quayside had developed over time without being confronted or stopped by management.

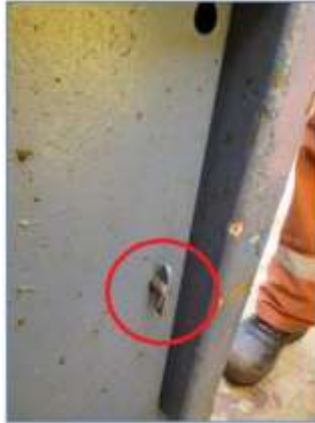
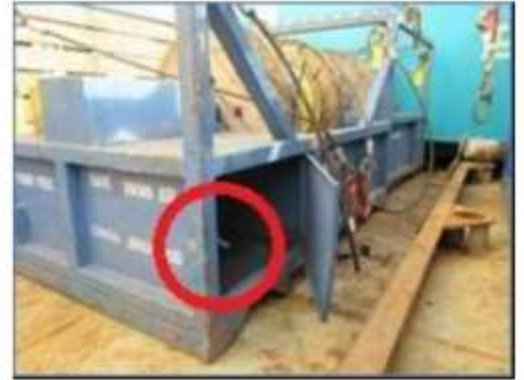
During the lift, the storage door had opened which revealed a small tool box inside which was not secured.

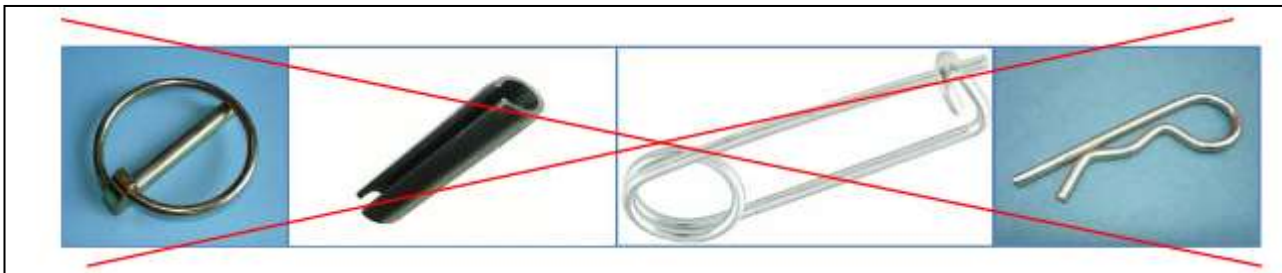
Unsuitable secondary retention methods include linchpins, R-clips, spring/roll/nappy pins or any other type of pin device. All these means of secondary retention for lifting equipment or securing at height can spring open or be knocked out.
