## IMCA Safety Flash 02/19

February 2018

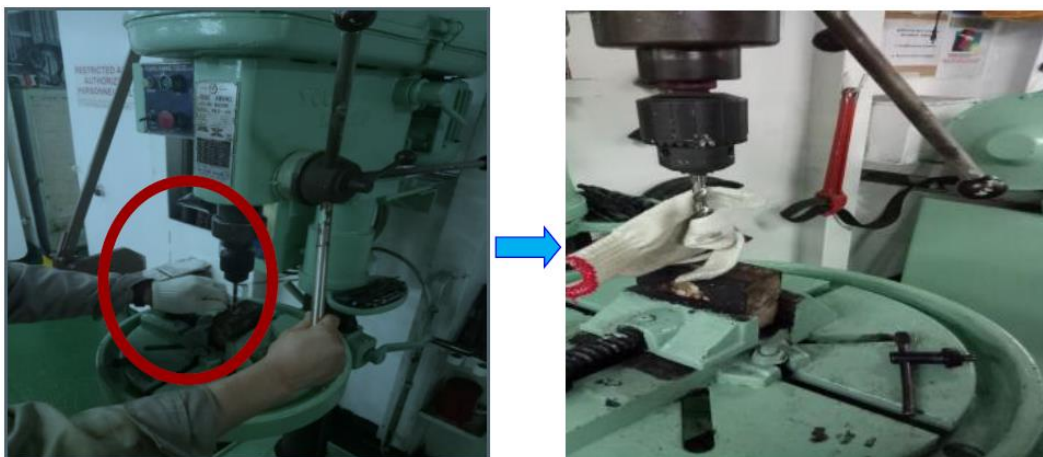
An electrician tried to modify a cable shoe using a pillar drill in the engine room workshop. During initial use of the drilling machine, the electrician secured the cable shoe with a vice and did not wear any gloves. However, during subsequent drilling to finalize/enlarge the hole, he did not secure the cable shoe properly, and he held it with his left hand whilst wearing cotton gloves, as the cable shoe had become too hot to touch.

His glove got entangled with the drill bit, resulting in a serious injury to his left index finger. Following first aid, he was medevaced by helicopter and transferred to hospital for further treatment. Medical examination revealed a partial amputation of his left index finger and open fracture dislocation of his thumb and damaged tendons, requiring surgery.

- ◆ There was no evidence of any risk assessment, and a toolbox talk (TBT) was not conducted;
- ◆ The electrician was wearing gloves while using the drilling machine, though there was a warning sign prohibiting wearing of gloves when operating drill posted nearby;
- ◆ Immediate causes:
  - improper use of personal protective equipment (PPE); glove got entangled with the drill bit

- carelessness; warning signage was ignored, and the cable shoe was not secured properly before drilling started;
- ◆ Causal factors:
  - inadequate planning and lack of risk assessment
  - electrician did not inform others of his intent to use the drill, and he was rushing to finish the work.

- ◆ Gloves and loose clothing should not be worn when working with rotating machinery;
- ◆ “More haste – less speed” - avoid shortcuts and rushing to finish the job.

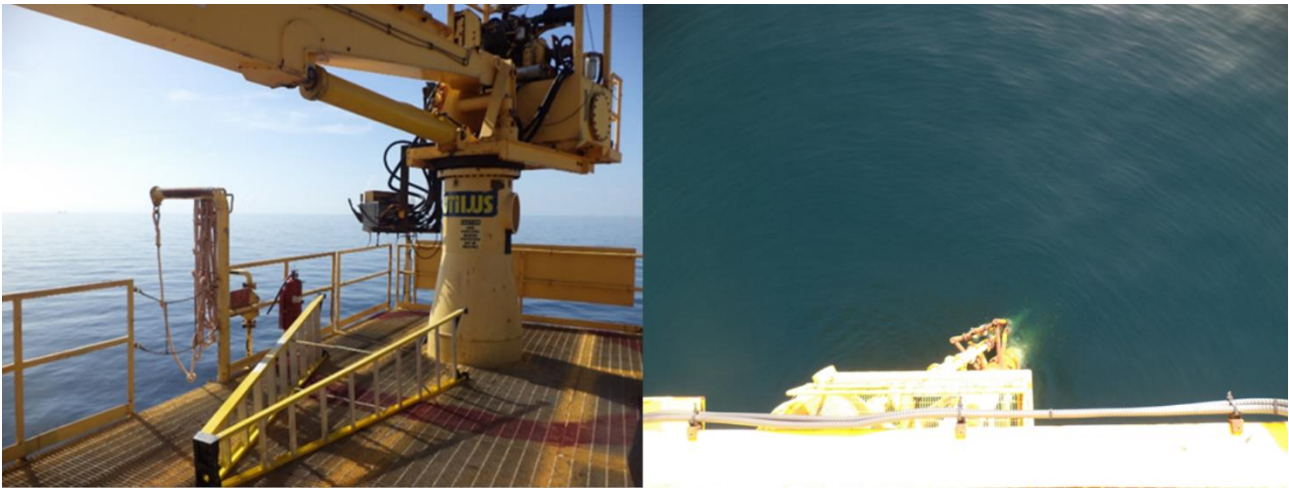
The worker was replacing a control valve on the platform crane. A 3m ladder was placed between the overboard handrail and the crane. As the mechanic was positioned on the crane skid (located around 2m above deck) he realised that he would need to descend the ladder to retrieve tools for the job. After repositioning himself on the ladder, his grip or footing was lost, causing him to fall backwards and land in the water approximately 24m below.

- ◆ High winds prevented the worker from retrieving a life vest which was thrown to him, but was later able to retrieve a vest which had been placed into a life ring;
- ◆ Strong currents caused him to drift further from the platform;
- ◆ The worker did not follow the safe work practices which required him to use fall protection for heights exceeding 6ft above the deck;
- ◆ The United States Coast Guard (USCG) regulation (33 CFR 146.20) requiring the use of work vests when working near or over water was also not followed;
- ◆ The job safety analysis (JSA) did not identify falling as a potential hazard during this operation.

*Location of crane mechanic at time of incident (left) and view over the handrail (right)*

- ◆ Ensure that proper procedures are implemented establishing minimum requirements for working at height;
- ◆ Make sure personnel working at heights have knowledge and experience required to perform the job safely;
- ◆ Review all pre-job planning procedures to ensure all necessary response procedures are included:
  - consider equipment position and hazards when completing pre-job planning so as to minimize risk.

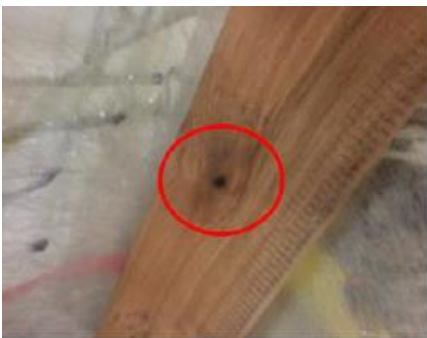
*Knots in the wooden step*

- ◆ Accommodation ladders and gangways, and associated fittings, should be properly maintained and inspected at appropriate intervals;
- ◆ When accommodation ladders and gangways are rigged, checks should be made for signs of distortion, cracks, or corrosion;
- ◆ Care should be taken to ensure all moving parts are moving freely and are lubricated as necessary;
- ◆ Checks should be made of any lifting equipment or wires;
- ◆ Examine the underside of accommodation ladders and gangways at regular intervals;
- ◆ Rigging and derigging of accommodation ladders and gangways should be conducted under appropriate supervision.

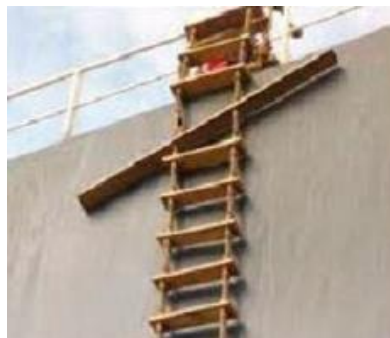
*Missing chock and steps unsafe for boarding*

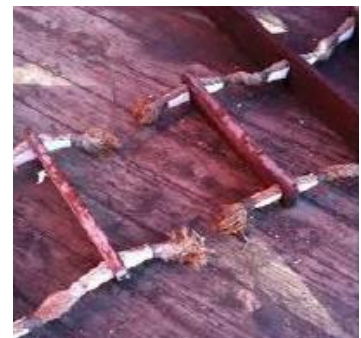
*Parted side ropes*

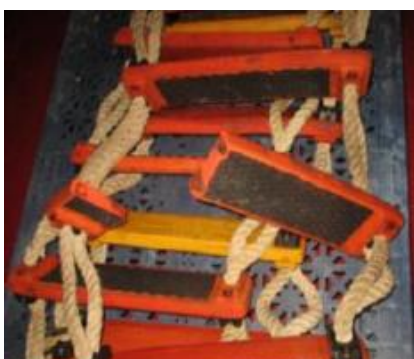
*Broken step on a pilot ladder*

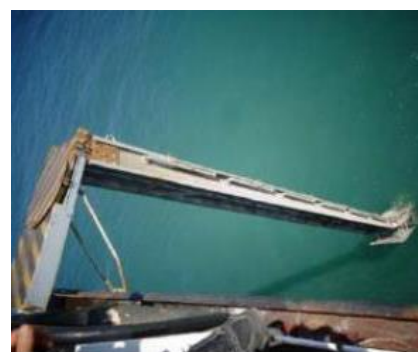
A member has taken a focus on pilot ladders and gangways, following an incident where a gangway collapsed, causing the death of the pilot. In that particular incident, a gangway wire parted causing the gangway to pivot at the top platform hinge and fall into the sea.

*Gangway damaged after wire parted*

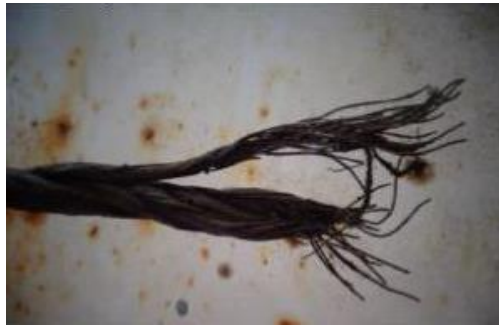
*Break following ineffective maintenance of gangway wire*

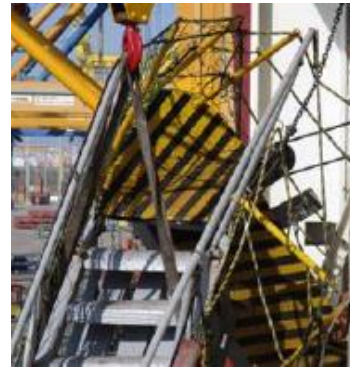
*Wrong operation of gangway*

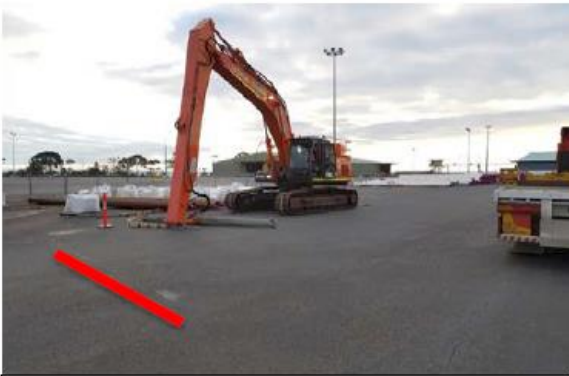
During load out of a 30cm uncoated line pipe onto a transport trailer, the vacuum lifter unit being used to move the pipe lost suction and uncontrollably released (dropped) a 12m length of line pipe (weighing 1.8Te) from approximately 2m in height. This occurred as the excavator was slewing towards the transport trailer to load the single pipe length. No alarms were sounded, and no warning was provided to the excavator operator at the time of the incident. There were no personnel in the area during the lifting operation. The vacuum lifter requires no personnel interaction, other than the excavator operator (who is located inside the excavator cabin).

Image 1: Showing Excavator (left) and location of trailer (right).  
Red line showing location where line pipe was dropped.  
Uncoated line pipe can be seen to left of excavator

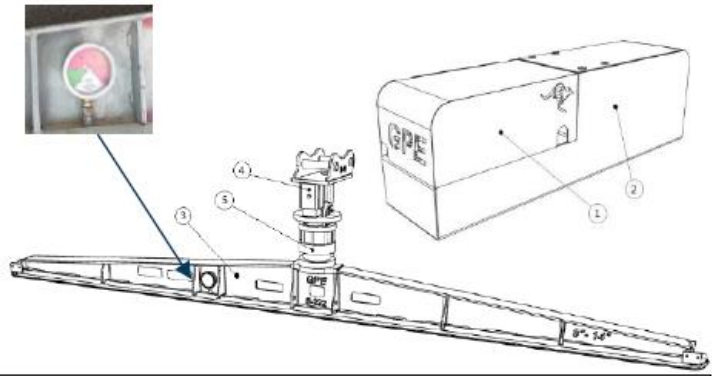
Image 2: showing the vacuum lifter unit installed on the excavator.  
1: Power pack 2: Vacuum reservoir 3: Vacuum 'shoe' 4: Polyhandler head adaptor 5: Hydraulic rotator and mount.  
Note: vacuum shoe gauge shown insert.

- ◆ The vacuum seal on the 'shoe' was worn out after moving over 5000 lengths of line pipe. Half of the vacuum seal was replaced on the morning of the incident; this created a situation where the seal was neither effective nor consistent across the length of the pipe;
- ◆ A guide tab was missing from the head of the unit which helps the operator align the vacuum shoe across the apex and centre line of the line pipe; this may have caused the unit to seal a few degrees outside of parallel along the centre line and contributed to the sudden loss of suction pressure;
- ◆ There was no routine testing done to ensure the vacuum unit was holding pressure;
- ◆ A full maintenance schedule was not provided by the equipment supplier.

- ◆ Ensure that personnel operating vacuum units have a full understanding of required maintenance (daily, weekly and other) including replacement of consumables such as shoe rubber seals;
- ◆ When using lifting devices that use suction pressure to hold the load, daily tests should be completed to confirm integrity. Our member suggests a 'ten for ten' test, where the load is held for 10 minutes to confirm no greater loss than 10% of pressure; this is a good example of verifying that the system is working as intended;
- ◆ Regular maintenance should verify that alarms function and work at correct levels for the work scope. In this instance, the alarms were function tested during the pre-start but did not sound during the event.

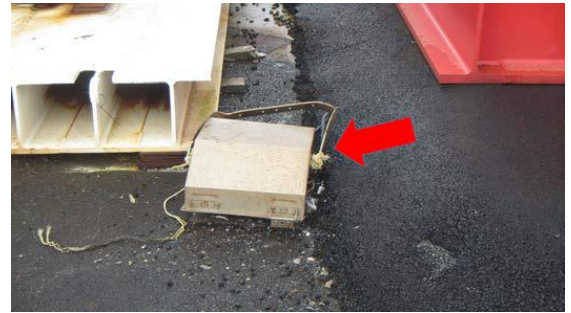
Yard personnel found a flood lamp broken on the ground. It was found to have fallen from a VLS tower that had been in long-term storage for a number of years. There were no injuries, however the area where the lamp landed was regularly attended by workers.

- ◆ Mounting bolts and bracket, together with secondary securing wire, were fully corroded;
- ◆ There had been no maintenance, nor inspections of any kind during the storage period;
- ◆ There had been no evaluation carried out at the start of the storage period, to consider removal of this type of ancillary equipment, or to increase secondary securing.

*The lamp weighed 15kg with the glass and bulb. It landed about 0.5m from the base of tower (red structure in top right corner).*

- ◆ Ensure storage philosophy and maintenance regime is discussed properly to ensure continued integrity of long-term stored assets;
- ◆ Ensure dropped object surveys include equipment in long-term storage;
- ◆ Consider removal of as many ancillary items as sensible, when initiating the long-term storage of equipment;
- ◆ Focus on material selection for secondary securing; ideally using seawater resistant stainless steel with double securing clips to withstand corrosion.

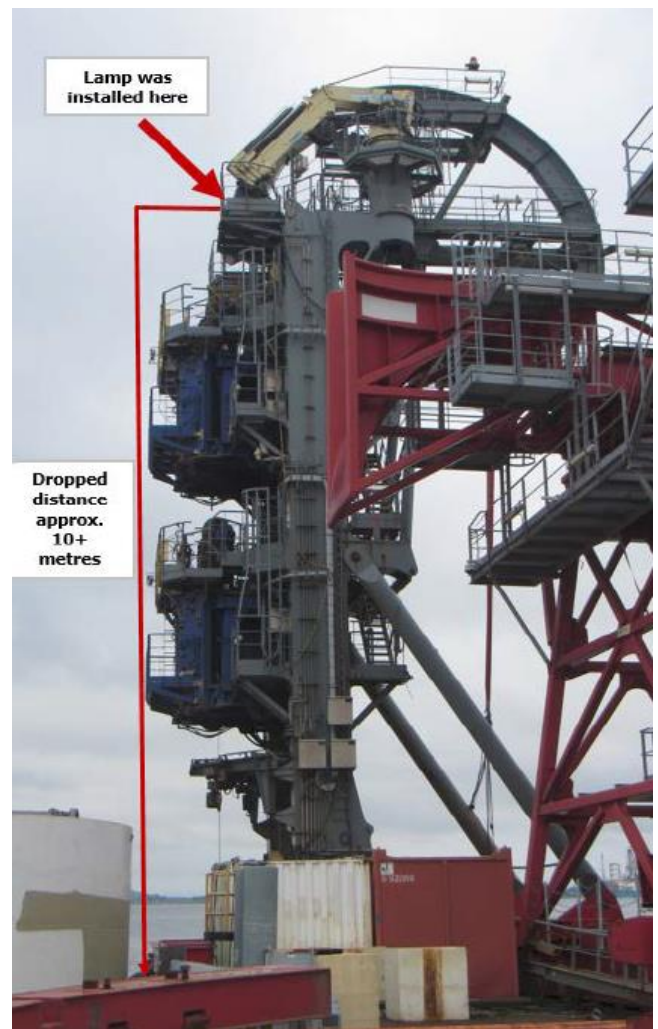
*The flood lamp fell approximately 10 metres*
