These flashes summarise key safety matters and incidents, allowing wider dissemination of lessons learned from them. The information below has been provided in good faith by members and should be reviewed individually by recipients, who will determine its relevance to their own operations.

I ROV Personnel Injury

2 Crane Incident

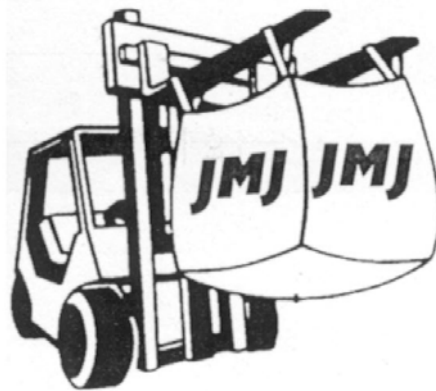
Single trip tote bags are commonly used in the onshore construction industry for delivering quantities of building materials such as sand. Because of the convenience, they have been adopted in subsea construction operations for delivering a quantity of sand bags, for example, to the seabed. While one of our members' vessels was mobilising, such a bulk loading bag failed causing the sand-bags which it was carrying, to drop onto the quayside. Nobody was hurt but the near miss incident highlighted that the practice of slinging these bags and the quantity of material which they are carrying, needed to be better controlled.

The bags are designed to be carried by a fork lift truck using the forks themselves to hold two sides of the bag as in the sketch below. Whilst this is not feasible for the member vessel's operations, the preferred solution is that the bag should be supported from a rigid cross frame or similar such that each corner is slung vertically. Alternatively, some bag suppliers may allow the bag to be slung by a four leg sling but the length of the sling must be sufficiently long to minimise the effect of the corners moving towards each other. (Sling leg lengths in excess of 3 metres, have been stated by one supplier).

- ◆ A suitable designed and certified lifting arrangement should also be supplied, so that the load can be applied equally at each corner of the bulk handling bag;
- ◆ The Safe Working Load (SWL) of the bag should be clearly identified and personnel instructed as to how much material this equates to (for example number of sandbags) as very often a 1te load will not even register on the larger cranes' indicators;
- ◆ The quantity of material loaded should take into account the dynamic loading caused by high accelerations of cranes working at sea and it should be noted that wet sand is very much heavier than dry material.

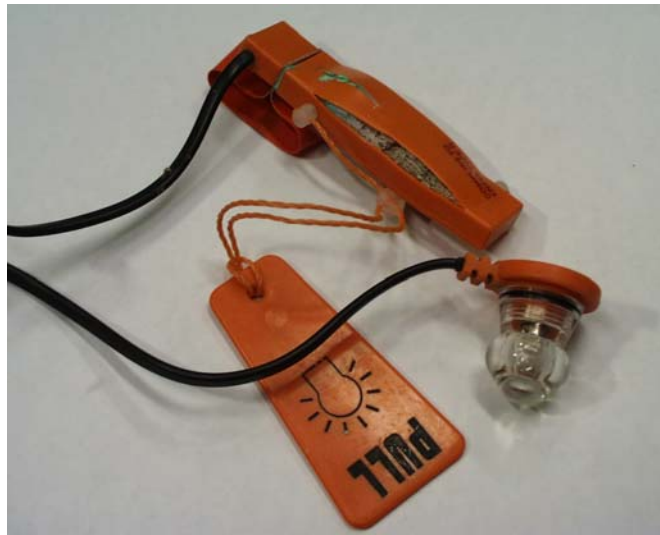
One of our members has reported that on one of their vessels they found that the battery to the lifejacket had swelled out, resulting in a ruptured battery. The maker of the battery is McMurdo and the expiry date was January 2002. Below is a picture of the ruptured battery.

When the member alerted its other vessels to this failure, another vessel reported that on checking its lifejackets, two lifejacket lights were found in a similar condition to that above. The expiry dates for their batteries were August 2001 and May 2003.

The member is now in discussions with the manufacturer on this issue.
