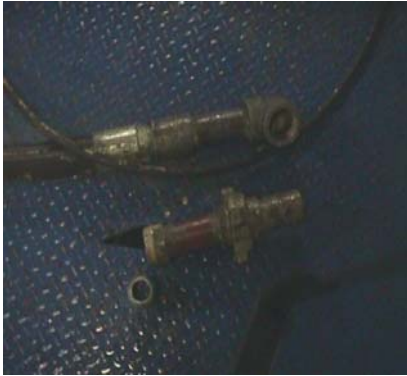
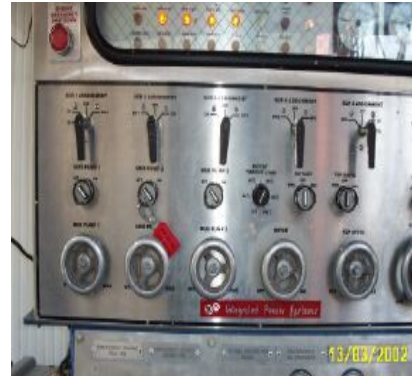
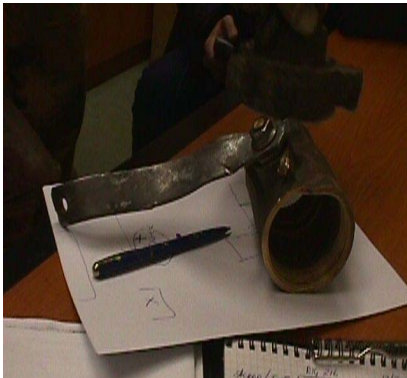
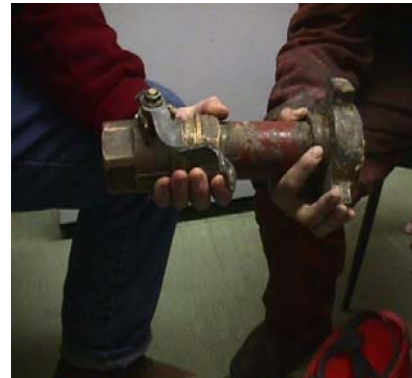
When the operation was completed, the floorman closed the ball valve and asked the roustabout to help him and pick up the filling hose. At that moment, the mud pump activation increased the hose pressure and the ball valve and hose blew, causing an injury to the right hand of the roustabout. The roustabout was visited and the doctor confirmed strong contusion from the elbow to the fingers of his right arm.

- ◆ the filling hose was not a heavy pressure type;
- ◆ the centrifugal pump and mud pump were controlled from the driller's console by the same device (see photo). This system is to be changed to eliminate the reoccurrence;
- ◆ there was no relief valve in the circuit;
- ◆ the roustabout hadn't received the appropriate training to carry out duties on the rig floor.

- ◆ Toolbox meetings and JSA to be implemented and developed in order to ensure proper planning;
- ◆ A relief valve will be installed, over pressure shall be safely released and a new control for pumps operating separately from the driller's console will be installed;
- ◆ Ensuring roustabouts will not operate on the rig floor without prior suitable training.
