IMCA Safety Flash 03/04

March 2004

SAFETY ALERT - CONFINED SPACE ENTRY

DIVEX PRODUCT BULLETIN

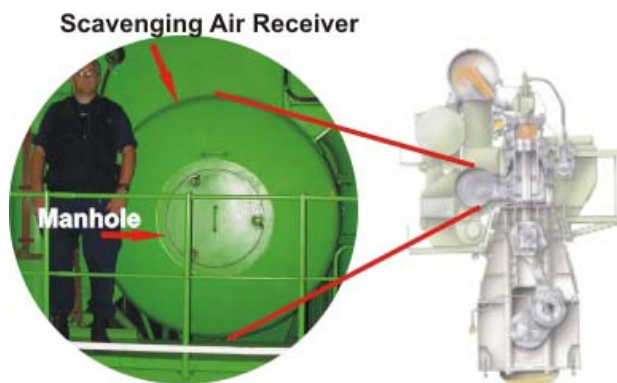
The vessel was powered by a Burmeister & Wain, 9 cylinder two stroke engine that develops over fifty-five thousand horsepower. The engine's scavenging air space can be accessed by two manholes located on both ends of the scavenging air receiver.

These circular manholes are secured by three L-shaped dogs having an outer edge that is tightened against an inner circumferential lip on the edge of the access hole. Tightening is achieved by the use of a handled fastener.

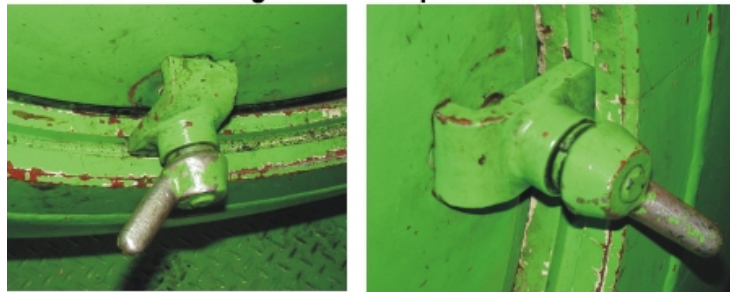
Dogs in latched position.

Coast Guard investigators determined that the engineer entered the scavenging air receiver alone. Although his reason for entering the receiver is not known, engine maintenance was performed in that space while at the first port and he may have returned to inspect the area for left behind tools and materials or to retrieve something. It appears that after his entry, the easily moved hinged / inward-opening door accidentally closed. Investigators believe that at that time, the upper left dog due to its weight and perhaps the vibration of the door as it closed, caused the dog to move allowing its edge to catch the circumferential lip at the opening. Once caught, even with the loosened fastener the door could no longer be opened from the inside of the receiver.

- All vessels complying with the International Safety Management Code (ISM) have a specific plan for entering confined spaces outlined within their Safety Management System.
- The confined space entry procedures include and identify various types of shipboard spaces such as those previously mentioned that could be encountered and which should be treated as confined spaces.
- Crew safety meetings address the identification of confined spaces and provide instruction on confined space entry procedures.
- Individual crewmembers that work in confined spaces review existing entry procedures and requirements regularly.
- All other vessels and maritime operations falling outside of ISM requirements develop and include in their marine safety programs similar confined space identification and entry procedures.

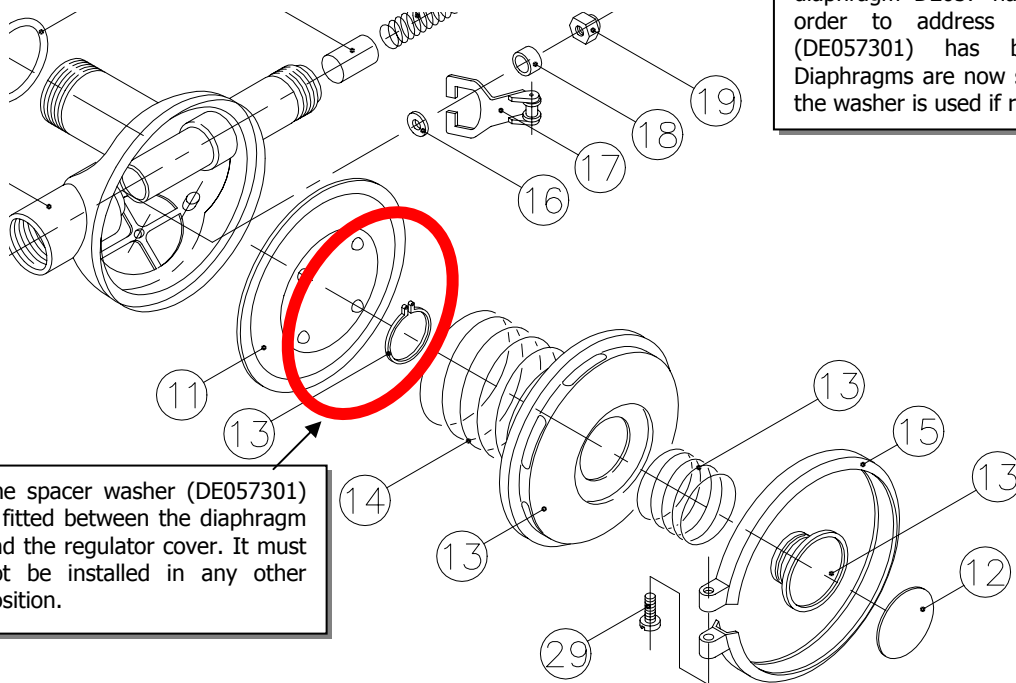
Due to small changes in component dimensions over recent years the "fit" of the Ultraflow regulator diaphragm DE057 has been seen to be variable. In order to address this issue a spacer washer (DE057301) has been introduced. All spares Diaphragms are now supplied c/w spacer washers and the washer is used if required.

Small changes in component tolerances for parts used on the Ultraflow regulator assembly has resulted in some cases with the assembled regulator not having as secure a grip of the diaphragm between regulator body and the cover as is ideal.

The spacer washer (DE057301) is fitted between the diaphragm and the regulator cover. It must not be installed in any other position.

The test is simple: when the regulator body/diaphragm/biasing spring/cover & clamp have been assembled and the clamp screw (#29 on diagram) tightened to the recommended torque setting of 8 inch /pounds.

If when holding the assembled regulator in one hand and holding around the clamp with the other and twisting, the clamp band can be turned without much effort by the technician then the washer should be fitted. If the clamp is secure without the washer being installed then it is not required. No tools should be used to grip either part.

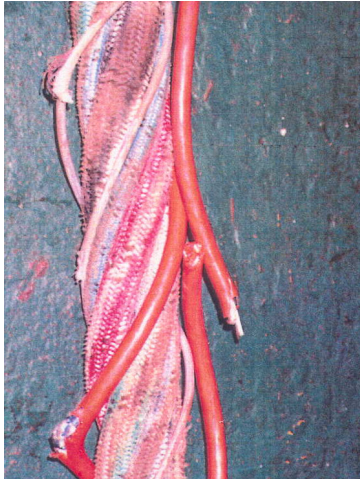
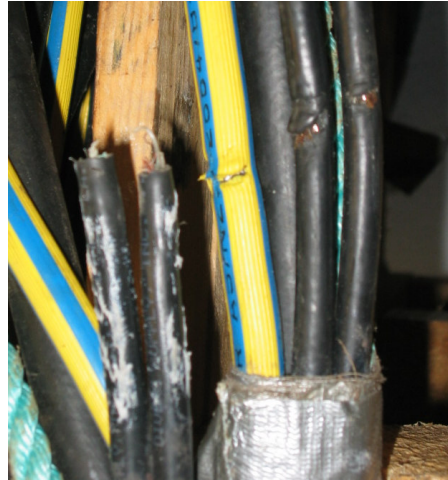
Past and recent examples of umbilical damage, both offshore WA

A recent, potentially fatal incident offshore again highlights the need for diligent umbilical management by divers, tenders and supervisors. Improper umbilical management has resulted in fatalities.

- Suitable for the tasks and project hazards
- Marked for monitoring the amount payed out
- Buoyancy suitable for the conditions
- Tender able to monitor and communicate with the diver by line pulls if required:-
 - Is a wet tender required
 - Are only weak links used to secure umbilical at the work site
 - Are the personnel competent for the conditions?
