IMCA Safety Flash 03/12

April 2012

2 Lifting Post Failure on Survey Equipment

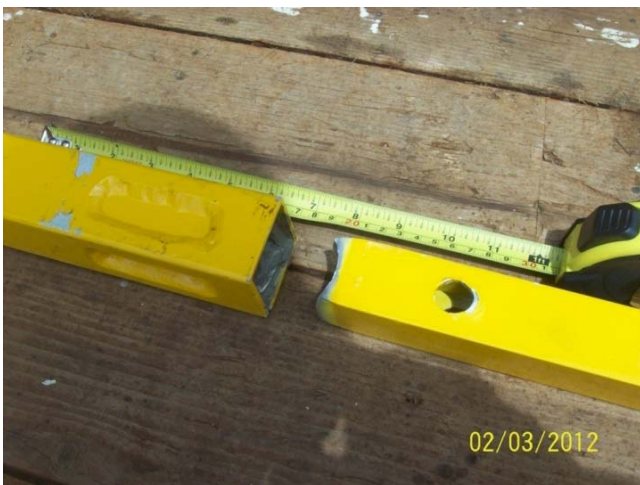
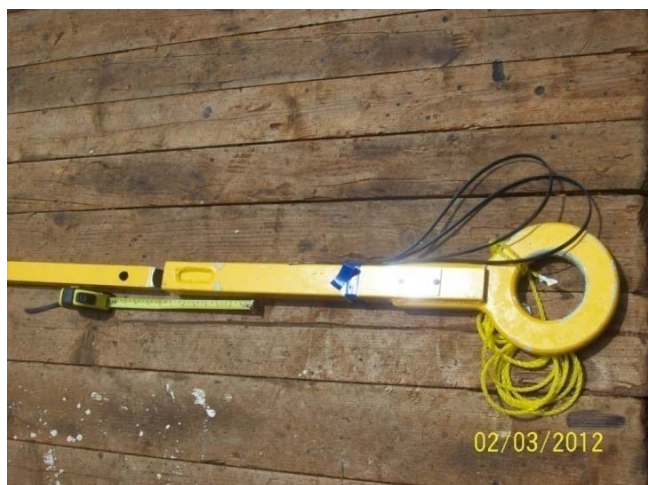
Showing failed lifting post

- ◆ The central lifting post had failed where the lower box section entered the upper box section. This area was not a welded joint. The weld connection was above this on all four sides through cut outs in the upper box section.
- ◆ The lifting arrangement for the equipment was inadequate for deployment subsea, as the additional forces of the splash zone had not been sufficiently factored into the design.

- ◆ Stopped use of this lifting arrangement until a new and safer design could be developed;
- ◆ Quarantine of spare lifting post and equipment owner informed that the Lifting certificate should be withdrawn;
- ◆ Check with other projects and with IMCA members to see if they are using similar equipment, and quarantine as necessary;
- ◆ Until suitable lifting points are designed and tested, all lifting of the tool shall be via basket with certified lifting points.
