## IMCA Safety Flash 03/18

January 2018

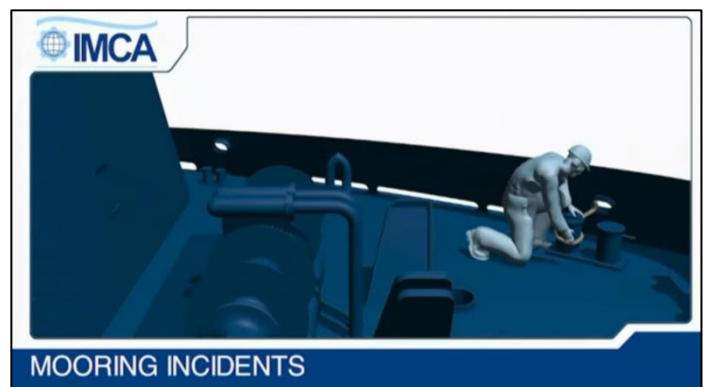
### 1 Snapped Mooring Line

The line was slackened as the vessel moved forward. After about 15 meters, the line got stuck in the storage drum of the winch; this prevented it from paying out even when the winch was being turned to allow slackening of the line. Due to the forward movement of the vessel, the line was not able to carry the tension and snapped near the winch drum.

The mooring line got stuck in the storage drum of the winch.

- ◆ Ensure mooring lines are laid out on the deck and remove any jammed or stuck ropes or lines in the drum or winch;
- ◆ Establish two-way communication between the mooring stations and the bridge;
- ◆ Ensure all persons involved in mooring operations wear appropriate personal protective equipment (PPE).

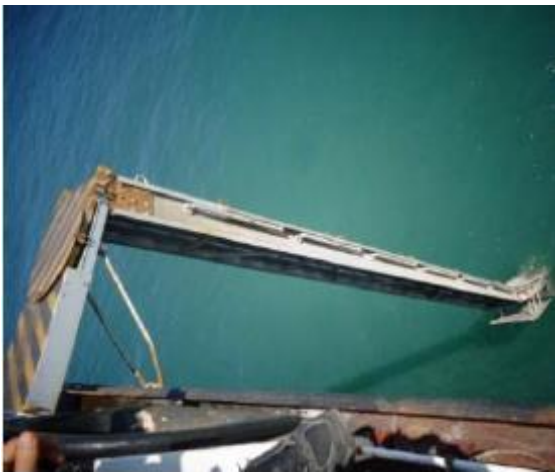
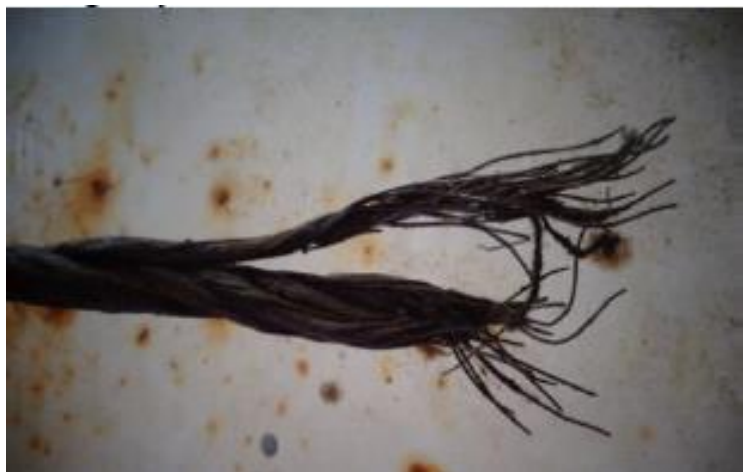
## 2 Gangway Damaged When Lifting Line Parted

A lifting line failed whilst vessel crew were lifting the gangway to stow it in position on departure from an anchorage. The gangway was hoisted to a position 20-30 cm below the final position, when suddenly the wire parted making the gangway pivot at the top platform hinge, and it fell freely to water level. Due to this free fall and sudden jerking the gangway was severely damaged – multiple cracks, rendering it unusable. It had to be replaced. There were no injuries.

The **immediate cause** was found to be that the gangway lifting wire had deteriorated and was not in good condition. A causal factor was inadequate maintenance – there was inadequate and improper greasing. The wires were dry on the inside resulting in the wire deteriorating faster.

- ♦ The risk of this wire failing on this recurring task was seen as tolerable;
- ♦ There was also no proper supervision or verification of the maintenance by the supervisor.

- ♦ Ensure required checks and maintenance of the gangway are carried out;
- ♦ Monitor overall condition of the gangway *including the wire* when picking up and lowering, and report any defects noted immediately;

- ◆ Ensure crew are aware of how to effectively grease lifting wires;
- ◆ Supervise and verify the greasing of wires to ensure this is done correctly.

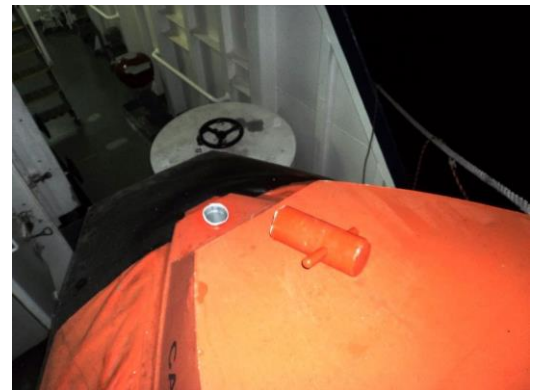
### 3 Fast Rescue Craft Damaged by Inappropriate Use

The mooring bollard on the FRC broke under tension when the FRC started to tow the oil boom.

The FRC was not fit for this purpose and this was not considered while planning or risk assessing the task in preparation for the exercise. A suitable work boat should have been used for positioning of the oil boom.

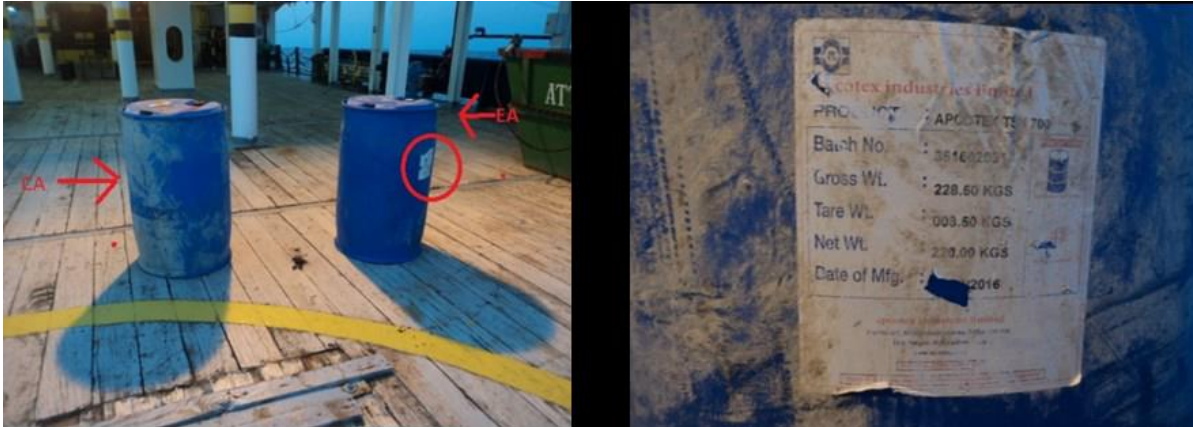
## 4 Inadequate Handling and Storage of Potentially Hazardous Substances

Two drums with unknown chemicals were observed, floating in the sea. The crew retrieved these drums onto the vessel, but they were not stored safely.

The vessel crew retrieved the drums on board without considering the risks, i.e. they were not aware of the type of product, or the condition of the plastic drums. The drums were placed without drip trays in close vicinity to a deck area commonly accessed by the crew, potentially exposing personnel to unknown risks;

Shore side management were not informed about the collected chemicals.

- ◆ A risk assessment should be carried out before handling chemicals or unknown substances potentially hazardous to health;
- ◆ Vessels should report immediately if unidentified floating objects are observed and retrieved onboard, so that adequate collection and destination can be arranged.

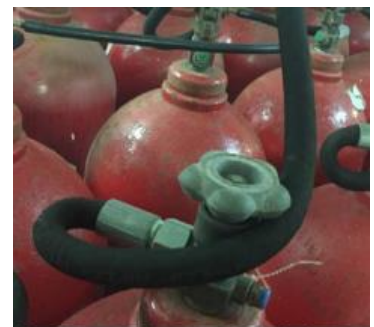
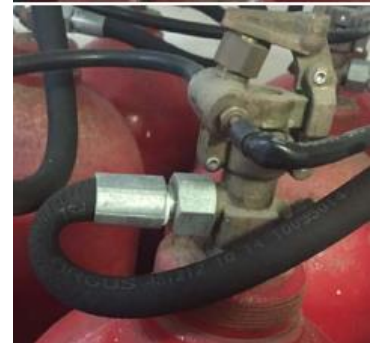
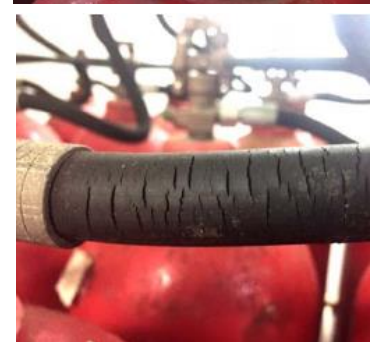
## 6 Fixed CO<sub>2</sub> Fire Extinguishing Systems - US Coast Guard Alert

During the inspection, it was noted that some of the hoses which connected the large CO<sub>2</sub> cylinders to the manifolds were wrapped around the bottle valve handles (as shown in the accompanying photographs). The bottles could have been in place for a long period of time, in their original positions without regard to the stresses placed on the connecting hoses.

Inspectors also found significant cracking of the CO<sub>2</sub> discharge hoses which were under tension (see photograph). This condition is known as ozone cracking and occurs when very small amounts of ozone in the atmosphere interact with the polymers that compose rubber products and certain other elastomers when those products are under tension.

The USCG notes that IMO has published [MSC.1/Cir.1318](#), "Guidelines For The Maintenance and Inspections of Fixed Carbon Dioxide Fire extinguishing Systems". This provides the minimum recommended level of maintenance and inspections for fixed carbon dioxide fire-extinguishing systems on all ships in order to demonstrate that the system is kept in good working order, as specified in SOLAS regulation II-2/14.2.1.2. In addition to other important information, it provides useful maintenance and inspection guidance.
