IMCA Safety Flash 04/09

I Burns Suffered in Confined Space

Understanding mooring incidents

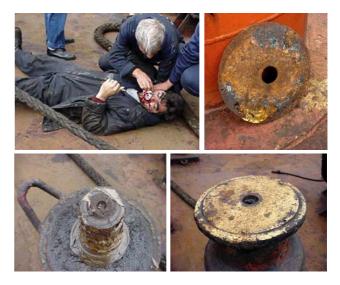
An A/B was seriously hurt when a roller fairlead detached from its pedestal whilst under the influence of a mooring line under tension. The A/B was standing in the snap-back zone and was struck by the rope, which hurled him into the foremast causing head injuries.

The rope hurled the roller fairlead 20 feet from the ship to the quayside.

The angle or directional lead of a rope should be considered when using leads in order to prevent incidents like this. But this particular incident also highlights the importance of proper maintenance of mooring equipment.

Do not forget to include in the maintenance schedule the checking of all grease nipples on mooring equipment (deck machinery) to ensure the nipples remain usable. It is a good idea to highlight grease nipples in order to prevent them from being overlooked.

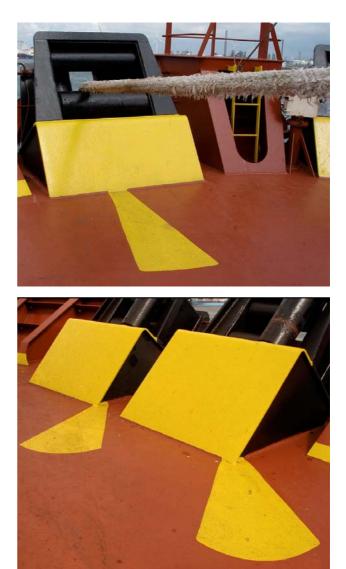
If snap-back zones are painted on the deck then crew will be alerted to the danger when they notice they are standing in a highlighted zone.

Painting these areas also helps supervising officers instruct crew to keep clear when lines are coming under tension.

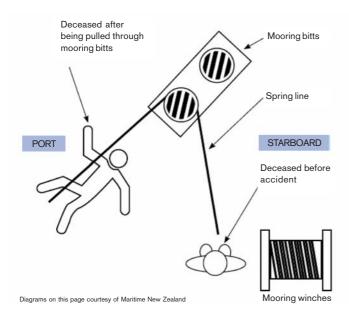
The diagram forms part of an investigation report into the death of an A/B who was dragged through a set of bitts by a mooring line.

This incident also highlights procedural and awareness issues because the mooring party forward informed the bridge that all lines were clear when they were in fact still in the water. Nobody noticed that as the vessel was manoeuvring away from the berth, one of the lines became snagged on one of the wharf buttresses.

stepped in a bight of the mooring line as it became taut and was then dragged through the bitts as the fouled line ran from the vessel.

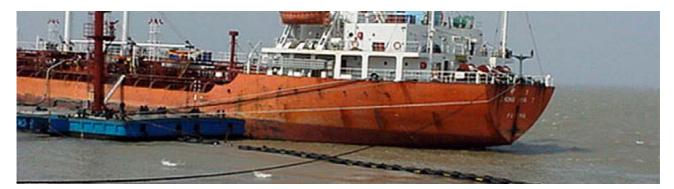
The image below shows a vessel considerably overhanging her berth. She is therefore unable to lead any stern lines aft of the ship. The image shows one line in particular being lead an extremely long distance, rendering it pretty much useless.

The ship has correctly put out as many lines as possible but should also consider the use of the anchor and mooring lines running aft from either the main deck or other suitable areas. In situations like this it is important to analyse local tidal and weather patterns in order to predict how the vessel will be affected. The vessel owners should be informed and cargo operations stopped (or not commenced) if conditions do not appear safe.

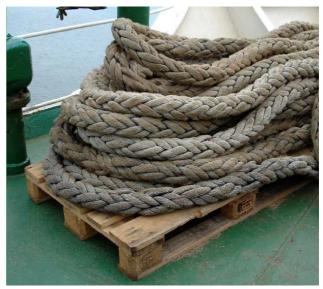
Ropes correctly stowed off deck
