IMCA Safety Flash 04/12

April 2012

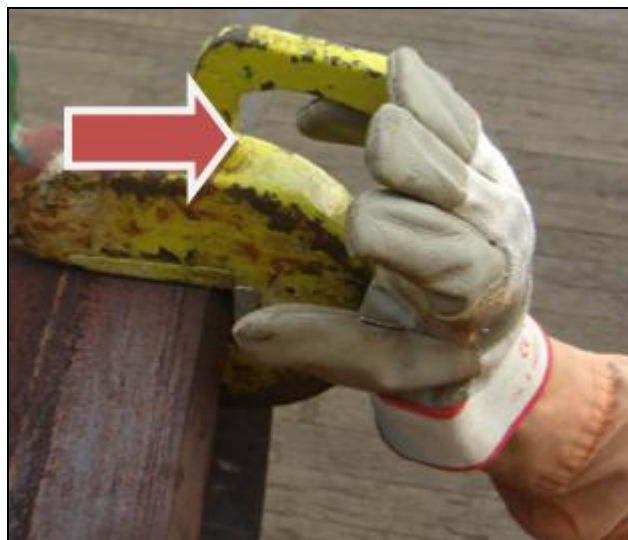
The injured person was holding the handle of the pipe hook at the end of the pipe, and as the pipe was lifted, it made a backward swing motion and sandwiched his right little finger between the pipe end and the barge structure, resulting in a deep cut.

Illustration of right hand position holding the pipe hook

- ◆ Whilst a tag line was provided for safer control of the load, this was not used, and the injured person was holding onto the end of the pipe joint;
- ◆ The injured person was an experienced rigger but complacent, and had placed himself in the line of fire.

- ◆ Always make use of tag lines rather than handling the load itself, particularly for lifts of pipes or other long and unwieldy loads;
- ◆ Appropriate and sufficient risk assessment – including 'last minute risk assessment' should be conducted before engaging the hands;
- ◆ Avoid placing oneself 'in the line of fire'.
