IMCA Safety Flash 04/15

March 2015

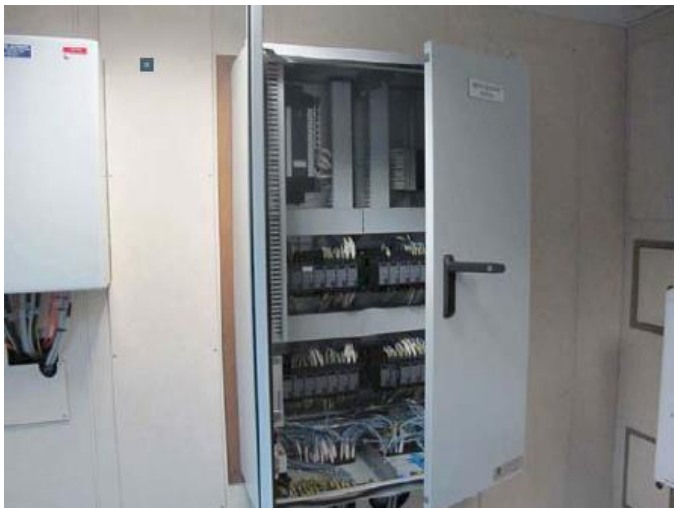
A member has reported an incident in which a ship's electrician received a 220V AC shock. The incident occurred when working on a 24V remote input/output (RIO) module on joy-stick electrical equipment. The electric shock was transmitted from the left hand to right hand due to the fact that the path of least resistance was across the body and to ground through the factory fitted anti-static earth strap. The electrician suffered minor burns to the left hand.

Figure: instrument cabinet

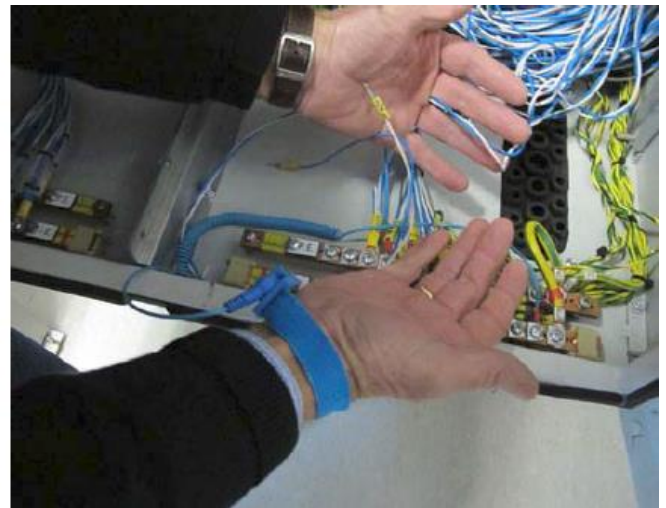
Figure: anti-static earth strap

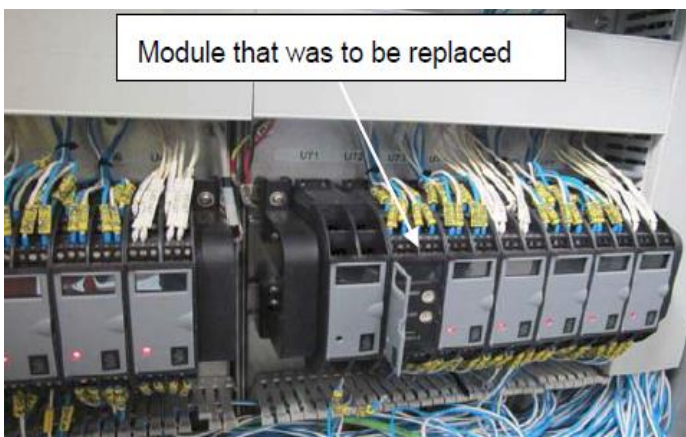
Figure: module that was to be replaced

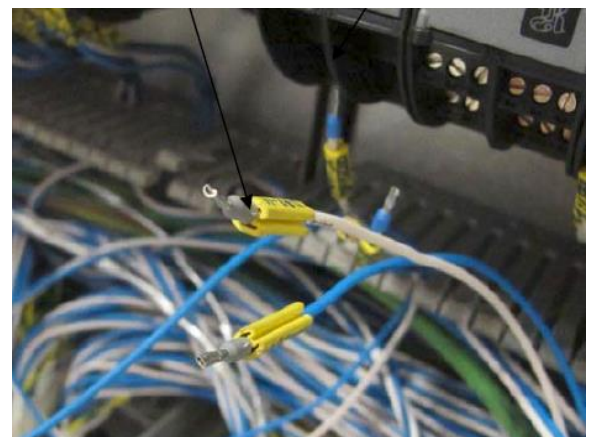
Figure: white cable that touched the electricians hand causing electric shock

- ◆ Personal risk assessments were not adequate due to complacency in the task to be undertaken;
- ◆ Harm could be caused to any person when they are exposed to 'live parts' that are either touched directly or indirectly by means of some conducting object or material;

- ◆ As part of the isolation process the equipment had to be checked to ensure electrical energy had been isolated or disconnected from its source, this should be done using a voltage tester/probe and compatible proving unit;

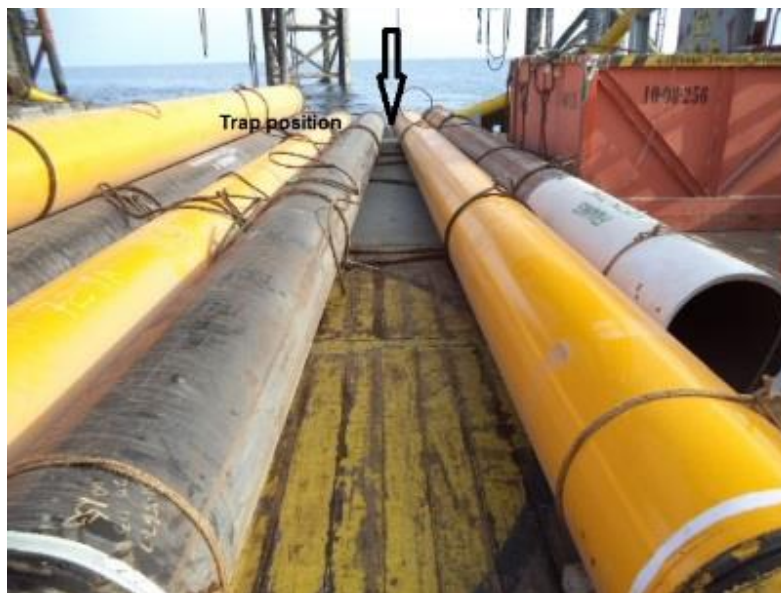
A member has reported an incident in which a crew member was injured during lifting operations. His legs were trapped whilst he was walking between casings being lifted, when one of them moved. The incident occurred during backload of tubular cargo (drill casings) from a nearby rig. The crewman was walking between two casings to connect the pre-rigged lifting slings to the rig crane hook. As he was preparing to connect the lifting strop, the movement of the vessel caused one of the casings to shift, which trapped his legs, causing multiple fractures and serious abrasions to both lower legs. He was medevaced by helicopter and spent approximately two weeks in hospital for treatment and rehabilitation before being repatriated.

Figure: showing worksite and place where injury occurred

- ◆ The injured person had been told by the banksman not to walk between the casings but disobeyed the instruction;
- ◆ No-one on deck exercised the "Stop Work Policy" (SWP) to immediately halt the operation and correct his unsafe behaviour.

- ◆ Reviewed risk assessment for cargo handling;

- ◆ Ensured that no crew members walked between, underneath or on top of cargoes;
- ◆ Ensured that all cargoes were adequately secured to prevent unplanned movement during operations;
- ◆ Vessels carrying tubular cargo to check that sufficient quantity of wedges available on board for cargo operations, and raise requisitions in case further wedges were needed;
- ◆ When working with tubular cargo, Samson posts to be used whenever possible, to prevent tubular cargo from rolling.

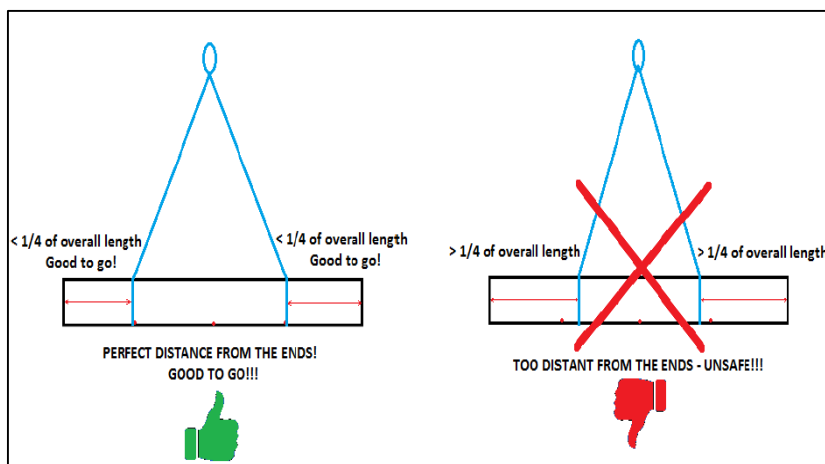
- ◆ Cargo should be loaded in such a way as to minimise movements when offloading. Unnecessary movements of tubular cargo may cause displacement from their safe position and move wedges from their chocking position;
- ◆ Wedges used in adequate quantity and size (the size should be at least 25% of the tubular diameter);
- ◆ Slings should be placed from each end so that distances are never more than 1/4 of the total length of the tubular cargo;

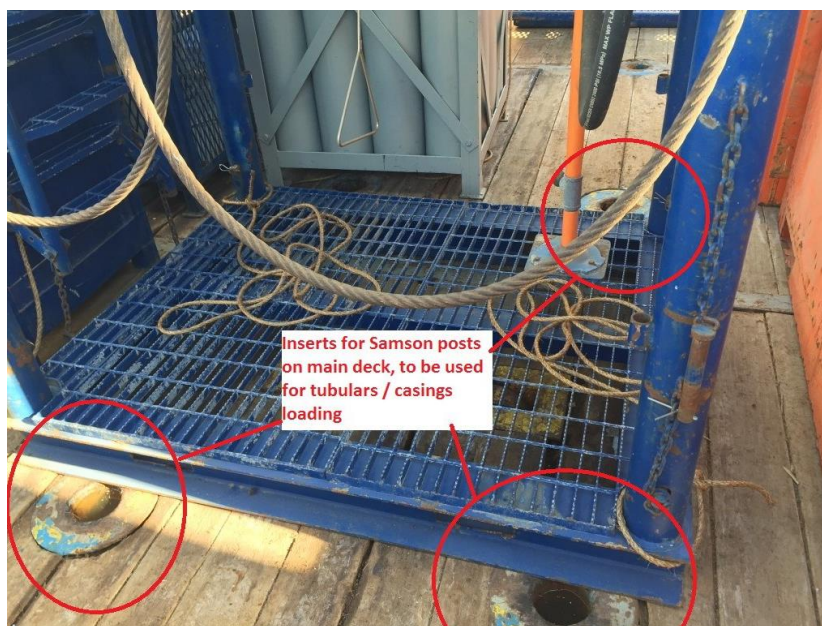
- ◆ The use of Samson posts should be considered where possible;

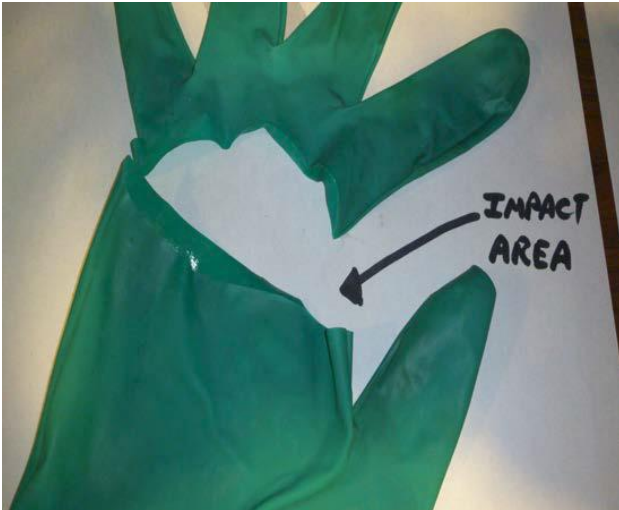
A member has reported an incident in which there was an unexpected high pressure oil discharge causing injury to someone's left hand. The incident occurred during the reconfiguration of a trenching ROV. A crewman was disconnecting hydraulic pipe fittings to the chain tensioning cylinder on the mid digger section when there was a high pressure release of oil from a pipe fitting, which hit his left hand and sprayed on to his face causing a skin irritation.

Figure: actual glove worn by injured person

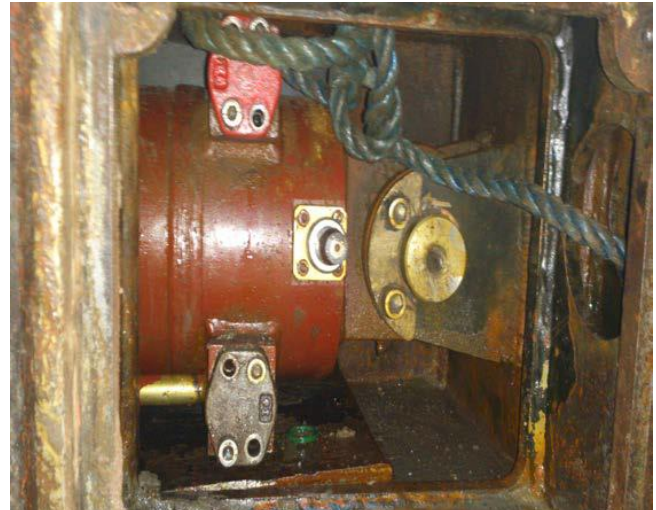
Figure: position of fittings on hydraulic cylinder

- ◆ Hydraulic pressure was trapped in the annulus side of the digger chain tensioning cylinder and owing to the hydraulic circuit configuration it was not possible to relieve this pressure without opening a pipe fitting;
- ◆ The pressure gauge for the digger chain was piped to the full bore side of the cylinder to measure the pressure exerted on the digger chain; it was possible to have no pressure in the full bore side but pressure may still remain in the annulus side, creating a situation where the annulus side could be pressurised with no indication.

- ◆ Installed adaptor plates and drain fittings to cylinder as a means to detect and relieve pressure;
- ◆ Revised Safe System of Work with detailed information for checking for and relieving stored pressure in circuit;
- ◆ Started review on all jet trenchers and WROV to rule out the possibility of a repeat incident on another vehicle.

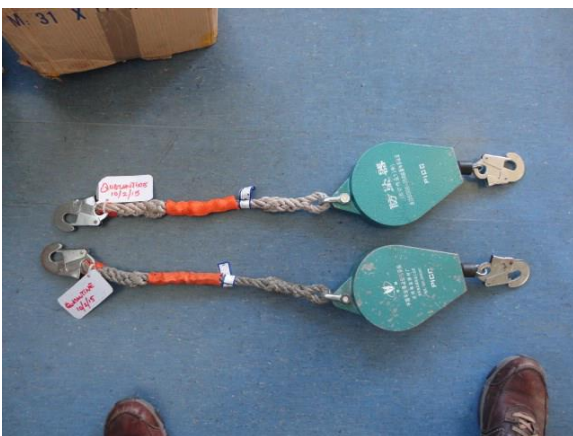
A member has reported a near miss incident in which lift arrest equipment was found to be faulty and was subsequently removed from use. During an annual inspection of equipment on a vessel, the inspecting person found that on three fall arrest devices, there was no stenciling on the arrestor and the safety device on the hook did not function correctly, as the hook could be opened without using the safety clip.

Figure: showing quarantined fall arrest devices

Members may wish to carry out further spot checks of fall arrest equipment, and ensure that fall arrest equipment is always sourced from a reputable contractor.

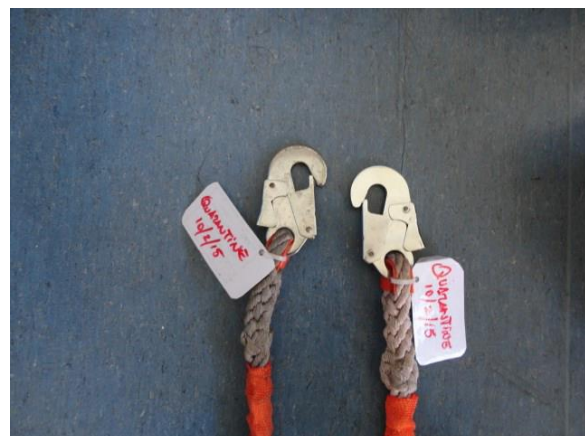
Figure: showing hooks with faulty safety clips

- ◆ A clear guideline was the readability of the label. Because the fall arrest devices didn't have the original labels showing the year of manufacture proof of this could not be ascertained;
- ◆ The safety device on the hook was not working; the hook could be opened without using the safety clip.

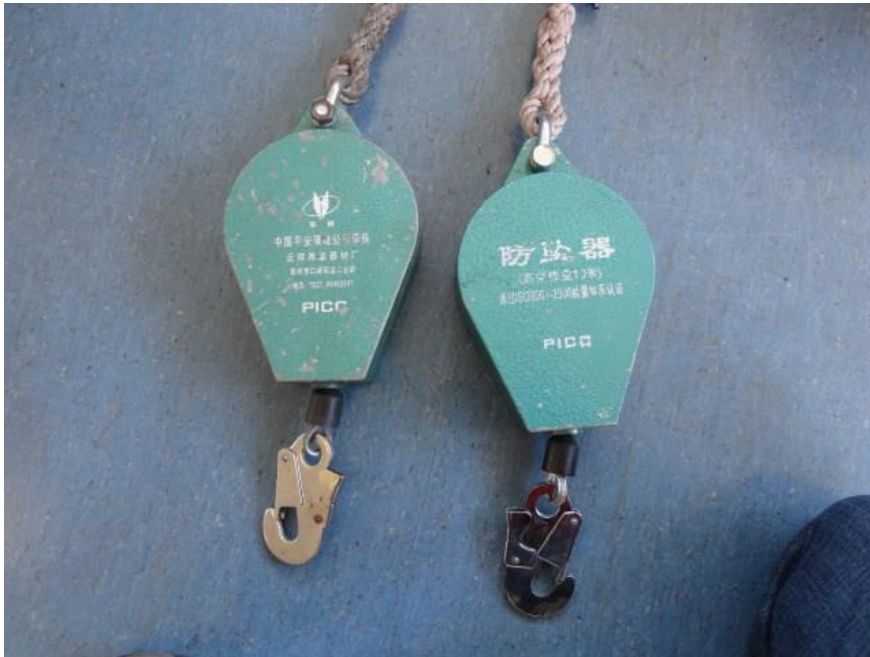
Figure: “PICC” Fall arrest devices

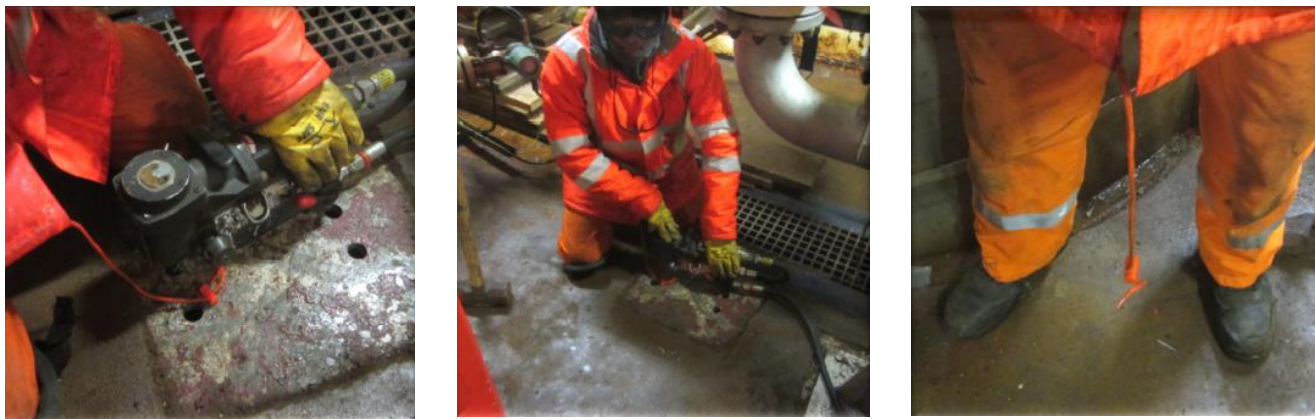
bottom the drill operator's jacket was hanging very close to the revolving spindle of the magnetic drill. There was potential for the drawstring to be drawn into the tool causing injury to the operator.

Figures: showing storm jackets with draw string and illustrating potential hazard

- ◆ The immediate cause of the incident was that long, “parka” style storm jackets were supplied with a drawstring and toggles that could become snagging hazards. This was especially hazardous when using or working with rotating machinery or equipment;
- ◆ Members should ensure their crews are aware of this form of hazard;
- ◆ As far as possible, alternative clothing without draw strings should be used.

He immediately stopped the job and the hazard was highlighted. The entire work party removed the drawstrings from their jackets and the hazard and intervention was shared with the rest of the crew. The intervention was further discussed at start of shift meetings and it was apparent that these lanyards could and had become snagged when climbing ladders and had got caught on plant and equipment etc. It was agreed that the drawstrings were impractical as their use on this type of jacket would restrict both leg movement and body positioning.
