## IMCA Safety Flash 04/19

March 2019

### Fire!

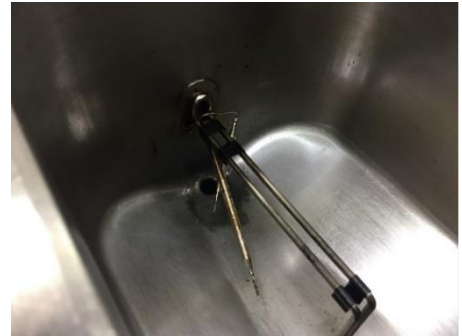
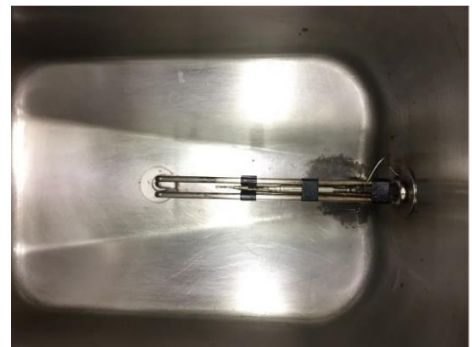
The deep-frying pan was switched off and a lock out/tag out was applied for further investigation. The frying pan was allowed to cool down and the oil drained out. When the oil from the deep-frying pan was cooled down and drained it was noticed that the temperature sensor elements of both thermostats were not in the original place.

- ◆ Temperature sensor elements of both thermostats were not fitted in the original place;
- ◆ The galley crew were not aware of the function of the temperature sensor elements inside the deep-fryer, nor of the potential consequences if those sensor elements were in the wrong place.

- ◆ Lack of awareness;
- ◆ Lack of familiarity with equipment.

*Temperature sensors*

- ◆ Clear instructions provided for galley crew about the cleaning of a deep-frying pan, including ensuring that the galley crew are aware of proper positioning of the temperature sensors inside the deep-frying pan during the cleaning process, and know not to move them;
- ◆ Recommend check of positioning of temperature sensors on similar equipment in galleys on other vessels;
- ◆ On this specific vessel, replace thermostat sensors in the original position and check thermostats with a calibrated temperature probe.

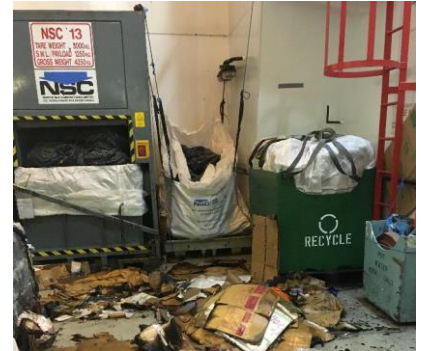
The fire resulted from sparks which fell from the starboard funnel into the well deck area and ignited a 1 tonne gabion sack containing cardboard (which was being stored for onshore recycling).

- ◆ A build-up of soot in the exhaust system, caused by prolonged operation of vessel engines in low load;
- ◆ Lack of maintenance routine for clearing of soot within the system.

- ◆ Extensions installed onto drain plugs to provide easier access for planned maintenance activities;
- ◆ As a secondary precaution, gauze type spark arrestors manufactured and installed on top of each exhaust stack;
- ◆ Update planned maintenance regimes, with regard to the cleaning of soot collectors and routine checks for soot removal.

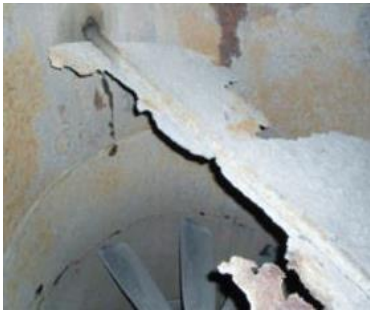
A member reports four recent Port State Control detentions for its vessels; two of which related to fire safety, fire dampers and fixed firefighting equipment. In one incident, the fire dampers for four engine room ventilation fans were found to be faulty. On the same vessel, the manual isolation valve for the low-pressure CO<sub>2</sub> firefighting system was found to be in a closed position. Crew would not have been able to deploy the CO<sub>2</sub> firefighting system into protected spaces from the remote location. Additionally, the wrench used to open the manual isolation valve was not present in the local control area.

*Corroded engine room fire damper*

- ◆ Check that fire dampers are free of damage and corrosion;
- ◆ Check that fire dampers are clearly marked including open and closed positions;
- ◆ Ensure fire dampers are easy to operate;
- ◆ Ensure flame screens are in good condition;
- ◆ All operating handles, wires and stoppers should be in good working condition;
- ◆ All such equipment should be regularly inspected and maintained as part of a planned maintenance system;
- ◆ Crew should be familiar with the operation of fire dampers and this familiarity should be checked regularly with drills.

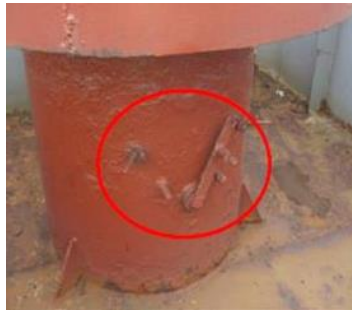
*No 'open' or 'close' markings*

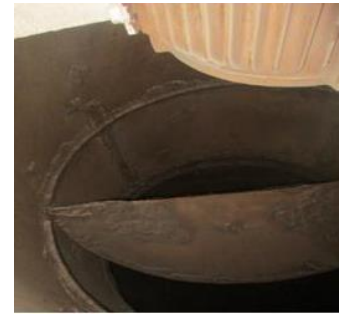
*Broken flap on engine room fire damper*

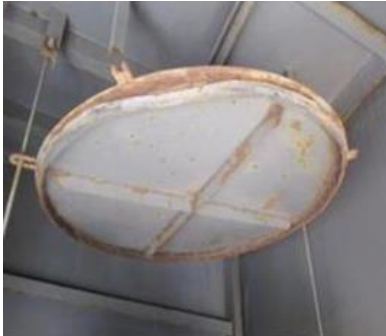
*Poor sealing of fire damper*

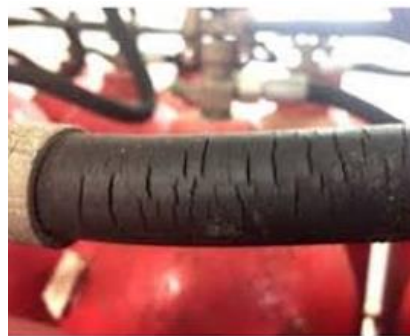
*Brittle hose on fixed CO<sub>2</sub> bottles*

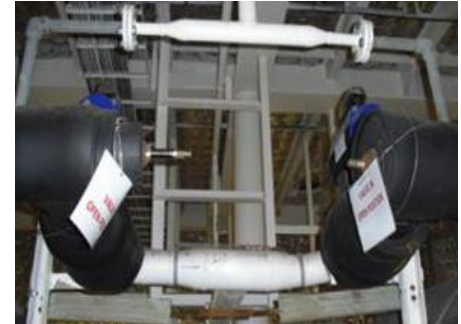
*Low pressure valves for CO<sub>2</sub> system kept closed*

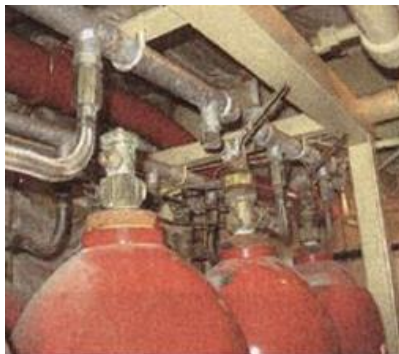
*Disconnected CO<sub>2</sub> bottles*

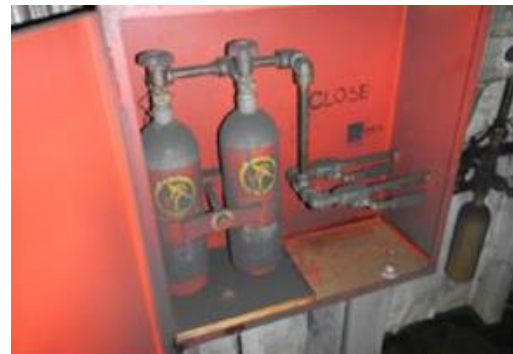
*Faulty CO<sub>2</sub> actuation valves*
