I Starting Air System Incident

2 Pollution Caused by Burst Hydraulic Hose

3 Caution Notice – Kirby Morgan Regulators

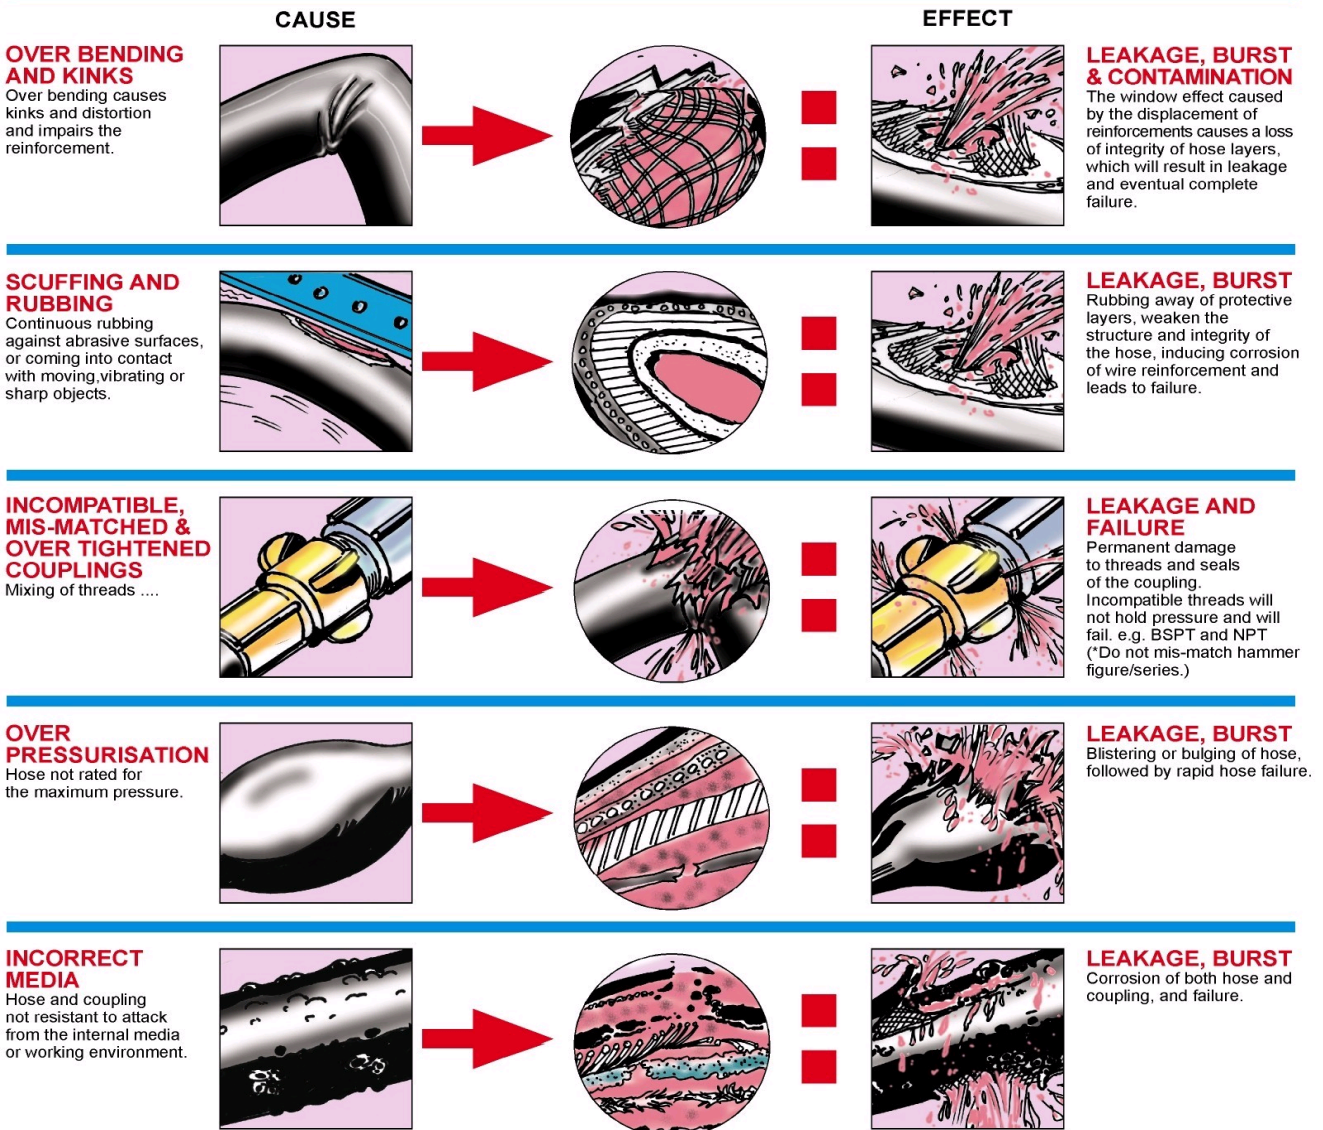
Flexible Hose Safety

Lack of care in the installation and use of flexible hose assemblies will lead to failures, which can cause personal injury, threaten your installation and have impact to the environment.

REPORT THE FOLLOWING:-

Make sure you are using the correct hose for the application
