# IMCA Safety Flash 05/11

June 2011

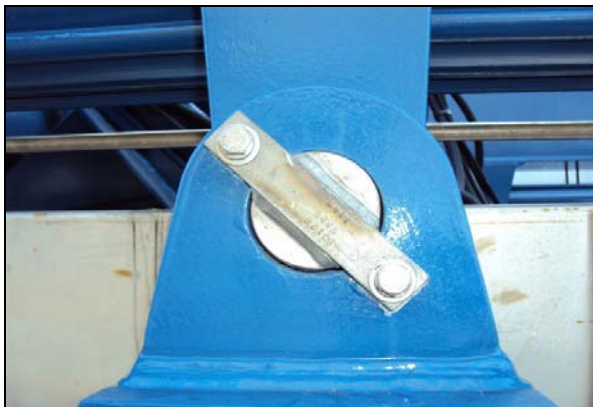
*Lift post pin installed.*

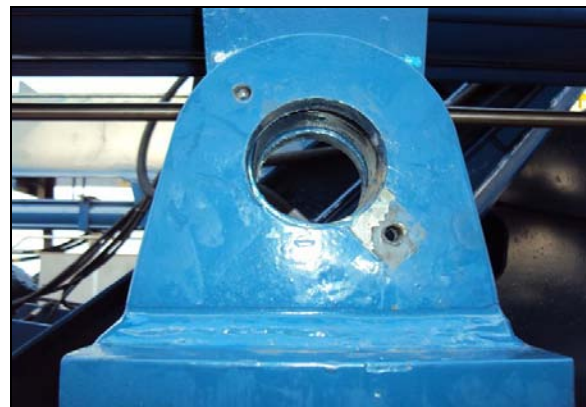
A member has reported an incident in which an ROV launch and recovery system (LARS) arrived offshore with parts missing. The LARS arrived onboard the vessel without the pin connecting the left side (standing on the LARS looking outboard) transport post to the A-frame.

Following investigation, it was learnt that the A-Frame lift post pin was in place when the new LARS system left the supplier, but was not in place when it arrived at our member's storage facility. The missing pin was identified during routine inspection after the unit had been lifted and transported (twice), lifted and installed aboard the vessel. For the pin to have been lost during transportation represents a high potential near miss for any vehicle (and passengers) who could have been struck by the pin falling from the moving transport vehicle.

*Lift post pin missing*

Our member, in co-operation with the supplier, took immediate steps to ensure prevention of future incidents. Additionally, our member is in the process of designing a lift post pin that will include a retaining pin. In the meantime, members are encouraged to conduct a careful inspection of all A-Frame lift post pins and verify that they are secure before equipment is lifted and transported.

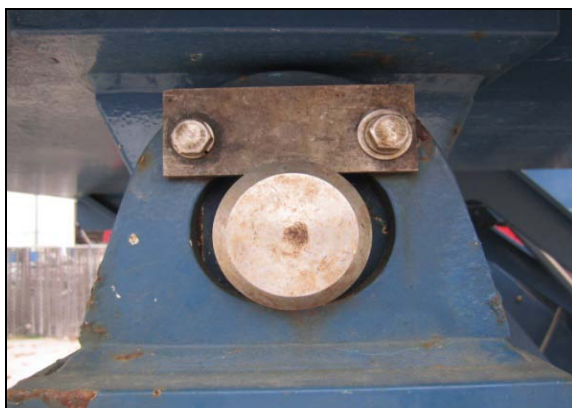
*Example of other lift post pin locking configuration*

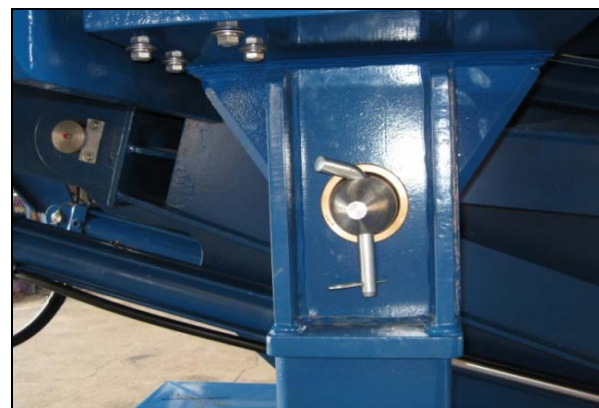
*Example of future locking pin design with retaining pin*

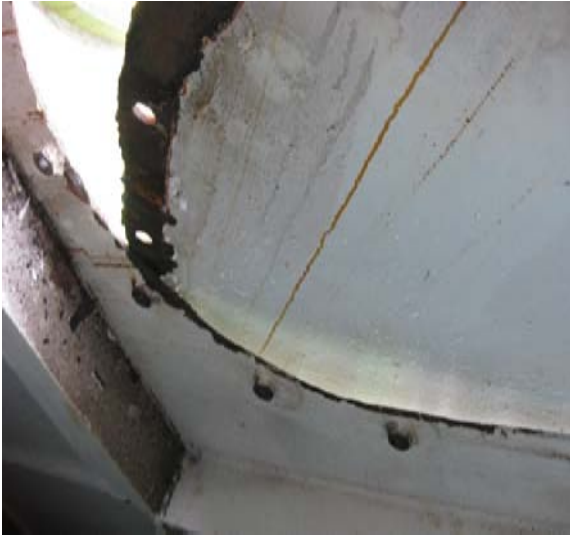
*Inspection hatch being prepared*

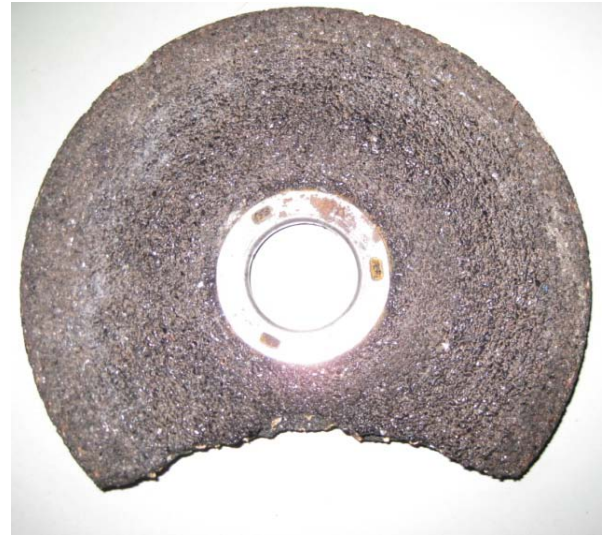
A member has reported an incident in which a crewman was injured whilst using a power tool in an incorrect manner. A crewman on night shift was required by the chief engineer to clean paint and corrosion off of the nuts on man-hole covers, so that the covers could be removed for inspection. He was instructed to perform this task using either a hand-held wire brush or a 4 inch angle grinder fitted with a wire wheel. These instructions were verbally acknowledged by the crewman, who had been employed on the vessel for nearly a year. Nonetheless he decided to use a 5mm grinding disk on the angle grinder instead of the wire wheel, and then proceeded to cut the threads off the bolts on the man-hole cover. As the grinding disk was being used in an incorrect manner, the disk jammed causing the grinder to deflect into his shoulder, cutting his boiler suit and causing bruising and a minor abrasion.

*Broken grinding disk after inappropriate use*

- ◆ Existing company procedures and clear instructions were not followed;
- ◆ Risk assessments had not been completed;
- ◆ The individual involved in the operation demonstrated a lack of safety awareness that put himself, his colleagues and the vessel at risk;
- ◆ The individual involved in the operation had received no training in this specific task.

- ◆ Complacency with regard to the use of power tools must be guarded against;
- ◆ All persons involved in a task, from deck officers and supervisors to deck crew, should have a clear understanding of the nature of the task and their duties with regard to the task;
- ◆ All crew should have a deeper understanding of the requirement for risk assessment for all routine and non-routine tasks;
- ◆ All crew members should be reminded of the importance of accepting personal responsibility for safety and that they all are empowered to stop work until safe operations are restored;
- ◆ Shipboard training and familiarisation should include specific training in particular tasks and equipment.

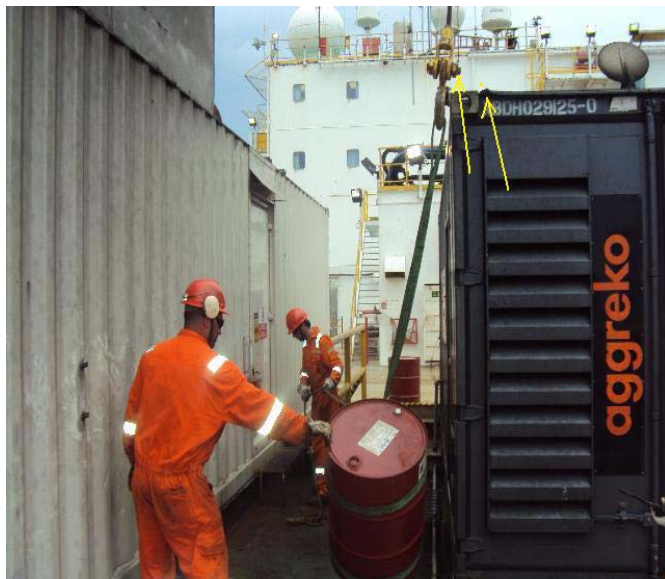
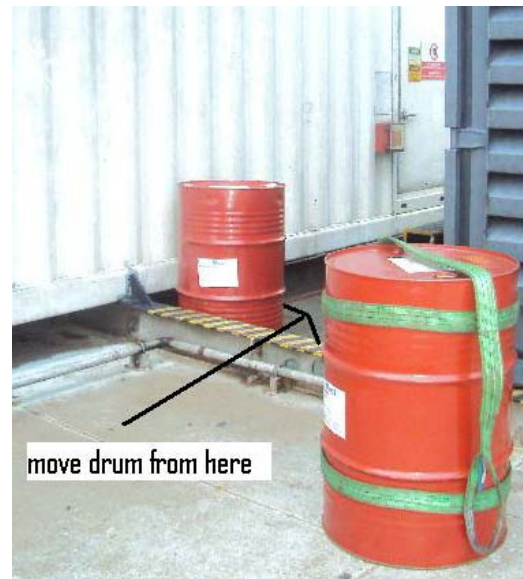
A member has reported an incident in which a crewman suffered minor crush injuries when his hand was caught between two objects during lifting operations. The incident occurred when some oil drums were being positioned on the deck using the crane, with the assistance of two deck crew. One was handling the tag line while the other was acting as the lift supervisor and was equipped with a radio to communicate with the crane operator. While manoeuvring the drums between a deck cargo of containers, the two deck crew attempted to man-handle the drums 1.5 meters horizontally without slewing the crane jib. The acting lift supervisor was pushing on the drum while the other pulled on the tag line. The acting lift supervisor radioed the crane operator and asked him to hoist a little; he was unaware at the time that the hoist wire was snagged on the container; this caused the drum to pinch the acting lift supervisor's hand between the drum and container. He sustained a minor crush injury and was sent ashore for x-rays.

*Showing area where oil drums were being moved*

- ◆ Existing company procedures were not followed;
- ◆ Risk assessments had not been completed;
- ◆ The individuals involved in the operation demonstrated a lack of safety awareness that put themselves, their colleagues and their vessel at risk;
- ◆ The individuals involved in the operation had received no training in this specific task.

- ◆ Complacency with regard to any lifting operation, however small, must be guarded against;
- ◆ All persons involved in a task, from deck officers and supervisors to deck crew, should have a clear understanding of the nature of the task and their duties with regard to the task;
- ◆ All crew should have a deeper understanding of the requirement for risk assessment for all routine and non-routine tasks;
- ◆ All crew members should be reminded of the importance of accepting personal responsibility for safety and that they all are empowered to stop work until safe operations are restored;
- ◆ Shipboard training and familiarisation should include specific training in particular tasks and equipment.

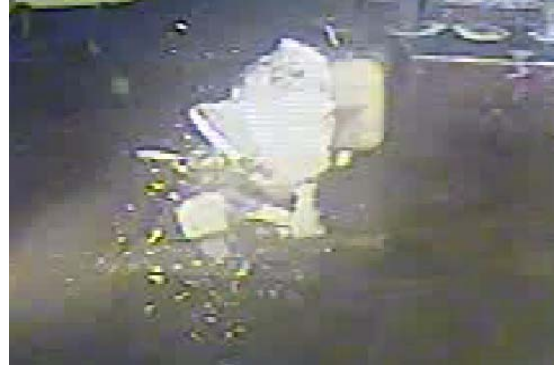
*Buoy is destroyed when lasso cuts through it*

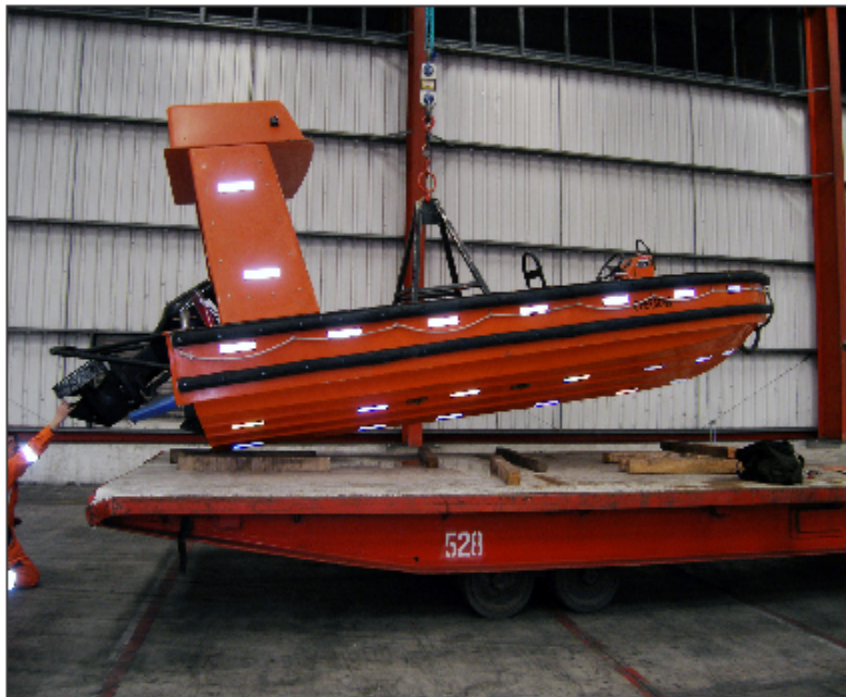
Figure 1

The rescue boat, a Watercraft WHFRB 6.50 had a certified weight of 980kg, but was 1450kg when weighed after the accident (Figure 1). Subsequently, several rescue boats of the same model carried on board *Tombarra's* sister vessels were also inspected and weighed, and they too were found to be significantly heavier than when supplied.

In all cases, in an unladen state, the boats' weights were close to or exceeded the safe working load (SWL) of their davits. With crew, fuel and equipment on board, the SWLs of the davits were exceeded.

Weighing of the rescue boat

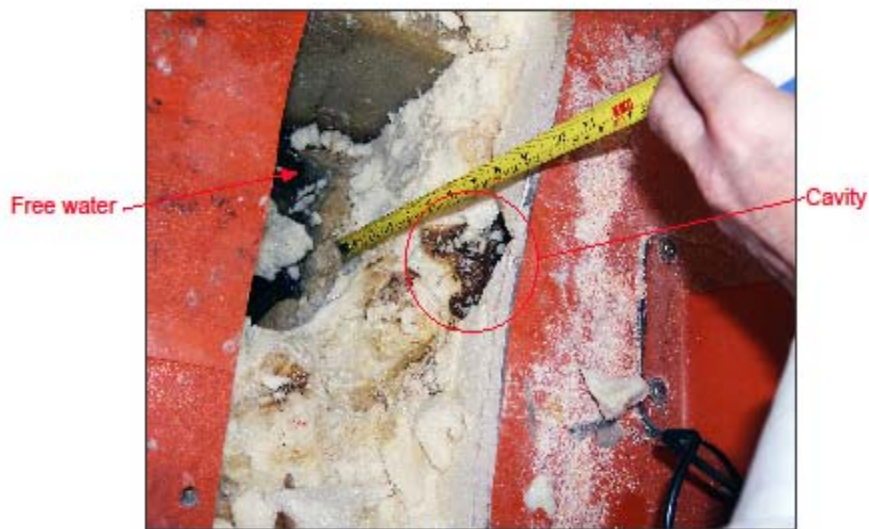
Figure 2

Investigation has identified that 14 of the 15 foam-filled compartments in *Tombarra's* rescue boat had been penetrated by water. In addition, the foam in the lower sections of the hull contained cavities and there were voids between the foam and the hull. In these areas the foam appeared to be of varying consistency and colour (Figures 2 & 3).

Below deck inspection

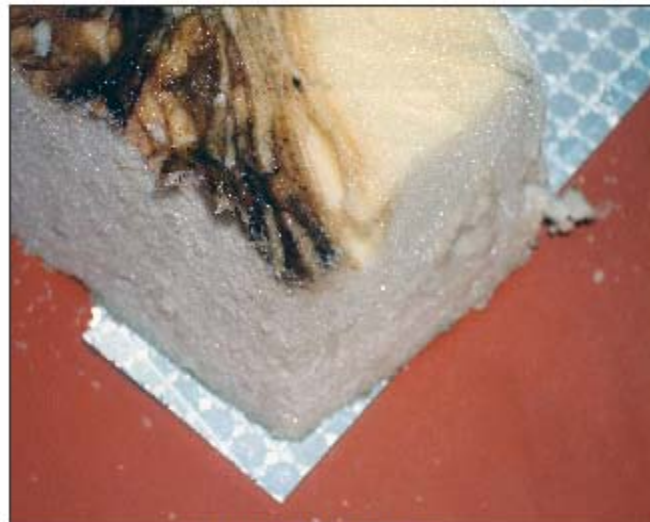
Figure 3

Foam sample from cavity

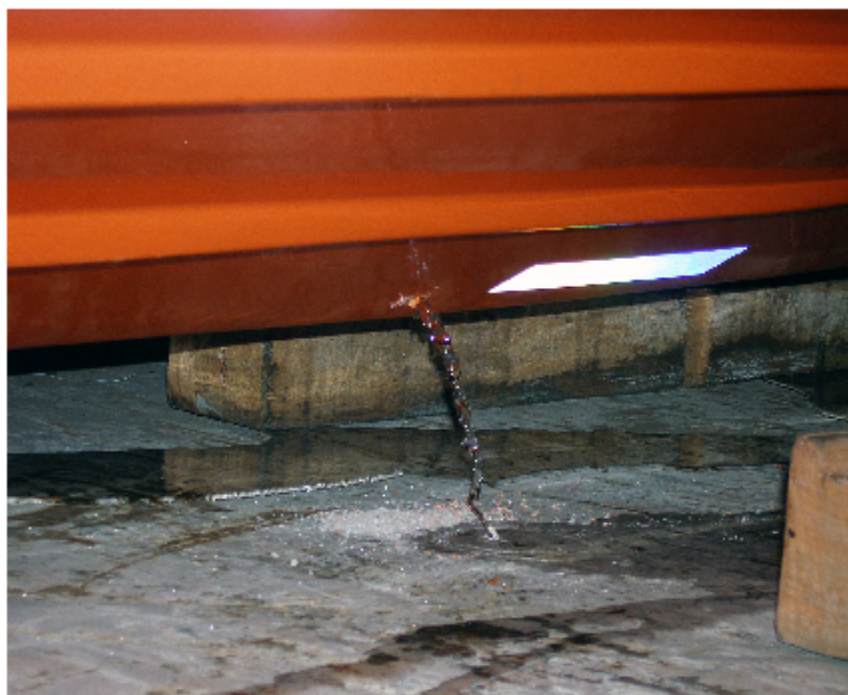
Figure 4

Although the boat was fitted with a drain plug on the transom, the internal compartments were not interconnected. The removal of the plug therefore allowed the water to drain only from the aftermost compartment. The water in the remaining compartments was trapped and had to be drained by separately drilling into each compartment through the hull (Figure 4).

Water draining from foam-filled compartments
