IMCA Safety Flash 05/14

April 2014

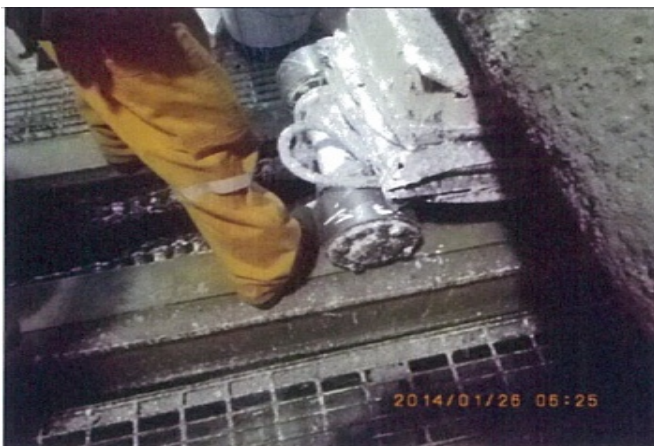
A member has reported an incident in which a person sustained an injury to his right foot caused by a moving roller in pipe-handling equipment. The injury happened when a crewman took a window of opportunity during a short repair period to paint pipe numbers on the ends of the pipes. The operator of the roller did not ensure that the area was clear moving the roller, and the crewman was caught by the roller and sustained a crush injury to the right foot.

Figure: (L) showing position of injured person's right foot

- ◆ Operator operating the roller machines failed to ensure the ramp way/area was clear before activating the pipe transfer machines;
- ◆ There was a lack of supervision from the work supervisor;
- ◆ The operator of the roller machine was not able to communicate effectively with other workers.

- ◆ The task of numbering of pipes was transferred to another, safer, location;
- ◆ An alarm warning system was installed to alert the operator of the presence of personnel in the path of the rollers;
- ◆ Signage was installed warning personnel that they were 'in the line of fire' in this location.

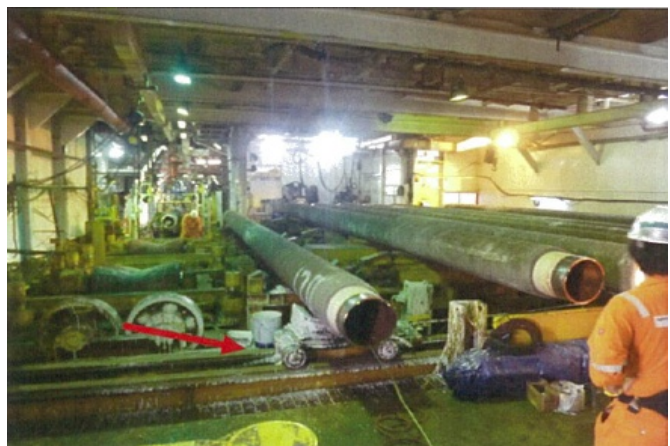
Figure: (R) Showing injured person's position at time of incident

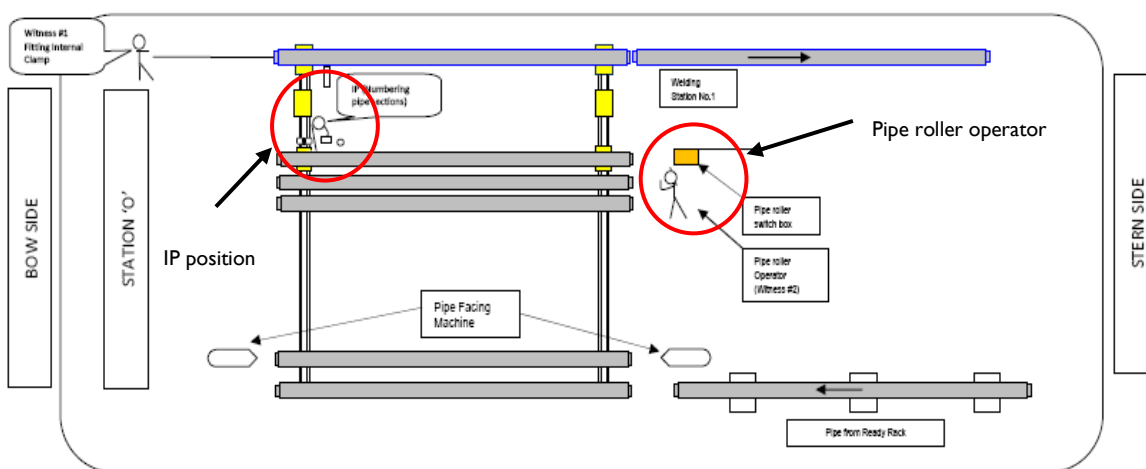
Figure: (Above) diagram of incident site

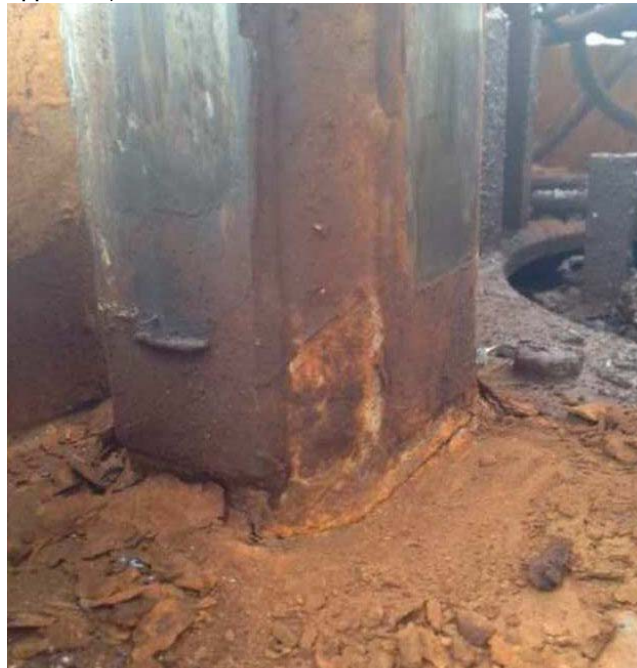
A member has reported the discovery of a failure to a snubber on an ROV launch and recovery system. This was discovered during maintenance and annual load test of the ROV. When the tether management system (TMS) was separated from the ROV to facilitate maintenance work, this highlighted that the snubber did not appear to be sitting level. Upon investigation, it was found that the starboard snubber guide runner had detached from the snubber. Whilst this did not prevent the snubber function from operating, it did result in the snubber not maintaining its level when operating. On closer inspection, the port side snubber guide runner was found to have cracked welds also. The failed items were not associated with the load path and therefore there was no risk of dropped objects.

Figure: (Above) showing cracked welds

- ◆ Cleaned and prepared area for repair and welding;
- ◆ Close visual inspection of the other ROV onboard the vessel. No cracked welds were observed, but the welding was reinforced as a contingency;

- ◆ Added a six monthly visual inspection of the snubber assembly to company preventative maintenance system.
