IMCA Safety Flash 05/15

April 2015

I Fatal Incident during Change-Out of Chain Wheel (Gypsy) on Anchor Handling Tug Supply (AHTS) Vessel

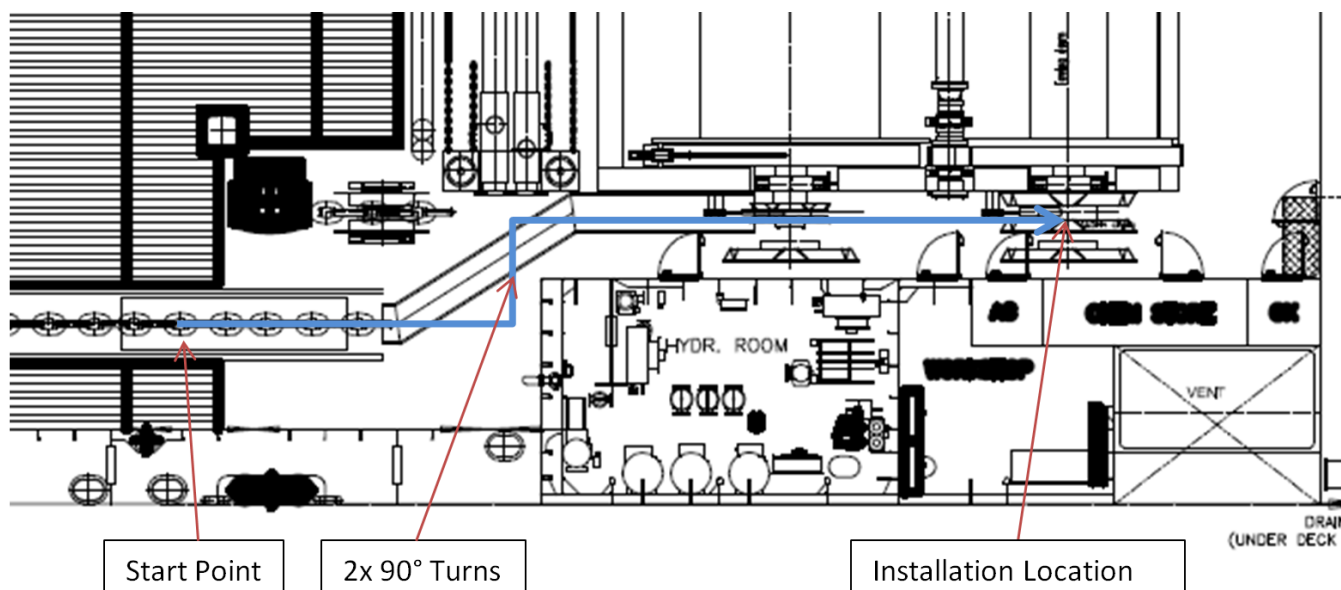
The crew disconnected the gypsy wheel from the crane without checking its final landing position. Therefore, they did not see that the rims of the gypsy wheel were on each side of the skid rail for the chain lifter. Immediately after disconnecting from the crane, the crew started to roll the gypsy wheel. This resulted in the starboard rim dropping into the gap in the rail causing the gypsy wheel to tip beyond balancing point. It fell over and pinned two crew members against the bulkhead. This resulted in one fatality and one first aid case.

Figure: Plan view drawing of the intended route for the installation of the gypsy

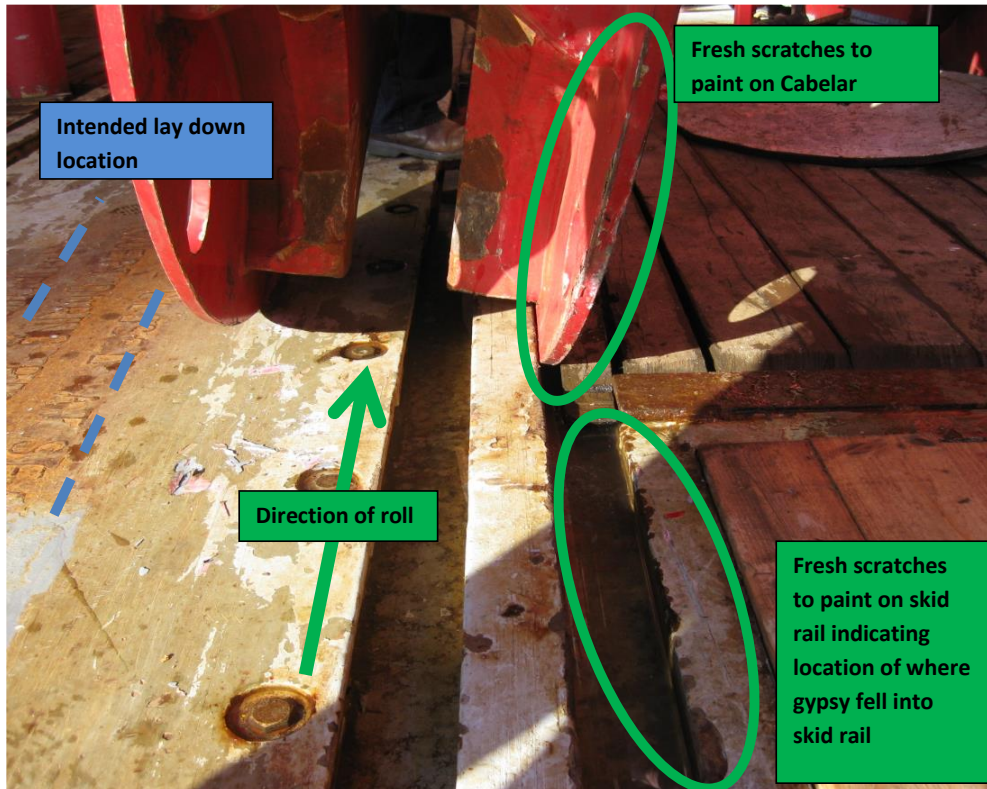
- ◆ The immediate causes were:
 - Gypsy wheel rolled into skid rail causing it to tip over
 - Lack of risk management:
 - Failure to identify hazards and risk
 - Failure to comply with safe working practices;
- ◆ Contributing factors:
 - Inadequate design review for this particular mode of operation conducted by vessel
 - Gypsy wheel was not handled in the intended method as established when vessel was designed

- Insufficient lifting or handling appliances for handling and changing the gyps wheel;
- ◆ Root Causes:
 - Inadequate monitoring and verification of organisational performance
 - Weaknesses identified in the design review processes
 - Lack of effective implementation of risk management.

Figure: Showing the cause of the gypsy wheel tipping over (in this photo the term “cabelar” is used as well as “gypsy”)

- ◆ Gypsy wheel should not be manually handled or rolled;
- ◆ Monitoring and verification of worksite performance was found to be inadequate.

- ◆ Company-wide instruction forbidding free-rolling of these heavy items;
- ◆ Technical task force to evaluate a safe method for the installation of gypsy wheels in the short and long term and review change out methods across the fleet;
- ◆ All vessels to review and re-risk assess current methods for handling gypsy wheels and submit risk assessment for approval.

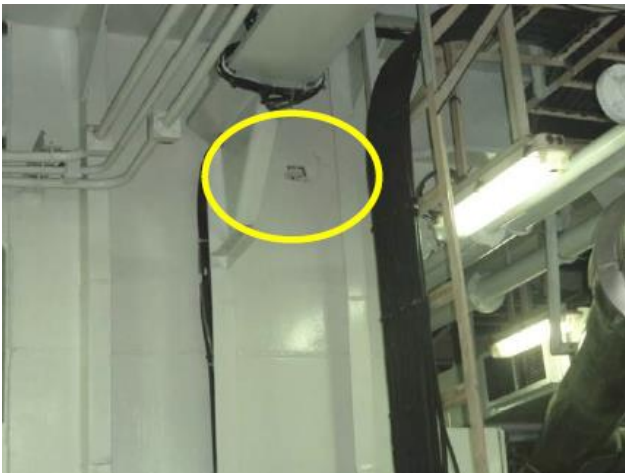
A member has reported an incident in which a chain hoist failed causing a 700kg load to fall into the moonpool. The incident occurred when crew were moving moonpool carriages and frames into position during mobilisation of multibeam echosounder equipment through the moonpool. The moonpool carriage was successfully positioned. As the crew lowered the second moonpool frame into position, the chain on the hoist crane suddenly parted and the frame and carriage fell into the moonpool damaging one of the stopper bars on the wall of the moonpool before being stopped by the other stopper bars.

There were no injuries. There was some damage to the stopper bars and brackets.

Figure: Damage to engine room wall (other side of moonpool) following stopper bar broken

- ◆ Update annual load test to include dye penetration test to check for unseen cracks on hoist chain;
- ◆ Update procedures and JSA for moonpool activity;
- ◆ Replace hoist and chain and repair stopper bar inside moonpool;
- ◆ Defective chain sent to certified third party testing for examination of strains caused by overstressing.

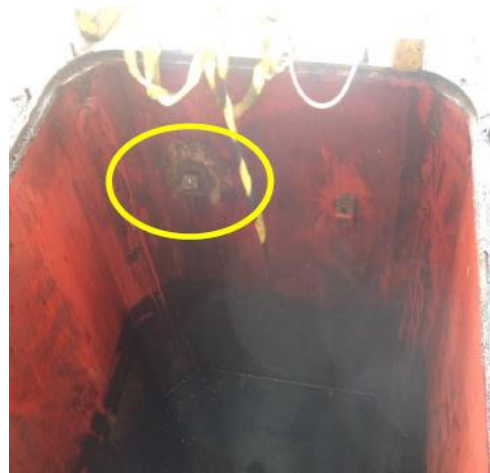
Figure: Damage to side of moonpool after stopper bar was broken

- ◆ Before starting the job, all personnel involved took part in a toolbox meeting and job safety analysis (JSA). A permit to work had been granted;
- ◆ The first lift, using the crane in remote control mode, was successful;
- ◆ The hoist crane had a safe working load (SWL) of 5 tons;
- ◆ The **immediate cause** of the incident was found to be that during the lifting of the frame, it was obstructed by one of the bracket stoppers;
- ◆ The **underlying cause** was stress and subsequent failure of the chain of the hoisting crane;
- ◆ The **root causes** were:
 - Lack of specific procedure regarding lifting a moonpool frame
 - Lack of awareness from crew who handled lifting moonpool frames to ensure smooth process during lifting.

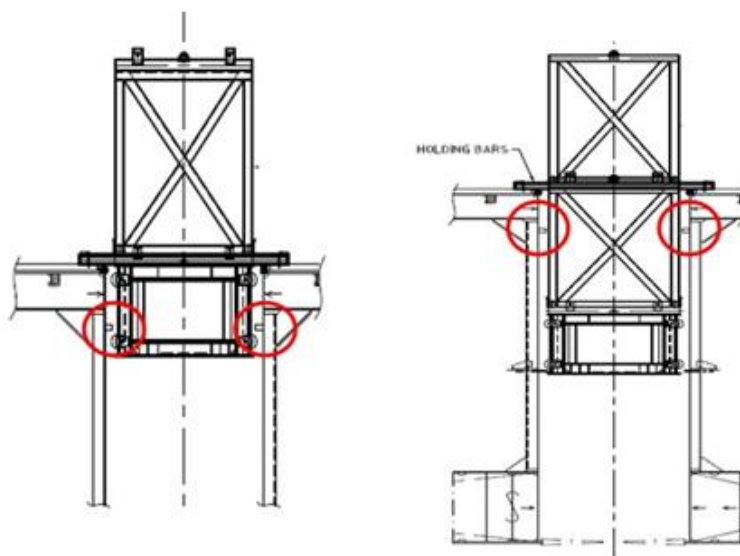
Picture 9 – There are 4 stopper bars on the upper of moon pool

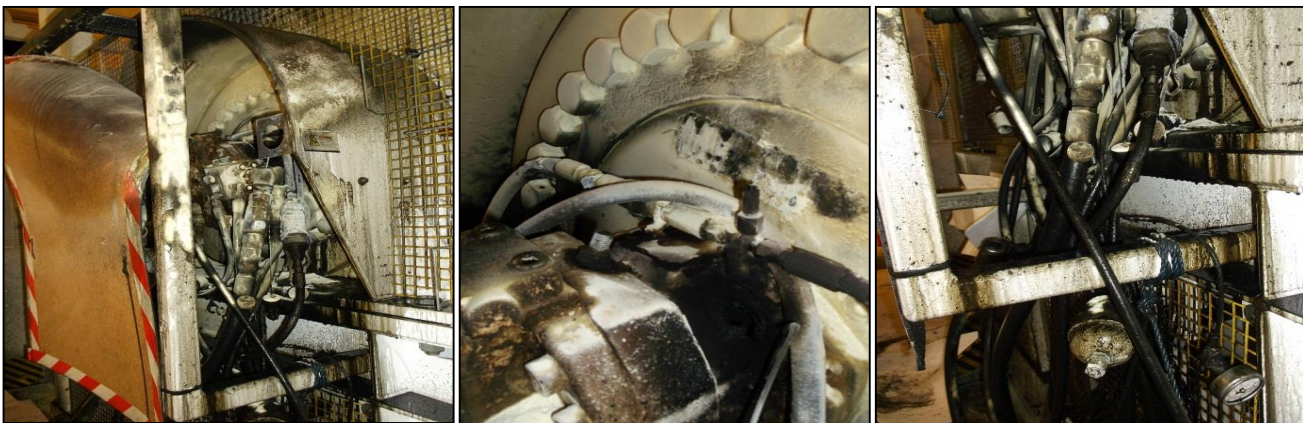
All electrical power to the ROV system was isolated. Due to friction, or some other unknown element, the winch drive motor caught on fire. The ROV crew extinguished the fire with portable extinguishers. The area was barricaded, a fire watch posted and all non-essential personnel except for the fire watch and his runner were cleared from the area.

Figure: Showing winch motor after fire

- ◆ A preliminary on-site investigation of the failure by the manufacturer was conducted with no conclusive root causes identified. The failed winch brake was shipped to the manufacturer for a detailed analysis to determine root cause(s);
- ◆ Following extensive testing and analysis, the manufacturer identified the most likely root cause of the run-off was probably a blockage in the winch secondary brake release line;
- ◆ Given the damage to the winch the incident investigation could not determine a **definitive** root cause but were able to establish through elimination a probable cause for the occurrence. A series of actions to prevent occurrence had been established these were included in the manufacturer's technical bulletin.

- ◆ The manufacturer released a service bulletin to all operators of winches with this type of brake advising them of two checks to perform to prevent recurrence:
 - One check, the Brake Release Line Check, verifies that the release pressure was dropping in the specified time and should be performed every time the brake release line or hydraulic power unit (HPU) controls were serviced;
 - The second check, the Motor-to-Brake Load Transfer Check, verifies that the load has fully transferred from the hydraulic motor to the failsafe brake and should be performed before the HPU was purposely shut down while the winch is under load.
