IMCA Safety Flash 05/19

March 2019

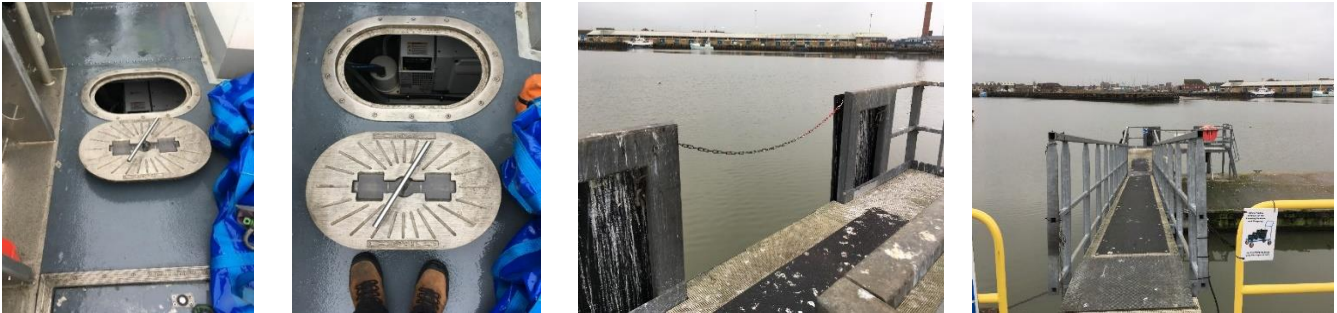
On arrival in port, the passengers disembarked the CTV via the personnel transfer pontoon. One passenger was lagging behind the others and then made his way back on to the vessel (to retrieve a personal bag) without alerting the vessel crew. At this point, the CTV crewman had already opened a deck hatch to retrieve equipment from below decks and was stood below deck with his head protruding through the hatch opening at deck/foot level.

After speaking to the crewman in relation to the bag he had left on the CTV, the passenger attempted to gain access to the vessel cabin via the walkway in which the hatch was open. This action had the potential to injure both the CTV crewman and the passenger. The passenger was prevented from doing so by the site representative, who thus prevented injury to two people.

- ◆ The passenger re-boarded the vessel without alerting, or seeking the permission of the vessel crew;
- ◆ The passenger was suffering the effects of seasickness and was possibly less aware of potential hazards;
- ◆ The chain on the pontoon between the vessel and the pontoon was not replaced following disembarkation of passengers and site representative boarding;
- ◆ There was no physical barrier for the open hatch - site personnel providing barrier/lookout;
- ◆ Due to short notice and early hour of the day for the crew change, the passengers had not received a site induction but were provided with a site 'chaperone' and should have received a vessel induction.

- ◆ Barriers should be in place around open hatches;
- ◆ Where possible, hatches should be opened when only vessel crew are onboard;
- ◆ All persons onboard should be informed when hatches are opened;
- ◆ Development of procedure for management of opening hatches to add to vessel SMS;
- ◆ There should be clear site and CTV induction stating that permission is to be sought before boarding a CTV;
- ◆ Physical barrier (gate) to be closed and bolted once all passengers have disembarked the CTV.

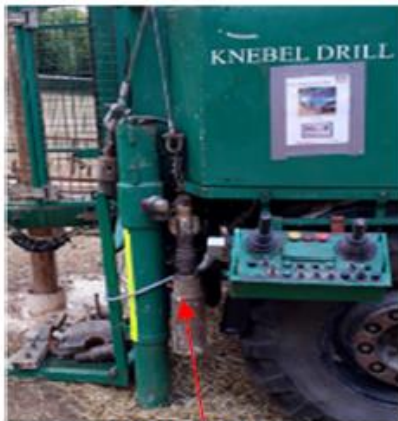
Hoist plug

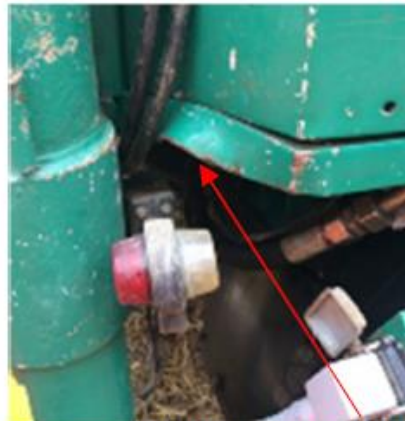
During drilling operations on a land-based drilling rig, the thimble within the hard eye of the winch wire momentarily caught (snagged) on the edge of the drill rig chassis. It then released in an uncontrolled manner very close to the driller. The incident occurred when the driller found it necessary to raise the drill mast, resulting in the winch wire being pulled upwards. As the winch wire was pulled up, the thimble caught on the edge of the drill rig chassis. The driller failed to notice that the winch wire had become snagged and continued to raise the mast, thus continuing to increase the tension in the wire until the steel thimble bent, causing the wire and attached hoist plug to release in an uncontrolled manner.

Damage sustained to chassis and steel winch wire thimble

- ◆ Failure to identify and recognise snagging hazard;
- ◆ Incipient complacency in what was seen as a 'routine' task.

- ◆ Investigate engineering/practical solution: retract the winch wire to a safe position when not in use; where this is not possible, lower the winch wire to a safe location away from all structures and other potential snagging hazards. Keep contained within a trip tray or bucket to prevent a tripping hazard;
- ◆ Highlight the importance of managing all lifting operations, including winch operations and awareness of complacency creeping into routine tasks;
- ◆ Review procedures and task risk assessments to ensure that the potential for lifting equipment (winch wires) becoming snagged is appropriately considered and mitigated. All control measures should be included;
- ◆ Careful check of potential snagging hazards before operation of the winch or the lowering/raising of the drill mast.
