IMCA Safety Flash 06/14

April 2014

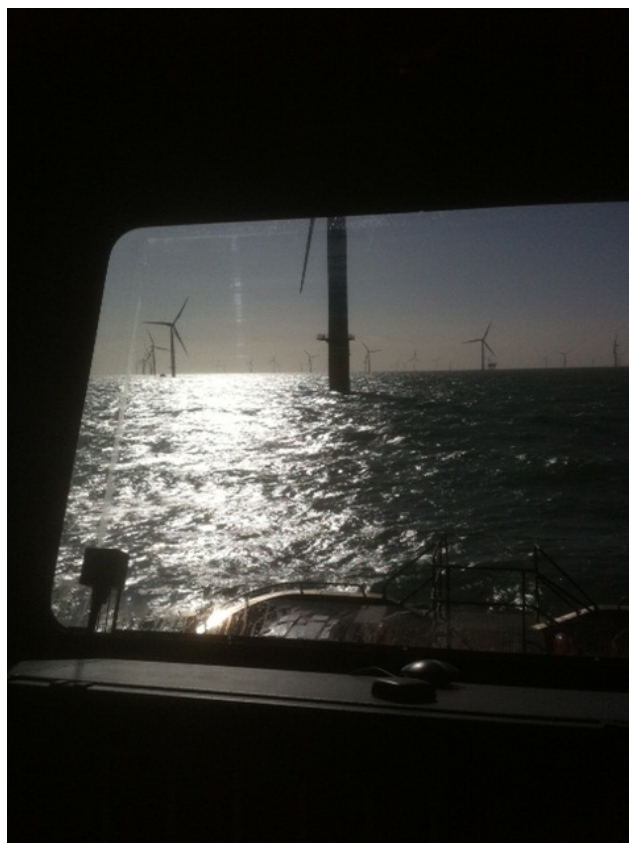
A member reported an incident in which a CTV (crew transfer vessel) made a heavy impact on a boat landing on an offshore renewable energy turbine tower. The weather conditions were 1-1.5m significant wave height, wind on the beam of the vessel and a flood tide. On this occasion the sun was low in the sky almost directly behind the turbine tower and was causing significant glare on the water. Although sunshades were in place and adjusted, the Master found it difficult to judge the final approach and landed on the boat landing in excess of the threshold limit of 200 KN. There was no damage to the vessel or injury to crew.

View as seen by vessel Master shortly before incident

- ◆ The heavy impact was recorded by the 'vessel black box' monitoring equipment;
- ◆ Whilst the conditions made manoeuvring the CTV challenging, more than 30 landings had already been made without incident;
- ◆ The glare made it difficult to judge the distance in final approach;

- ◆ The approach could have been delayed to allow for the glare to reduce.

- ◆ Revision of generic risk assessment for navigation along with procedures for small vessel operations;
- ◆ Reminded vessel Masters to take into account all elements of visibility and to adjust their passage plans and approaches accordingly, including delaying a pickup, if they deem that the conditions are not safe.

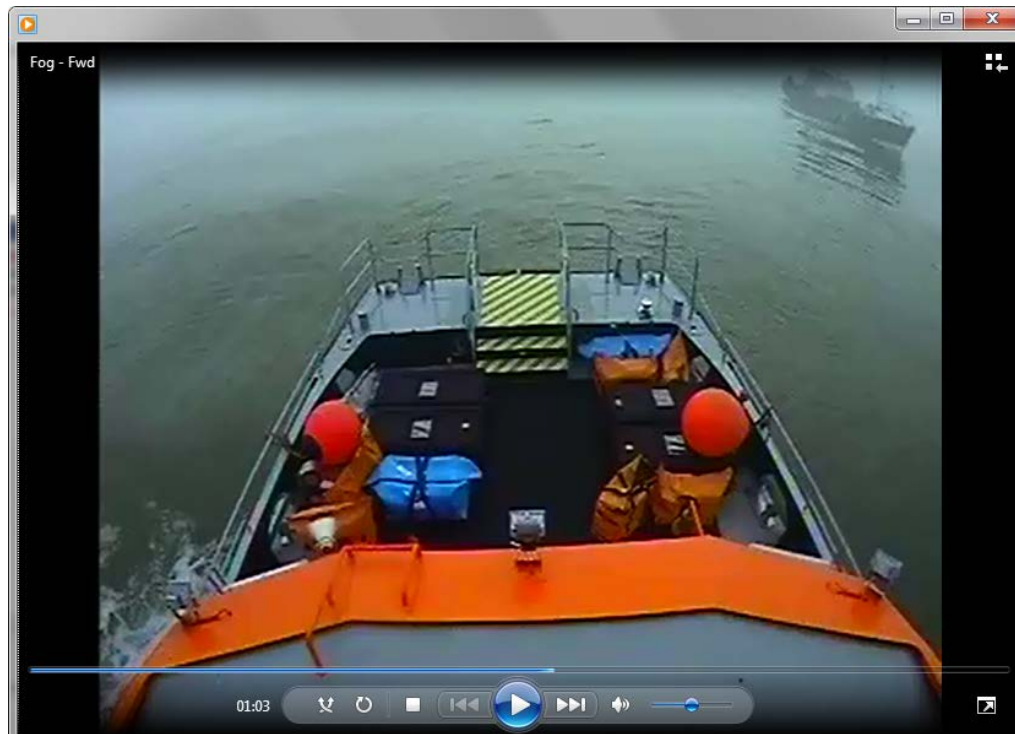
A member has reported a near miss incident in which an offshore wind farm crew transfer vessel (CTV) avoided another vessel in its path during a period of restricted visibility. The incident occurred when the vessel was on passage along the designated wind farm traffic route. It entered a fog bank which resulted in visibility being reduced to less than 100m. Upon entering the fog bank, the Master reduced to minimum steerage way, posted a lookout in the wheelhouse and commenced making sound signals as required by International Maritime Organization (IMO) collision regulations. In addition to this, a second crew member prepared to mount a watch on the foredeck, and the intercom external speaker was activated to monitor for sound signals of other vessels.

Another vessel ahead was sighted at less than 100m away. It was at anchor in the wind farm traffic route. The Master immediately stopped the CTV and then proceeded slowly around the anchored vessel, which was not making any sound signals nor was an Automatic Identification System (AIS) signal noted. Although the CTV had radar operating on the 2 mile range the anchored vessel was not detected. This incident was reported to the UK Marine Accident Investigation Branch (MAIB) and the client.

Showing fog from bridge of CTV

- ◆ Amend the generic risk assessment for navigation, along with the company procedures for small vessel operations, to reflect this incident;

- ◆ Ensure Masters are aware of their radar settings, as improperly adjusted rain and sea clutter or gain settings can affect reception;
- ◆ Ensure Masters are able to use known objects such as channel buoys to confirm correct calibration.
