IMCA Safety Flash 06/17

March 2017

Focus: Fire Safety

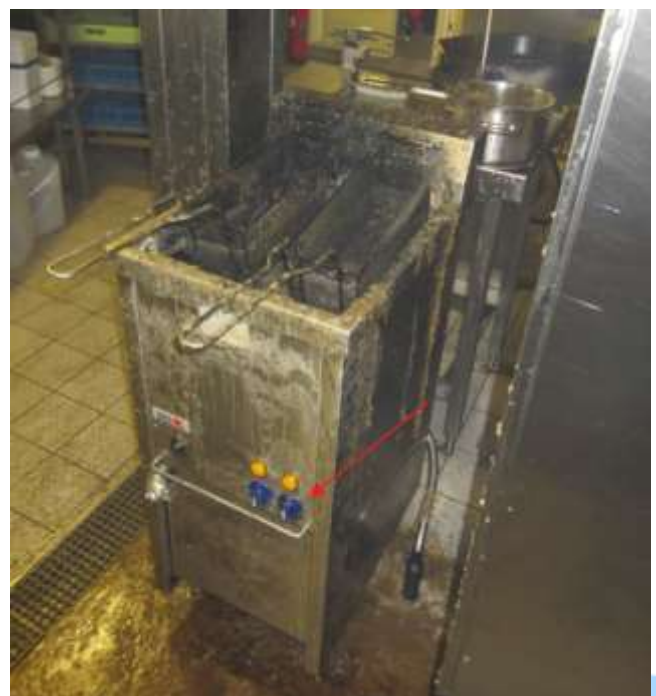
- ◆ The galley crew said that the deep fat fryer was turned off 10 minutes before they left the galley;
- ◆ The deep fat fryer had a thermostat with maximum 210°C, and thermal fuses which should have cut out, with an alarm sounding, at 246°C and 275°C. These two thermal fuses had not cut out;

- ◆ No fault was found with the thermostat after the fire. It could not be said with certainty that the thermostat was without fault – an intermittent fault could have been present;
- ◆ The oil used in the deep fat fryer had a flash point of ~250°C, but the user manual for the device requires that the oil used should have a flash point higher than 350°C;
- ◆ The most likely cause of the fire was the high oil temperature;
- ◆ The deep fat fryer was left in an unsafe condition:
 - The two baskets were not removed
 - The lid was not in use
 - The heating element was not clean, and the thermostat is under the heating element. Therefore, the thermostat could have been reading an incorrect temperature;
- ◆ Two days before the incident, the deep fat fryer had been inspected and repaired by the engineers, but no work order or record was made of the corrective work or repair.

- ◆ Incorrect use of equipment/machinery:
 - The flash point of the oil used was too low
 - The deep fat fryer was left in an unsafe condition;
- ◆ Inadequate tools and equipment: the thermostat may have had an intermittent fault;
- ◆ Our member's investigation recorded the following **root causes**:
 - Lack of knowledge and lack of experience of what kind of oil should have been used in the deep fat fryer
 - Inadequate maintenance standards – no proper records were kept after repair work was conducted on the fryer
 - Lack of skill/poor practice: the galley crew ought not have left the fryer in that condition
 - Inadequate work standards: procedures were not adequate for the correct use and cleaning of the fryer.

- ◆ Ensure oil with the correct flash point is used in all such fryers on all company vessels;
- ◆ Ensure that all repair work is properly documented in company planned maintenance system;
- ◆ Make sure focus/attention is given to ensuring galley equipment is left in safe and appropriate condition after use, and that there are proper procedures for cleaning the fryer.

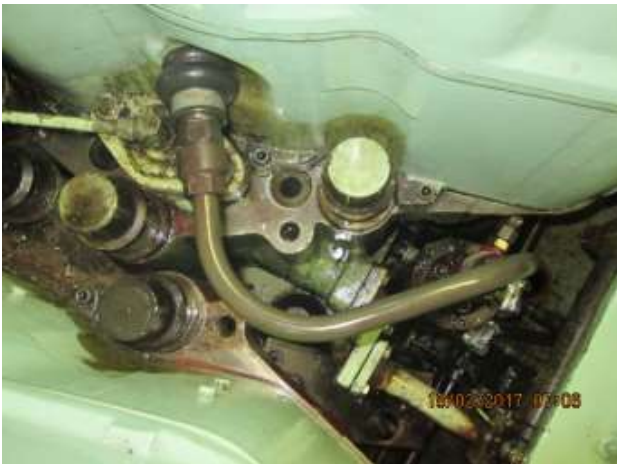
Top view of the failed pipe in place

- ◆ The cause of the incident was a failed high pressure fuel pipe coupling between the fuel injector and delivery pipe. This caused fuel to run onto hot engine components which created smoke.

- The leak originated from the fuel coupling which contained an O-ring seal inside. Upon inspection the O-ring was not brittle or damaged
 - The pipe was inspected and showed no signs of visible damage. Further analysis would take place;

- ◆ Investigate similar systems to ensure no other latent failures or defects that may result in recurrence;
- ◆ Ensure main engine fuel pump overhaul to include fuel pipe pressure testing and seal renewals.

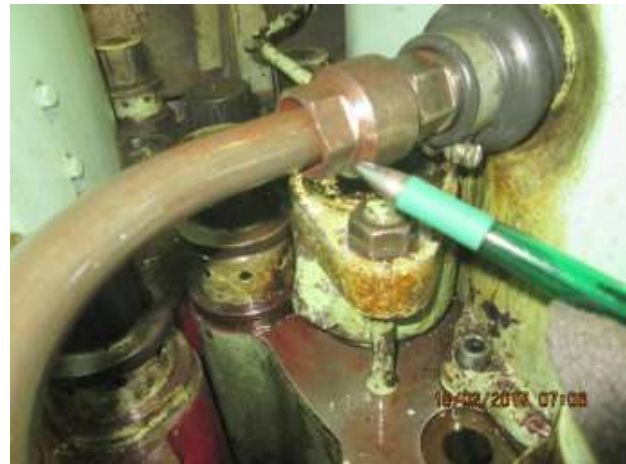
Location of failure at the fuel pipe coupling

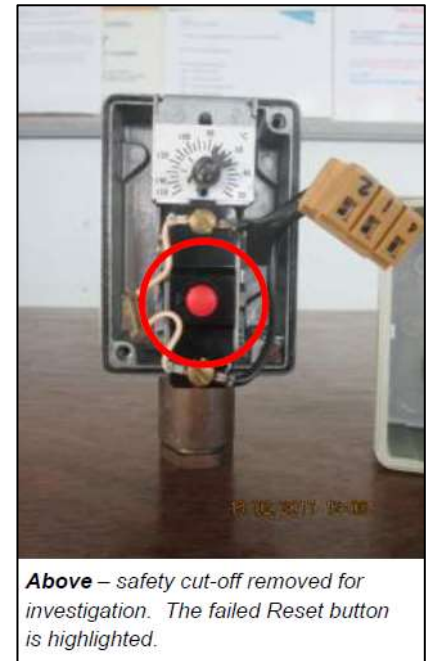
- ◆ The **immediate cause** was the overheating of the lube oil pre-heater, which in turn overheated the paint on the heater casing, causing smoke;
- ◆ The engineer carrying out the work noted his concerns with the operation of the heater. He shut down the system by activating the heater stop button, and had the intent to report a possible fault;
- ◆ Events overtook his intentions: the smoke activated the smoke detection system and raised the General Alarm;
- ◆ The **root cause** was discovered to be a failed switch in the safety cut-off mechanism, which was found to have failed in the "Reset" position; this meant that, even if the heater had tripped, it would have immediately reset itself thereby keeping the heater on.

- ◆ Investigation of similar systems to ensure no other latent failures or defects that may result in recurrence;
- ◆ Immediately pursue and action any outstanding defects related to communications and/or emergency response systems;
- ◆ Implement and publish a procedure for emergencies occurring during drills and exercises.

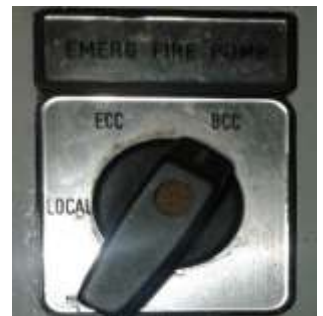
A member has reported a near miss incident in which it was discovered that an emergency fire pump could not be started from the bridge. The discovery was made during a fire drill exercise on a vessel. The Master immediately informed the chief engineer. The chief engineer took action and noticed that the Emergency Fire pump main switch in the engine room was switched to local control. He switched it from local control to bridge remote and informed the bridge to start again; on this attempt it was started successfully and came on line.

- ◆ **What went wrong?** The vessel's Emergency Fire pump main control switch in the engine control room was switched to "local control" instead of "remote/bridge control". This meant that the Emergency Fire pump could not have been started from the bridge;

- ◆ Chief engineer to ensure that the main switch in the engine room is always stationed on "Bridge Remote Control". A sign or notice to this effect to be posted in the engine room to remind engineers to always leave the switch on bridge remote control.
