IMCA Safety Flash 06/18

March 2018

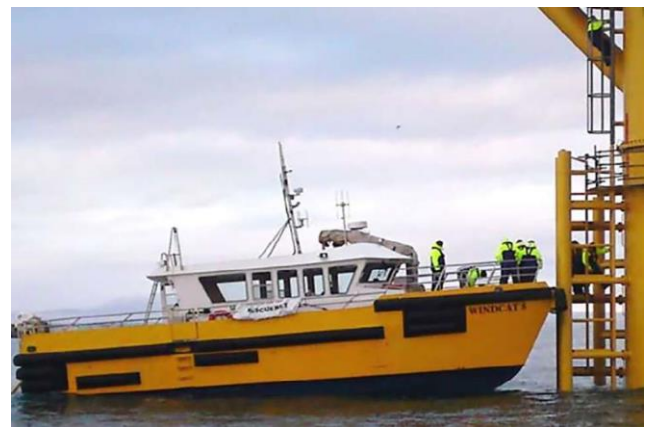
There was a catastrophic engine failure and subsequent fire on the 15 metre windfarm crew transfer vessel (CTV). The engine damage was caused by a big end bearing failure.

There were no injuries to the two crew or the 12 embarked wind turbine technicians. The fixed firefighting system was operated, but it was ineffective because not all the engine space vents had been closed. The fire caused only minor damage and eventually extinguished when it ran out of fuel.

The MAIB recommended that training and guidance be provided to CTV crews on the action to be taken in the event of critical propulsion alarms, and to ensure they are familiar with the use of fixed fire-fighting systems.

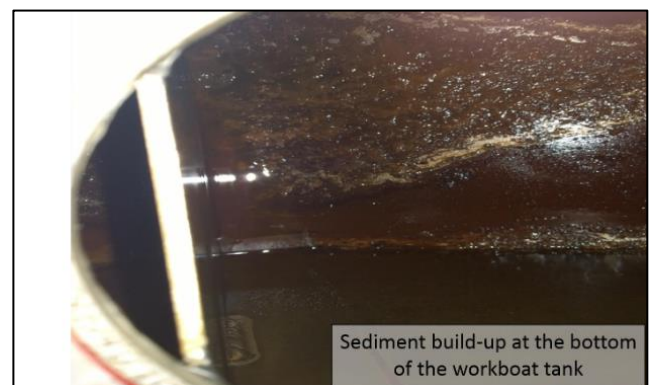
Vessel engineers discovered that the fuel in the tank was contaminated due to water condensation causing a build-up of bacteria. The source of contamination was water or moisture in the tank due to condensation in the tank head space; this resulted in a build-up of bacteria turning into sediment. The sediment caused the fuel oil fine filter to clog preventing the engine from starting.

Planned maintenance system (PMS) instructions with respect to inspection and maintenance were clear, but had not been followed. The vessel did not hold spare filters on board.

- ◆ Check fuel and tank quality through planned maintenance inspections, treat and/or clean as applicable;
- ◆ Ensure workboat fuel tank levels are maintained to prevent condensation/water building up;
- ◆ Ensure a stock of essential fuel filters are held on board.

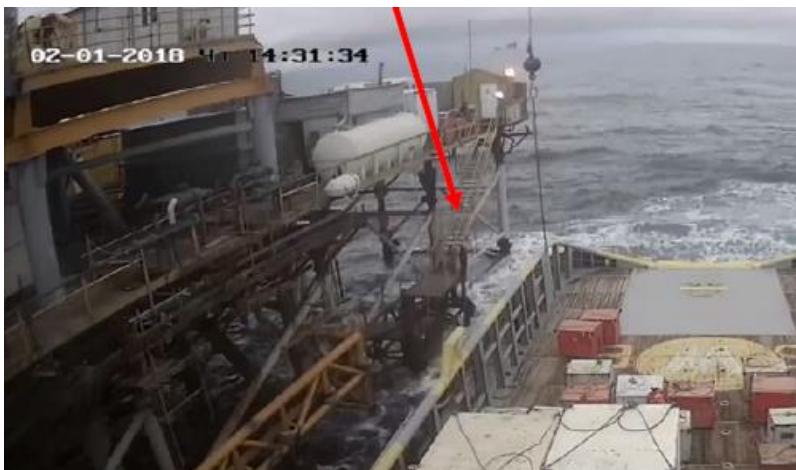
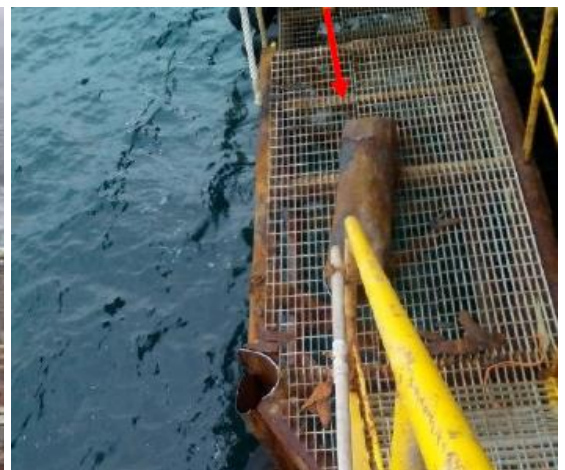
The vessel's stern collided with the platform mooring bollard which was damaged. No one was injured. This damage was allegedly not noticed at the time by the crew, and was identified and reported by the client at a later stage.

- ◆ Given the unfavourable operational conditions, there was excessive exposure to risk, possibly driven by inadequate planning. The operation should have stopped when conditions were found unsafe;
- ◆ Concerns had been raised previously, relating to the absence of fenders and mooring buoys around the platform, and regarding the limited reach of the crane. These had not been addressed. Vessel management should keep their fleet management informed of operational hazards and enable corrective actions with clients and other 3rd parties, as needed.

Ensure that there is properly documented and agreed guidance available on methods of safely approaching platforms, on escape routes and on go/no-go zones, particularly when new locations are involved.

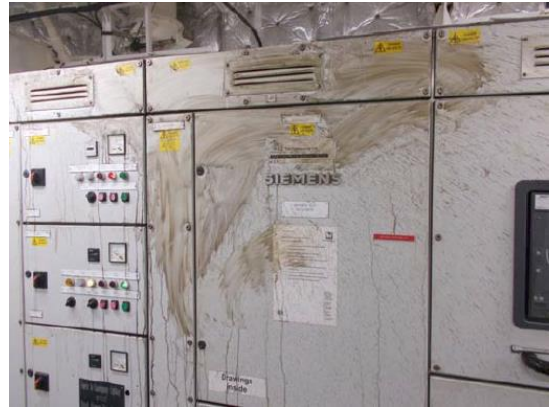
When the task started, a fine mist was noticed coming from one of the nozzle heads in the emergency generator switchboard room. Further to this, water was seen spraying out of the nozzles onto the 440V and 220V switchboards, transformers and surrounding areas. An all stop was immediately called over the radio.

The source of the water has not been identified, however it is suspected to have been as a result of condensation forming in the pipework supplying the nozzles. These pipes are of considerable length.

Following the incident, the vessel team placed bags with a small air vent onto the nozzle heads to collect any unexpected release of water during checks;

- ◆ Nozzle heads to be covered appropriately during these tests;
 - the planned maintenance system was updated to include instructions to cover nozzles within electrical switchboard spaces and any other sensitive areas during these tests;
 - other vessels and third-party contractors were advised to take similar precautions.
