IMCA Safety Flash 07/00

December 2000

Subject Lifting Equipment Manufacture

Safety Notice No. DVX003/2000
New Concern related to Divex
L.P.Hoses

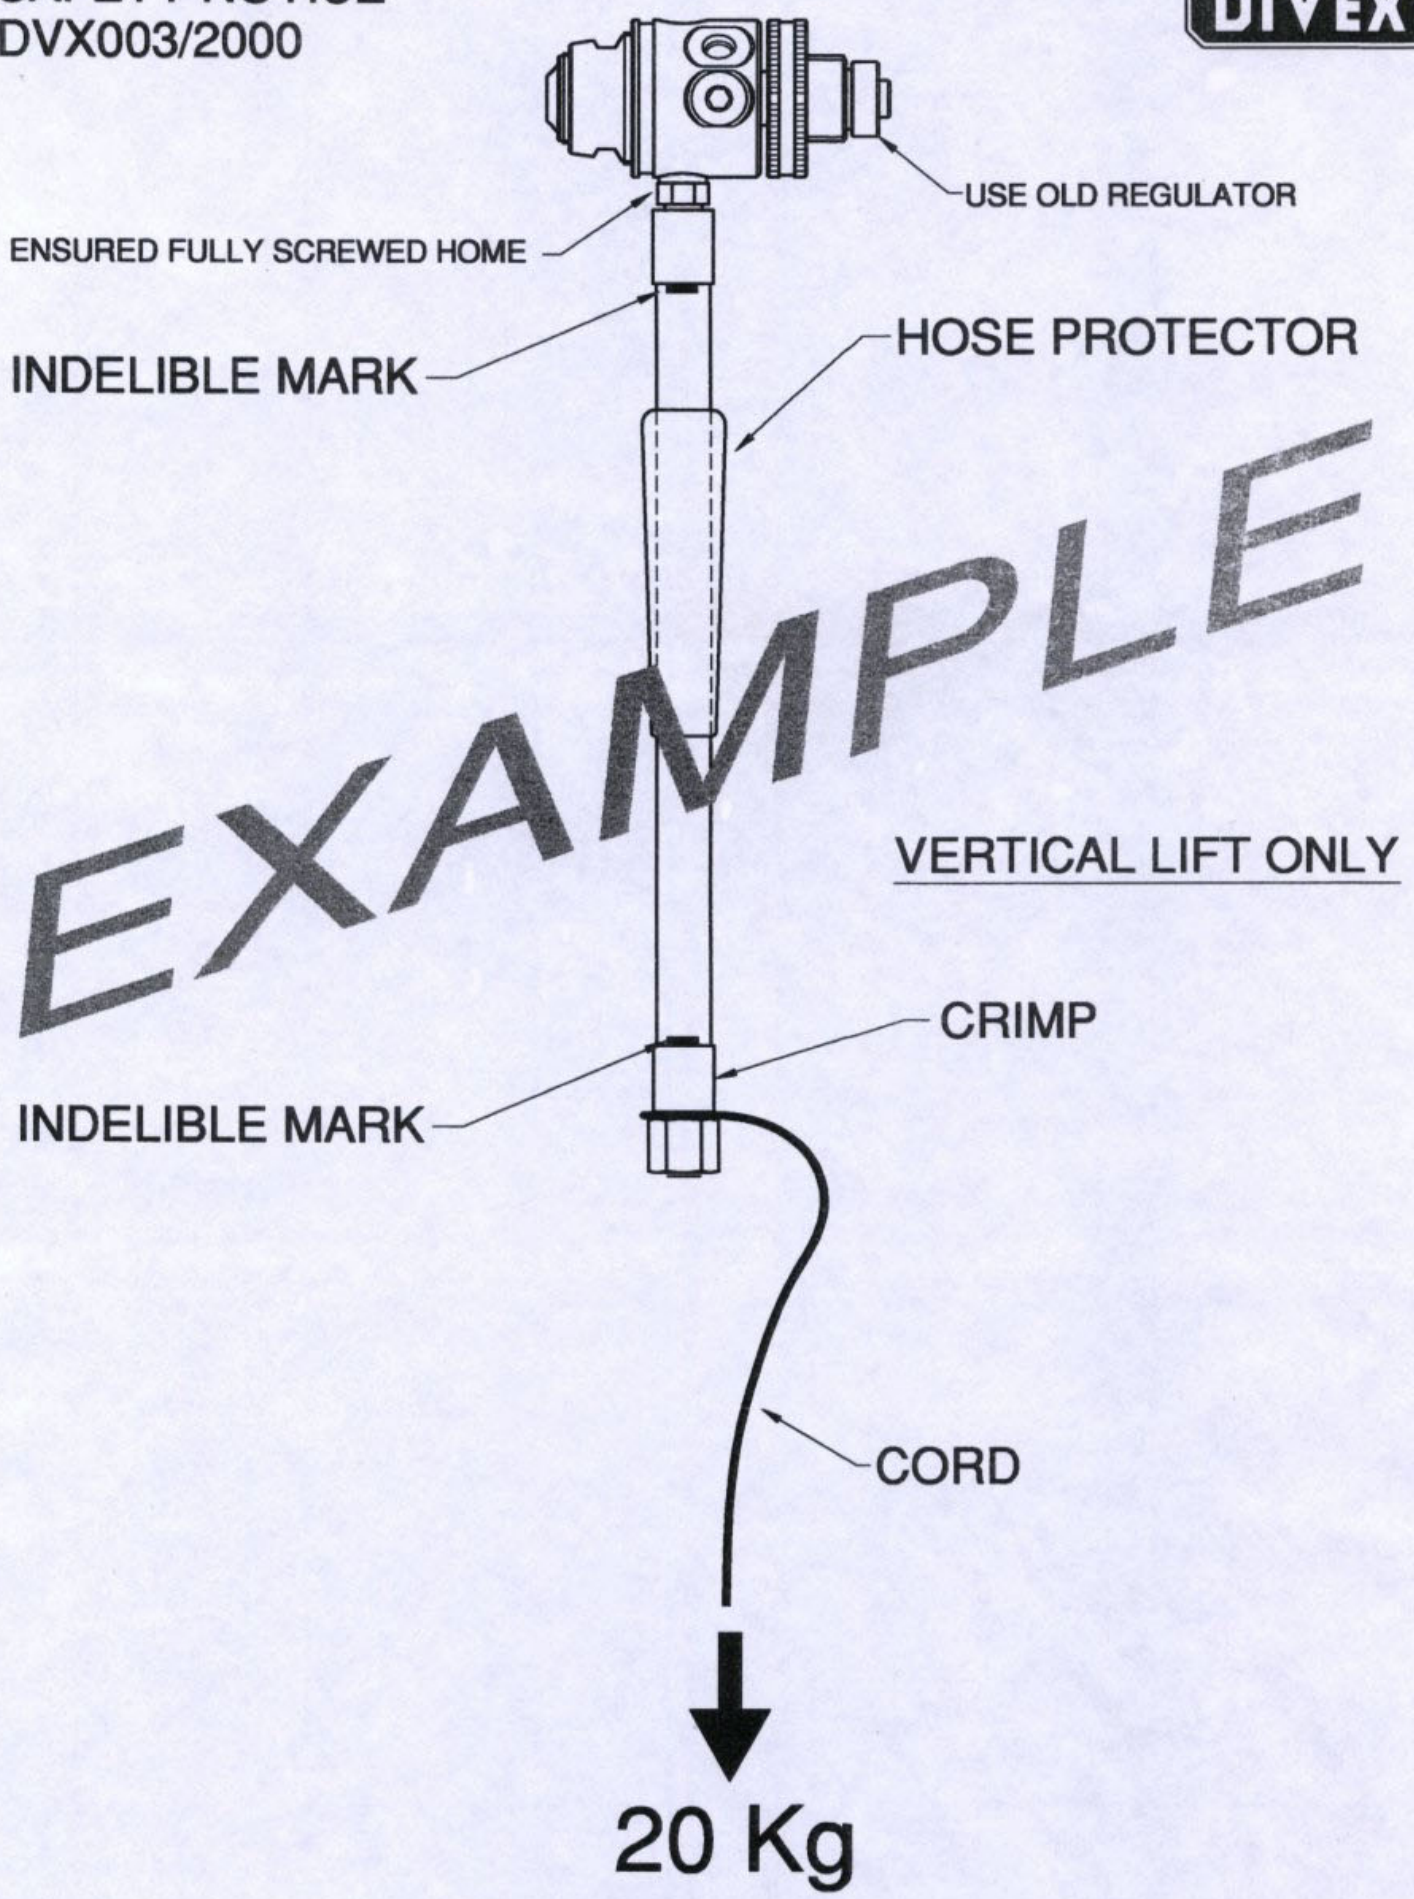
SAFETY NOTICE
DVX003/2000

Unfortunately, we have been made aware of two failures of hoses that were manufactured in accordance with the improved procedure. Two hoses, being used at different locations, have been reported to part from the ferrule at the mask/helmet end of the hose. The failed hoses had been fully pressure tested, load tested and certified by Divex. Despite the above these failures have occurred and to date we have not established the cause of failure.

1. With an indelible pen mark the rear of the crimp where it meets the hose at both ends (this may require the hose protector to be pulled back).
2. With the hose fully screwed into the first stage regulator and the other end mated to a suitable fitting apply a load of 20 KGs to the hose assembly for one minute minimum - see attached sketch.
3. Remove the load from the hose assembly and check to ensure that the indelible pen marks have not moved from their original position.
4. Hoses that show no signs of movement can continue in service and the indelible mark may be used as an ongoing check/ confirmation of no movement of hose.
5. Any hose that shows signs of movement **must** be withdrawn from use and returned to Divex immediately.
6. **Mark the returned hoses for the attention of Kathleen Scanlan**
