IMCA Safety Flash 07/12

July 2012

I LTI - Incident with Circular Saw Leads to Loss of Thumb

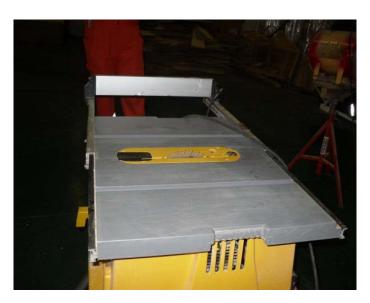
- ♦ No risk assessment had been conducted for the operation;
- The equipment was incorrectly set up and incorrectly operated by the injured person, though he stated that he was familiar with the operation of the equipment;
- The bench saw was supplied on board with the necessary safety equipment and full instructions for its safe operation. These instructions included reference to the use of the safety guard, a special tool for pushing the wood through, and the requirement to set the cutting blade to the correct level in accordance with the thickness of the wood that was being cut:
- The instruction manual appeared not to have been available at the workplace and the safety requirements for the safe operation of the saw were either not fully understood or were disregarded;
- There was no guard fitted to the circular saw blade.

Unguarded bench saw

- ♦ All power tools have the potential to cause serious injury if they are operated incorrectly and without the manufacturers' approved and fitted safety devices;

- A risk assessment must be completed and filed prior to using any power tool. The assessment must take into consideration the following:
 - the competence of the persons using the equipment

- the condition of the equipment being used
 - the provision and proper functioning of adequate safety guards and cut-out devices such as emergency stops and barriers

- general working environmental conditions such as lighting
 - availability and condition of any personal protective equipment;
- Guards must always be fitted to equipment when designed to have them in place during operations;

- Power equipment should be operated in accordance with the procedures and rules set for their safe use;
- Full training, manuals and instructions should be available, and manuals and instructions should always be read and fully understood by even experienced operators;

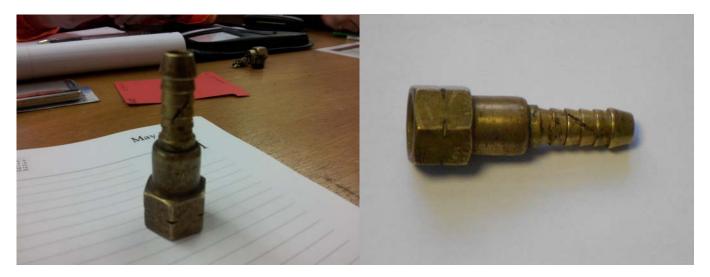
- The gas hoses were attached to the burner at check valves with crimped fittings;
- ♦ The oxygen check valve was damaged by the effects of the fire;
- The acetylene check valve was still connected to the hose. When the hose was removed it was found to have a deep score across the fitting (see image below). The damage was consistent with the blade of a hacksaw. It appears to have been caused when the hoses were being re-terminated. It was assumed that the oxygen fitting had similar damage which had added to the likelihood of its failure causing the gas release and fire;

- The equipment had been inspected and passed as fit for use by an external agency three weeks prior to the accident. The equipment was only inspected visually and the hoses were not removed to examine the fittings;

Damaged acetylene fitting

- The burning equipment was replaced;
- Instructions were included so that when re-termination takes place, the check valve fittings should be replaced with new fitting;
- Welders are now required to wear protective overalls appropriate to their work and additional training for welders was provided.
