IMCA Safety Flash 07/15

May 2015

I Second-Hand Equipment Causes Engine Breakdown

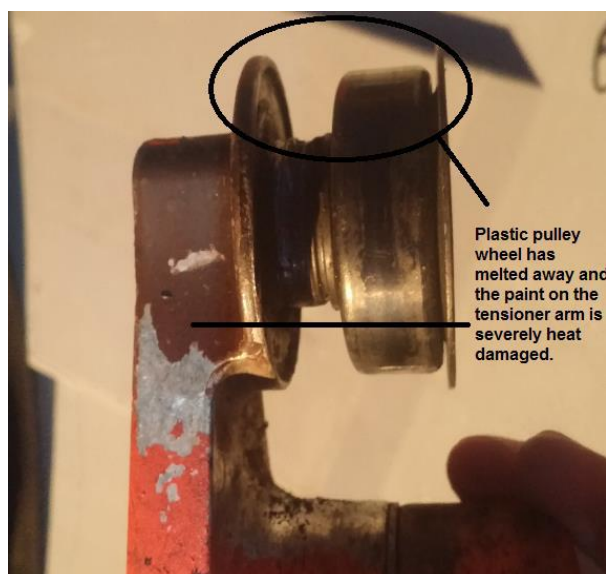
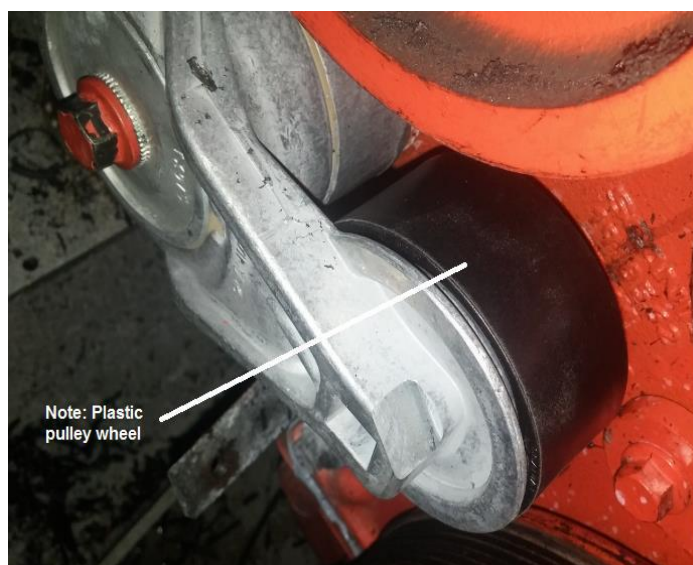
A member has reported an incident in which an offshore wind farm Crew Transfer Vessel (CTV) suffered an engine breakdown due to the drive belt automatic tensioner seizing. The incident occurred whilst the vessel was on transit from harbour to site. The port engine alarm activated, it was quickly discovered after short investigation that the main engine auxiliary belt that drives the alternator and the cooling pump had broken and the belt tensioner was badly damaged.

Figures: showing drive belt tensioner

- ◆ The bearings had fallen apart and the pulley wheel seized causing the belt to run over the stationary plastic wheel until friction caused failure;
- ◆ The engine manufacturer recommended that checks be made every twelve hours:

- ◆ It was noted that whilst the belt tensioner could be and was checked, it was very difficult to accurately check the pulley bearing as it was a sealed unit with no means of lubrication during its working life (only at manufacture) and it was not possible to see the condition of the bearing;

- ◆ Servicing guidelines and procedures: improvements were made to on-board servicing guidelines for engines of this sort;
- ◆ Communications and record-keeping: comprehensive and proper records should be made in the vessel maintenance log – and forwarded to management ashore – when changes were made to the engine, or parts therein were replaced.

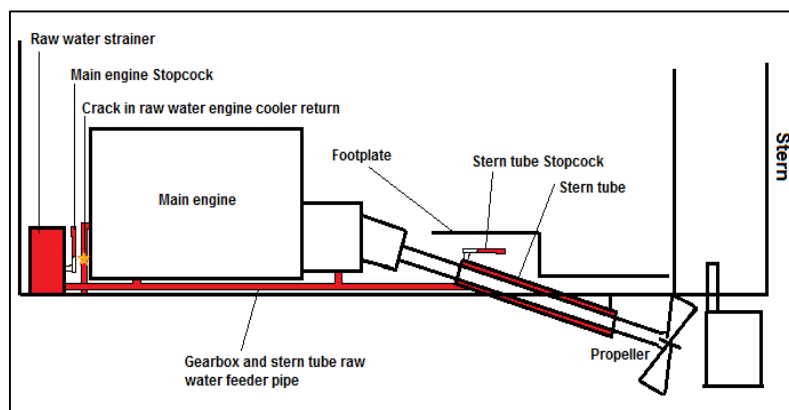
Figure: location of stopcocks

- ◆ During subsequent further fault finding to eliminate the source of the water flow it was found that the flow was coming from the stern tube;

- ◆ This particular type of vessel was propeller driven with water lubricated stern tubes. Underneath the floor plate at the stern gland there was another seacock;
- ◆ This seacock had not been highlighted to the crew during delivery of the vessel;
- ◆ There was no hatch in the foot plate to allow easy access to the valve;
- ◆ The pipe was repaired the following morning;
- ◆ An investigation is currently underway as to why the pipe cracked. Preliminary consideration was that it may be due to the weight of the temperature gauge causing the pipe to weaken over time.

Our member required the crews of other similar CTVs from the same manufacturer to check the plastic pipes in the engine rooms regularly for signs of deterioration or stress around the reduction glands and temperature/pressure gauges, and any deficiencies were to be immediately reported to the management.

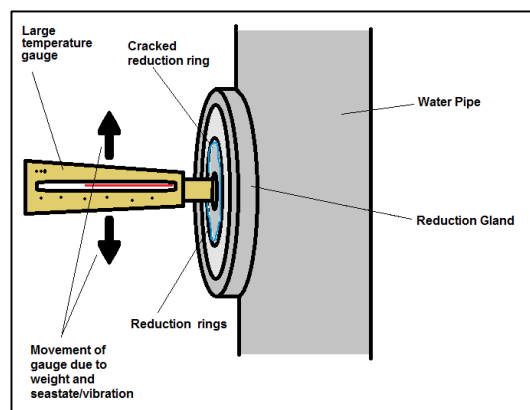
A member has reported a near miss incident in which large volumes of sea water were found in the bilges of a small boat (offshore wind turbine CTV). The water was discovered during pre-shut down checks when the vessel was alongside. After initial fault finding it was found that there was a leak due to a cracked raw water cooling return pipe from the port side main engine. The crew closed the raw water sea chest and after making every effort to temporarily seal the crack, went ashore to seek a long-term solution.

Figure: original fault

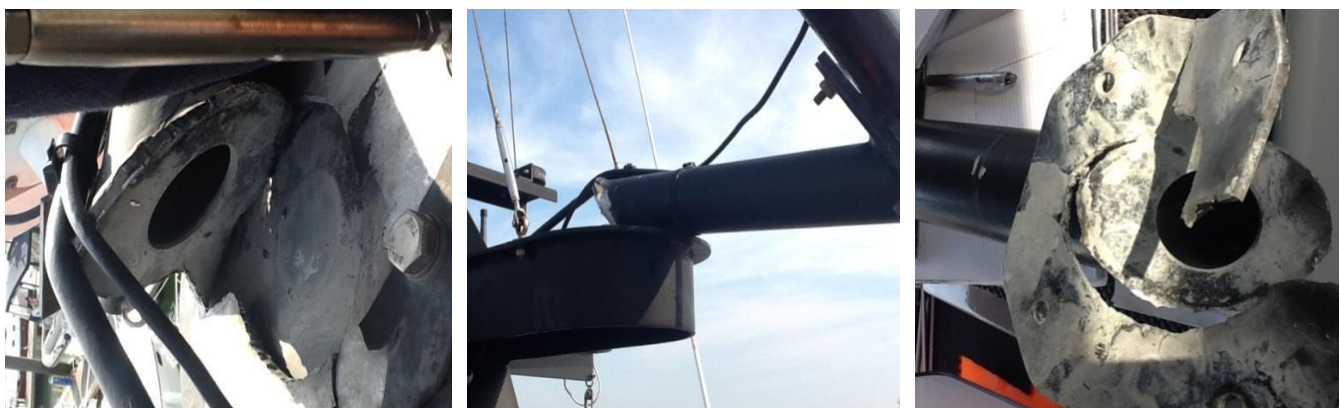
A member has reported two near miss incidents in which there has been a failure of a mast arm on a CTV. Both incidents related to weld fatigue. In both cases heavy aerials have caused welds to crack and break over time until the mast arm gives way.

Figures: photographs of mast damage following the first incident

- ◆ On CTVs, mast checks should be added to a planned maintenance or check schedule;
- ◆ These checks should focus on the tension of the shrouds and the strength of the welds supporting the mast arms;
- ◆ Extra special attention should be given to those parts of the mast that are unsupported and connected to large or heavy aerials or equipment.

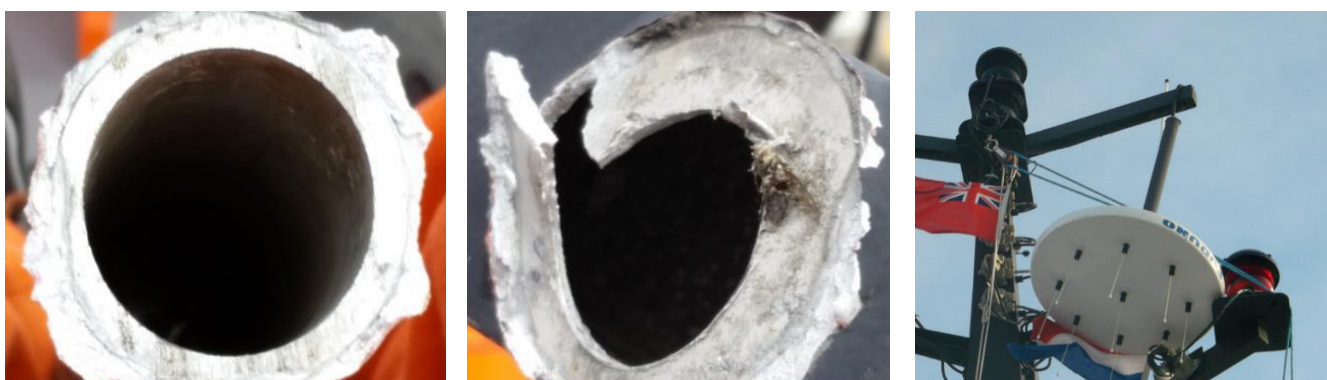
Figures: photographs of mast damage following the second incident

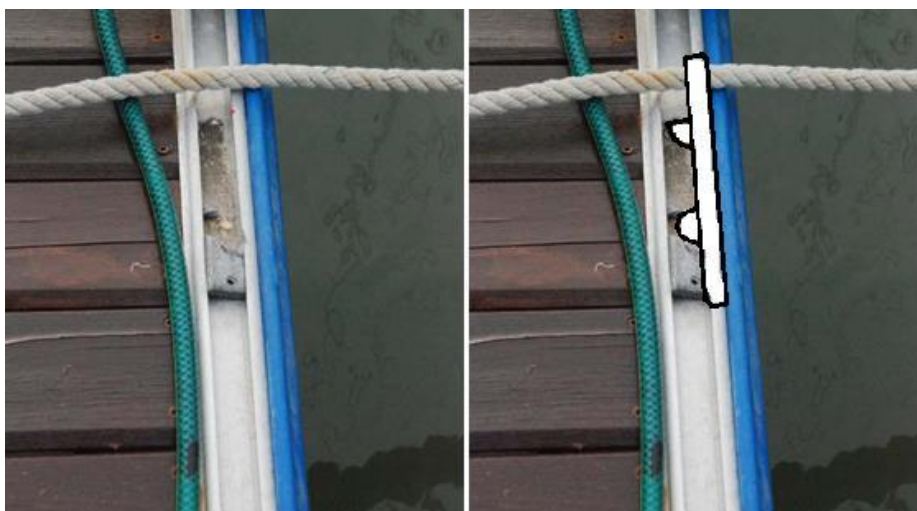
A member has reported an incident in which a pontoon cleat was damaged during offshore renewables Crew Transfer Vessel mooring operations. The incident occurred when the vessel was leaving its berth. When the mooring lines were being removed, the master caused the vessel to pull back onto the spring line to allow the forward breast line to be released. At this point the mooring cleat on the pontoon gave way and broke, flying across the pontoon near to where a crewman was standing whilst assisting with the mooring ropes. There was minor damage and no injuries.

Figure: showing damaged cleat

- ◆ The vessel had been moored in position for six days alongside the pontoon and had been tied to the same cleats for the whole time, most probably weakening the cleat due to the increased stress of the large vessel weight added to the wind force pulling on them;

- ◆ The vessel had been pushed away from the pontoon by the wind, which put significant stress onto the mooring cleats, possibly leading to equipment/material fatigue and consequent increased likelihood of failure;

- ◆ Larger, heavier crew transfer vessels should moor onto pontoon uprights or purpose-made heavy duty mooring points during bad weather, this was to avoid unnecessary stress or weakening to pontoon equipment designed typically for use by yachts and smaller vessels;
- ◆ Improve communications between master and crew onboard the CTV (for example, holding a toolbox talk) before manoeuvres were made in order to get underway, this was to avoid mooring lines being left attached and coming under load. In these cases the casualty was a cleat, but it could easily have been a critical piece of equipment or even an arm or leg;
- ◆ "Closed loop" communications should be adopted, i.e. feedback made that all communications were properly understood before action taken.

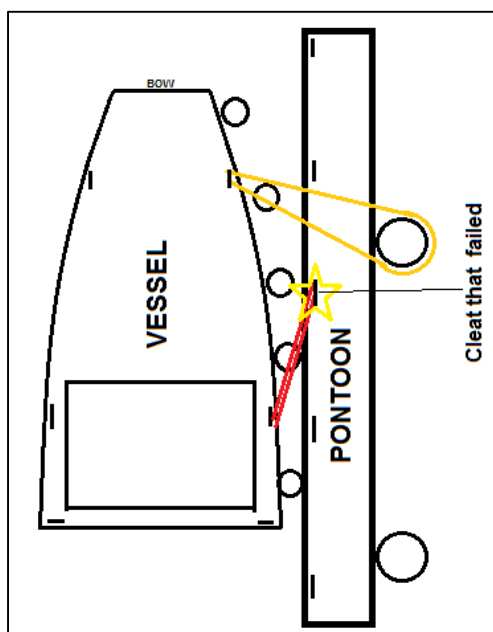
Figure: Schematic showing mooring line layout at the time of damage

- ◆ When the vessel was preparing to leave the pontoon to begin work after the bad weather, one mooring line had been left attached for one reason or another and come under load as a result of the vessel's movements.
