IMCA Safety Flash 07/17

March 2017

Theme: Vessel and Cargo Operations

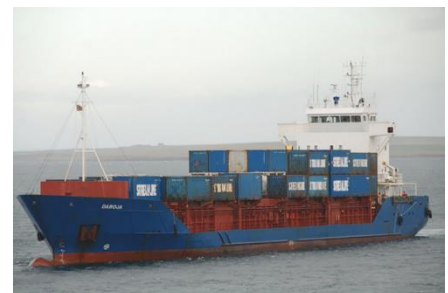
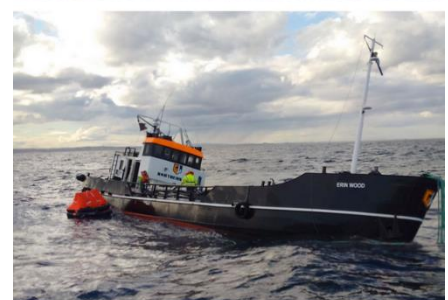
Incident 1: Collision between general cargo vessel *Daroja* and oil bunker barge *Erin Wood*

When these two vessels collided, minor damage was caused to the larger cargo vessel, but the smaller bunker barge suffered breaches of the hull, resulting in flooding of the vessel and pollution from leaking fuel cargo.

- ◆ The two vessels collided because a proper lookout was not being kept on either vessel;
- ◆ Complacency and poor watch-keeping practices;
- ◆ Failure to properly assess risk, particularly that of lone watch-keeping;
- ◆ Failure to secure and close watertight doors on the smaller vessel allowed flooding to occur;
- ◆ The crew of the smaller vessel were not competent, and an effective safety management system was not provided.

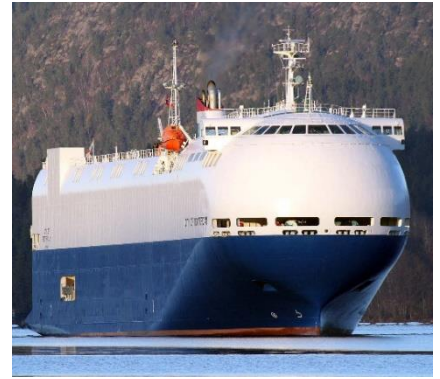
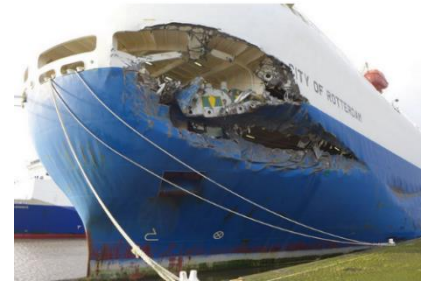
Incident 2: Collision between the pure car carrier *City of Rotterdam* and the ro-ro freight ferry *Primula Seaways*

When these two vessels collided in the Humber river, both were damaged but made their way to Immingham without assistance. There was no pollution and there were no serious injuries.

- ◆ The outbound *City of Rotterdam* manoeuvred into the path of the inbound ferry;
- ◆ This manoeuvre had not been corrected because the pilot on board had become disoriented after looking through an off-axis window on the semi-circular shaped bridge;

- ◆ The car carrier was of an unconventional design (see photo) and the pilot's disorientation was due to 'relative motion illusion', which caused the pilot to think that the vessel was travelling in the direction in which he was looking;

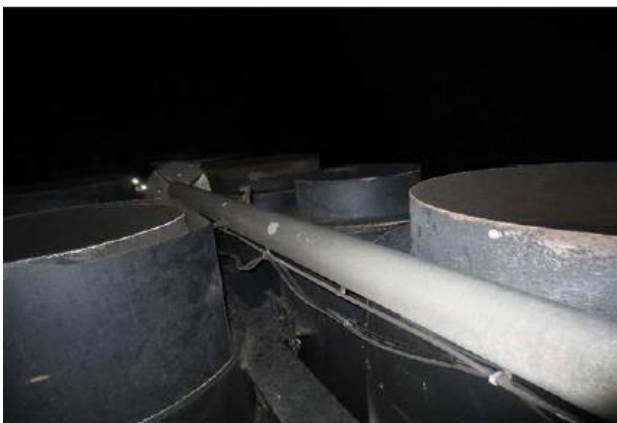
2 Vessel Mast Struck Bridge – Equipment Damage

A member has reported an incident in which the aft mast of a vessel struck an overbridge and broke, damaging the navigation lights on the mast. The incident took place during a transit of a ship canal in the United States. The aft mast of the ship struck the lower span of a raised vertical lift railway bridge. The aluminium mast post broke just above the base. As a result, the navigational lights on the mast post were damaged beyond repair. The mast fell safely on the funnel top and no persons were injured. The local United States Coast Guard (USCG) Captain was notified of the incident and the vessel continued to its next port of call, where repairs were conducted.

Mast resting between the stacks

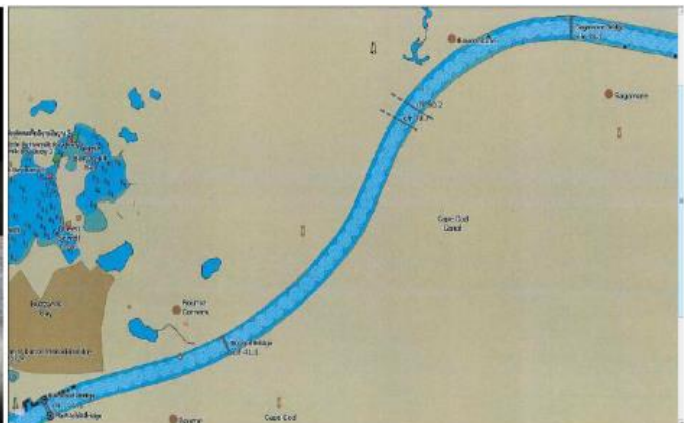
Canal Chart Showing Bridge and required clearance

- ◆ The air draft for the vessel had not been calculated. A predetermined static figure was used and compared with the height of whatever structure they would be transiting under;

- ◆ The static figure used was the air draft of the vessel in summer conditions, even keel and with mast lowered. This figure was used as air draft on the Pilot Card and confirmed verbally between the Pilot and the Master. No mention was made of the need to lower any mast;

In summary, there was incomplete planning of the voyage, inadequate communications, and a lack of understanding or proper assessment of all the risks involved. Of particular note is the fact that vessel air draft is a dynamic figure and should be calculated on a case-by-case basis.

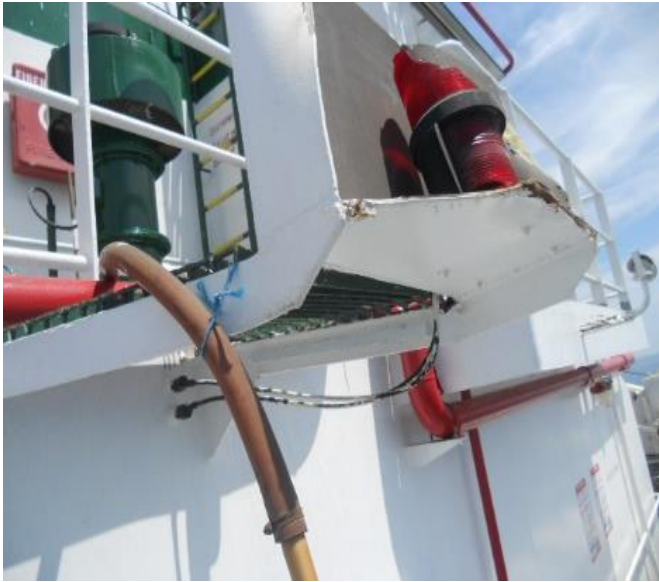
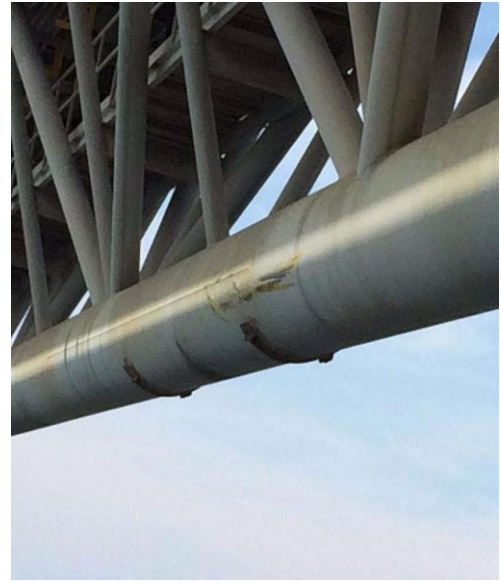
Incident 2: Loss of control of vessel leading to collision with platform

During personnel transfer operations with another vessel, one vessel came into contact with a fixed platform. The port side rudder failed causing the vessel to drift towards the platform flare bridge, making contact and causing slight damage to the flare bridge and the vessel’s navigation lights.

- ◆ The vessel was attempting to come alongside another vessel to effect personnel transfer, in the vicinity of a fixed production platform;
- ◆ Control of the vessel was lost, due to failure of a pin in the port side rudder angle feedback unit;
- ◆ Sea currents caused the vessel to drift into and collide with the bottom side of the flare bridge, causing minor damage.

An important lesson on both cases is the importance of extra vigilance and appropriate care when undertaking operations in the 500-metre safety zone. Additionally, the following should be noted:

- ◆ Greater understanding and ownership of marine risk from an installation perspective;
- ◆ Strict operating discipline in compliance with established procedures and recognised operating limits;
- ◆ Better quality communications between installation and vessels.

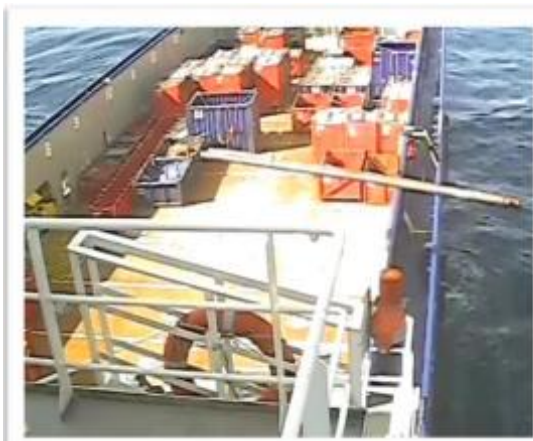
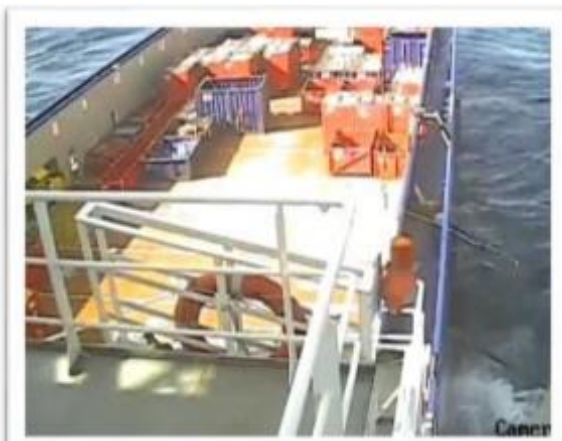
- ◆ A CCU was being back loaded from an installation when it hit a container already back loaded. The impact on the CCU caused it to then swing into a safe haven where it caught on the anti-snag bar and damaged the bar;
- ◆ A drill pipe back loaded from an installation swung inside a safe haven doorway, the lifting slings broke and the pipe fell overboard (illustrated below)
- ◆ A PSV without anti snag bars and no ‘tiger stripe’ highlighting the cargo rail tops suffered several snagging incidents, causing damage to the vessel, cargo and offshore crane.

- ◆ Vessel Masters should satisfy themselves that all potential cargo snagging areas on the cargo deck have cargo snag bars fitted. The anti-snag bars should be regularly inspected to ensure they remain 'fit for purpose';
- ◆ Vessel Masters should satisfy themselves that the cargo top rails are sufficiently highlighted to ensure crane operators looking down from height can easily identify potential snagging areas;
- ◆ Offshore crane operators should be made fully aware of the significance of the highlighted areas on the vessels top cargo rails and when/where possible avoid loading small CCU's against these areas.

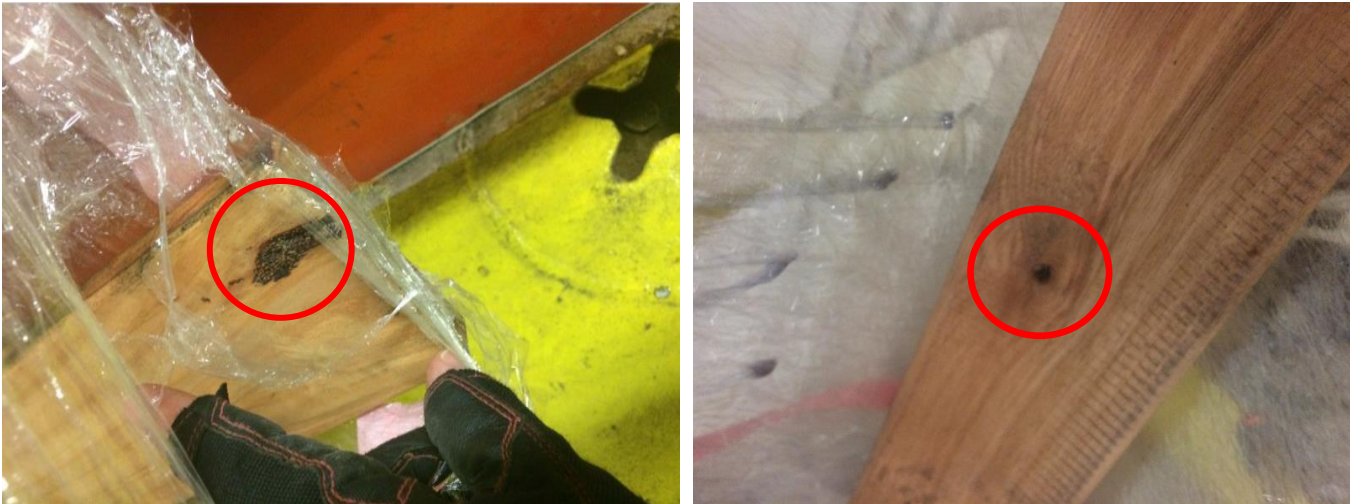
A member has reported an incident in which a vessel was supplied with a new pilot ladder which did not meet International Maritime Organization (IMO) or International Organization for Standardization (ISO) standard. This substandard pilot ladder was noticed by a Pilot in an Australian port. He brought the matter up with the Master via the agent.

Showing knots in the steps (circled)

- ◆ The technical specification of pilot ladders meets IMO requirements as per Resolution A.1045(27) – see below;
- ◆ Persons ordering or sourcing new pilot ladders should clearly know the IMO requirements and should specify to suppliers that every step on the ladder should be free of knots;
- ◆ New pilot ladders are thoroughly checked before use to verify quality and to ensure that the steps are clear from knots;
- ◆ Pilot ladders are always checked by the officer in charge before rigging and use to ensure it is fit for purpose, in good condition and secured properly to the vessel.
