IMCA Safety Flash 08/04

August 2004

1 Diving Helmets – Damage to Emergency Valve

2 Disguised Transportable Gas Cylinders

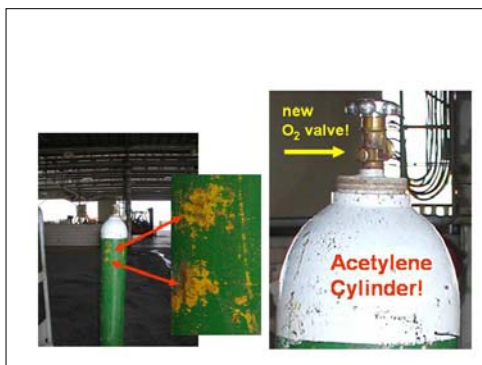
- Conversion of an acetylene cylinder to a 150 bar oxygen cylinder (picture 1).
- Conversion of an acetylene cylinder to Argon mixture gas cylinder (picture 2).

Cylinders having one or more of the above defects or are suspected to have been modified shall be set aside for additional control measures.

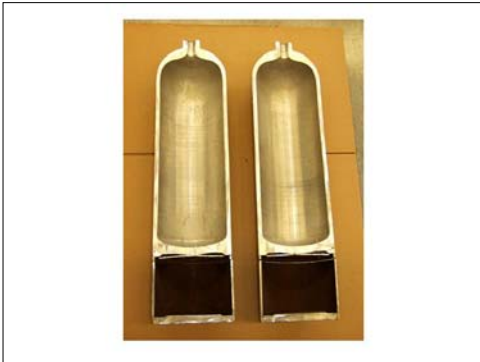
Picture 3

- A cylinder used by a smuggler (picture 3).
- A high pressure cylinder with a welded plug in the shell (picture 4).
- A cylinder with a falsified shoulder marking (picture 5).
