IMCA Safety Flash 08/09

June 2009

I Near Miss – Dropped Clump Weight

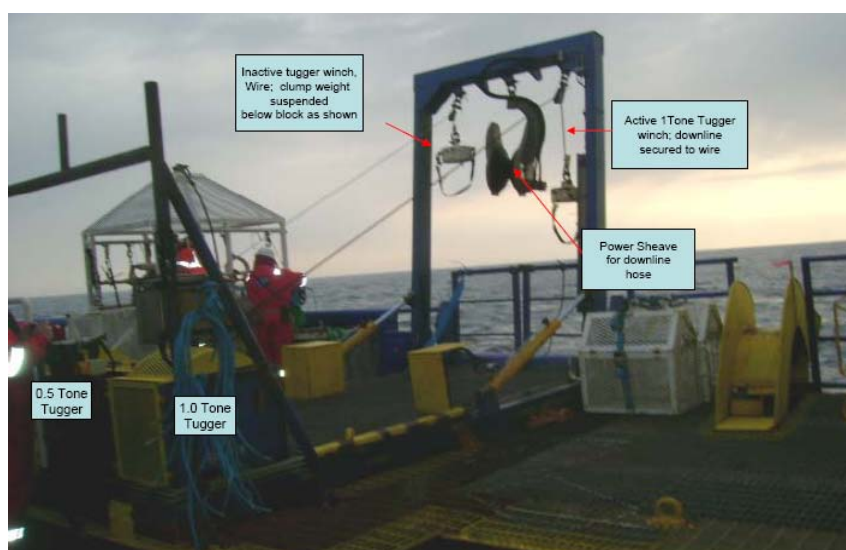
While recovering the tigger wire with downline to the surface, it was noticed that the winch wire clump weight could potentially foul the guard rails on the A-frame. The decision was made to boom out the A-frame further. As the A-frame was boomed out, the clump weight on the inactive wire rode up into the snatch block (because the tigger winch was not paid out as the boom was extended). The winch wire parted and the clump weight dropped to the seabed.

The clump weight landed on a protection structure approximately 10m from the divers who were working in an adjacent manifold. No one was injured and no equipment was damaged but there was a high potential for serious injury to the divers and for damage to subsea assets.

A-frame with tigger winch, snatch block and powered sheave arrangement

- ◆ The supervisor in charge of the operation on deck was himself operating the winch and A-frame rather than supervising 'hands off';
- ◆ The task risk assessment in place for the operation was not complete and did not cover all aspects of hazard and risk;
- ◆ There was no limit switch or proximity device fitted to safeguard against collision;
- ◆ The second tugger clump weight assembly was too close to the A-frame snatch block (when it should have been stowed with sufficient slack to take up any extension);
- ◆ There was a lack of awareness regarding the position of the second tugger winch clump weight and of the potential consequences of letting out the boom on the A-frame.

- ◆ Review of operating procedures and risk assessments for the use of lifting appliances incorporating independent hydraulic ram and winch controls, including:

- awareness of hook/load position when operating A-frame
 - position of divers – exclusion zone for divers to be determined from dropped object analysis and this should be written into operating procedures and risk assessments

- warning notices to be posted on A-frames
 - deck crew to be familiarised and deemed competent to operate equipment;
- ◆ Supervisors should remain 'hands off' and in a position to monitor and control operations;

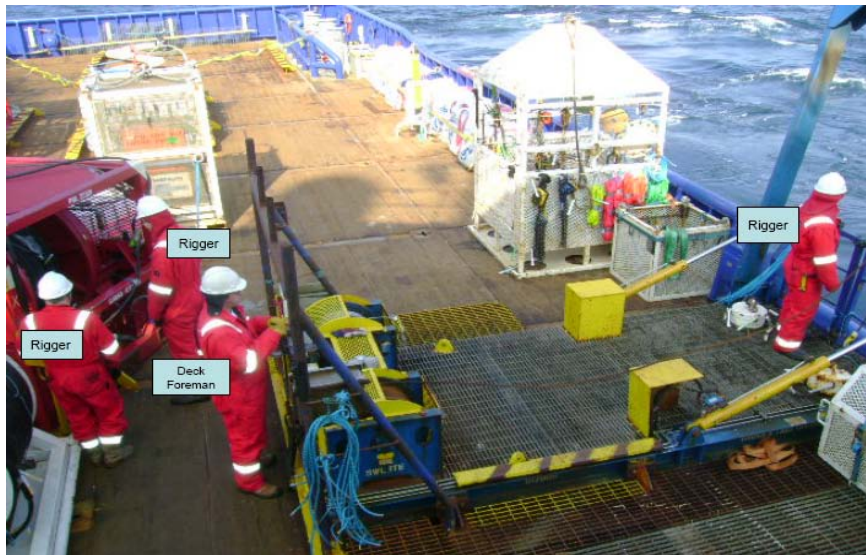
Position of deck crew during downline/tugger wire recovery

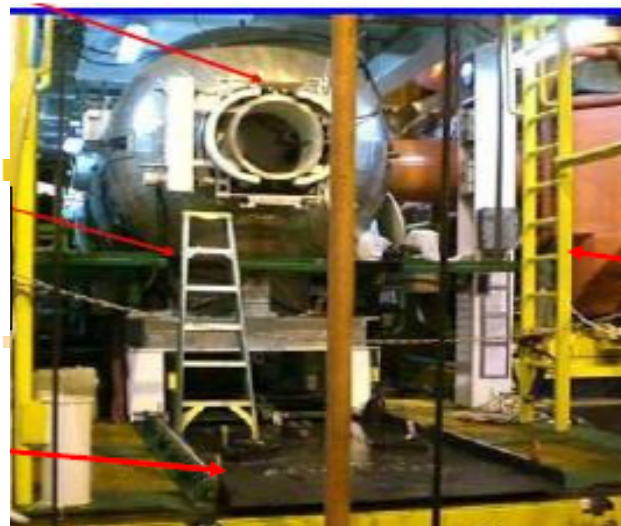
A member has reported an incident in which a person was injured in a fall from a different level. A saturation diver used the transfer under pressure (TUP) access hatch to come out of the saturation chamber while unloading equipment. To re-enter the chamber the diver held on to the top dogging bar of the chamber. The dogging bar rotated towards him causing him to lose his grip and fall approximately five feet on to the bell skid leading to muscle contusion and hairline fractures of his right forearm and right thigh.

- ◆ In normal circumstances the presence of the diving bell at this TUP access hatch made access and egress safe. When the diving bell was removed, there was less edge protection around the platform;
- ◆ The injured person did not recognise the lack of protection and increased risk of falling;
- ◆ The injured person used an incorrect handle (dogging bar) to pull himself into the chamber.

Grip used by diver when entering

Temporary ladder used by divers – tied off to platform

Base of diving bell rests on deck here and mated with flange here when not in use

Fixed entrance platform ladder

Saturation chamber from which diver fell

- ◆ Reinforce the importance of management of change procedures;
- ◆ Ensure the correct fixed handholds are used when accessing or exiting a saturation chamber;
- ◆ Ensure all relevant personnel are aware of the location and use of the correct handholds;
- ◆ Construct a removable platform with additional edge protection to facilitate access to and from the chamber when the bell is not present (see second picture).

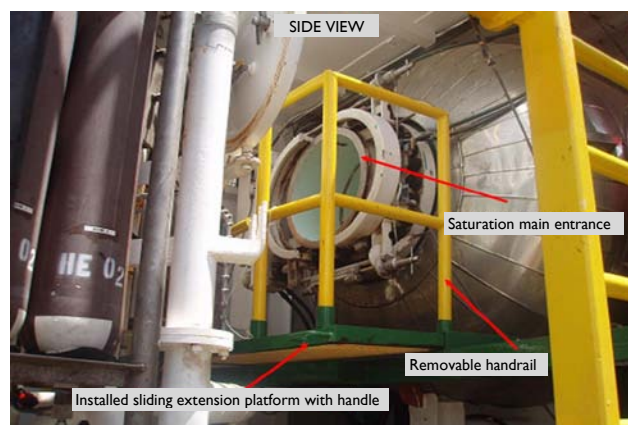
Movable platform to allow safe access to saturation chamber
