IMCA Safety Flash 08/11

July 2011

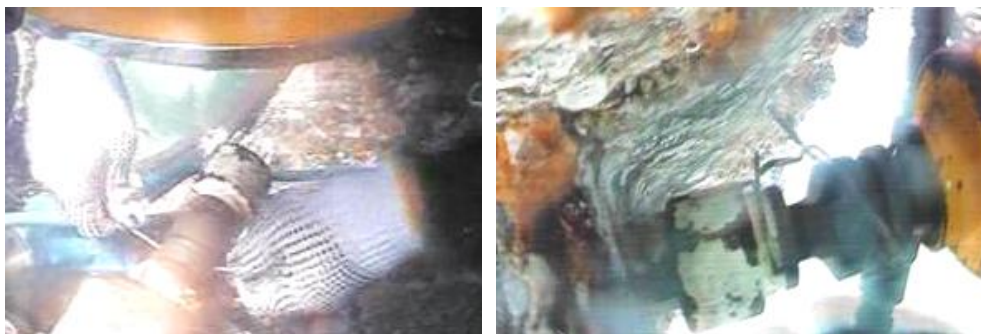
A member has reported an incident in which a diver sustained a cut injury to his left hand palm whilst working with a hydraulic impact wrench. A team of two divers were engaged in removing bolts of an old riser clamp at shallow depths. During one such bolt removal, when the first diver held the wrench's trigger handle using one hand, the wrench socket came off from the bolt and the wrench began to fall. He attempted to prevent the wrench from falling to the seabed, and whilst doing so, his left hand came in contact with the rotating/revolving socket, and the socket retaining pin (makeshift welding rod) cut the palm of his left hand.

An investigation revealed that a long welding rod twisted around the socket had been used as a retaining pin to prevent the socket from falling off during use. This practice was considered 'normal'.

Showing use of welding rod as a retaining pin

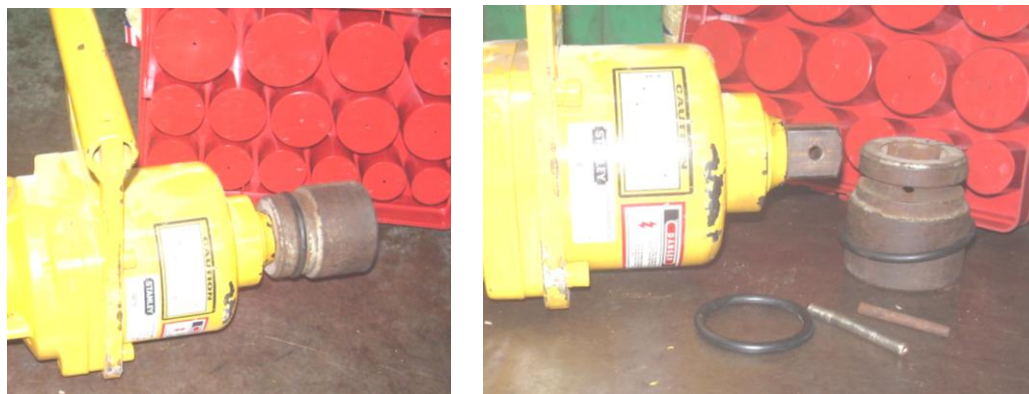
Showing correct size and length of retaining pin to secure the socket

- ◆ As advised by the manufacturer, use of the correct size and length of retaining pin, covered by an O-ring, to secure the socket.

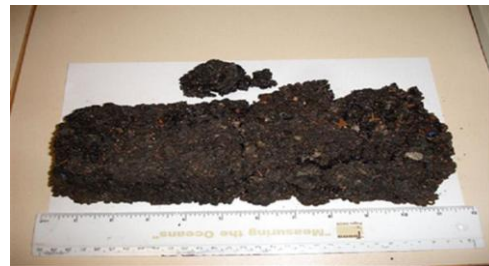
During positioning of a container on an offshore rig, a large lump of what appeared to be road tar was seen within one of the forklift pockets of the container. The lump measured 30 x 15 x 5cm and weighed 1.2kg. The container, which had forklift pockets on all four sides, had been on a round trip to the rig, gone back ashore and had been taken back to the rig before the hazard was spotted, some two weeks after its original despatch. The investigation could not determine at what point the lump of tar entered the forklift pockets but it could not have been at the supplier nor at the supply base, both of which have fully concreted yard surfaces. Therefore, it is possible that it was present for some time prior to the container's original despatch.

It is presumed that being sticky, the lump of tar was lodged against the top of the inside of one of the forklift pockets, only eventually becoming dislodged due to some form of shock to the container. This made it difficult for the supplier to spot and remove. It is also presumed that it was in one of the transverse forklift pockets and therefore invisible to gantry checks at the supply base.

Piece of tar – potential dropped object

- ◆ Use of mirrors and lights on extended poles;
- ◆ Use of brushes and sweep-through;
- ◆ Safe systems for doing checks at eye height to assist ergonomics.

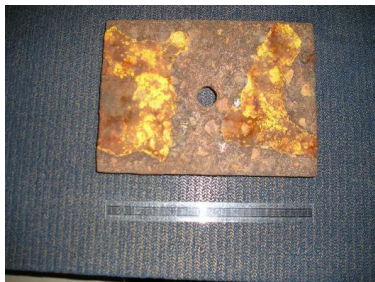
A vessel completed discharging a cargo of 20 inch uncapped casing to an offshore installation after a period of adverse weather. During routine operations on the installation a piece of metal, a D-ring plate cover, was found inside one of the discharged joints of 20 inch casing. The drops calculator classed the potential as a fatality if the object were to have been dropped from more than 2.4 metres.

D-ring plate cover - potential dropped object

Two of the above-mentioned objects (Case 2 and Case 3) were identified as belonging to the vessel and had become lodged inside the casing due to the vessel shipping water on deck during rough weather conditions. Subsequently, all wooden wedges used on this particular vessel were painted white on their top sides to make them easier to see in the dark.

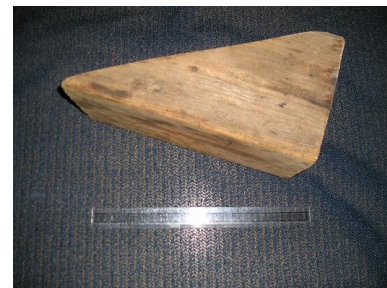
Several days after the object in Case 2 was discovered, on the same installation, a wooden wedge was found inside another 20 inch joint of casing. The drops calculator classed the potential as a fatality if the object were to be dropped from more than 3.7 metres.

Wooden wedge - potential dropped object

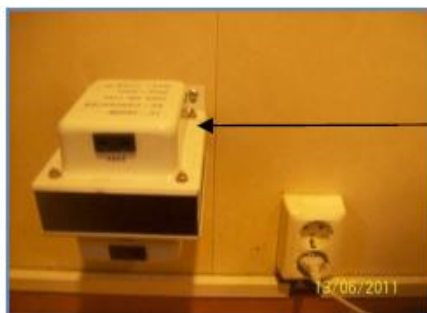
The running machine had been purchased for the vessel in the USA and required a 110v supply. A 220v/110v transformer had also been sourced in the USA and was mounted on the bulkhead next to the running machine, with a connecting cable into the vessel 220v supply.

Transformer 220v – 110v purchased in USA for running machine.

Transformer for use with running machine

- ◆ Ensure electrical equipment onboard has the correct connections, configuration and rating for safe use;
- ◆ Ensure that all electrical equipment purchased for the vessel is fully inspected and tested and a full risk assessment of its intended use takes place prior to installation and use.

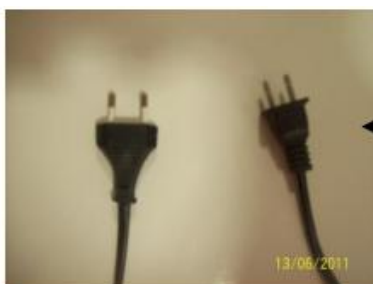
During initial investigation of the fault, the electrician decided to remove the 220v supply cable from the transformer to allow testing to be completed. The electrician unplugged the supply cable from the transformer connection first, unaware that it had two male connections (the standard configuration is one male and one female connection to ensure live terminals are recessed). As he started to remove the connection from the transformer, his left hand came into contact with the exposed live pins and he received an electric shock.

Supply Cable with TWO Male fittings.

Supply cable with two male fittings

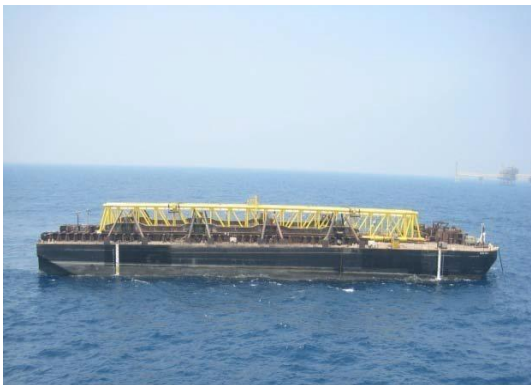
Cargo barge

- ◆ Ensure boarding arrangements on barges are properly considered before use; consider the possibility of development of improved or appropriate boat landing access on barges;
- ◆ Ensure adequate lighting is available on cargo barges;
- ◆ Identify appropriate tracking system for workboats;
- ◆ Investigate the use of alternate means of personnel transfer.

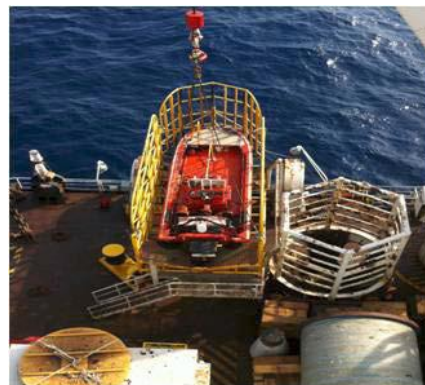
The workboat approached the cargo barge from the stern portside. One person disembarked the workboat onto the cargo barge. Immediately after this, the workboat was hit by two waves from the port side; the first filling it with water and the second causing it to capsize. The person who disembarked raised the alarm by radio. Two members of the crew climbed onto the hull of the capsized workboat and unsuccessfully attempted to right the boat by operating the manual handle to the self-righting gear. The other five persons made their way to the polypropylene rope attached to the emergency tow wire located on the stern port side of the cargo barge. Of these five persons, three did not hold on and drifted away, the deceased being one of them. The other two were recovered safely onto the cargo barge. A tug vessel present in the area, closest to the cargo barge, was requested to search for and recover the lost personnel. This tug recovered the two crew members from the hull of the capsized workboat, and two crew members from the water who had been holding onto the polypropylene rope. The third missing crew member was recovered later by a supply vessel in the area but was already dead.

Workboat used

- ◆ Inspection of the self-righting gear revealed that the safety pin utilised to prevent activation during transportation had never been removed. Inspection of the records of the workboat manual revealed that no reference was made to this device or that it should be removed before use at sea;

- ◆ Ensure that a backup vessel is always present during vessel to vessel personnel transfer;
- ◆ Ensure that workboat personnel have specific personal protective equipment (PPE) for transfer operations dependent on local climate and conditions, including personal locator beacons, life-jackets, waterproof radios, work suits as appropriate, and appropriate headgear;
- ◆ Ensure that during the hours of darkness the bridge watchman has access to night vision binoculars;
- ◆ Review procedure for personnel transfer, to include clear line of command and who should authorise the launching of a workboat;
- ◆ Develop drills and exercises for man overboard scenario remote from vessel;
- ◆ Amend planned maintenance schedule to include checks of self-righting gear and develop user checklist;
