IMCA Safety Flash 08/12

July 2012

I Near Miss: Dropped Objects

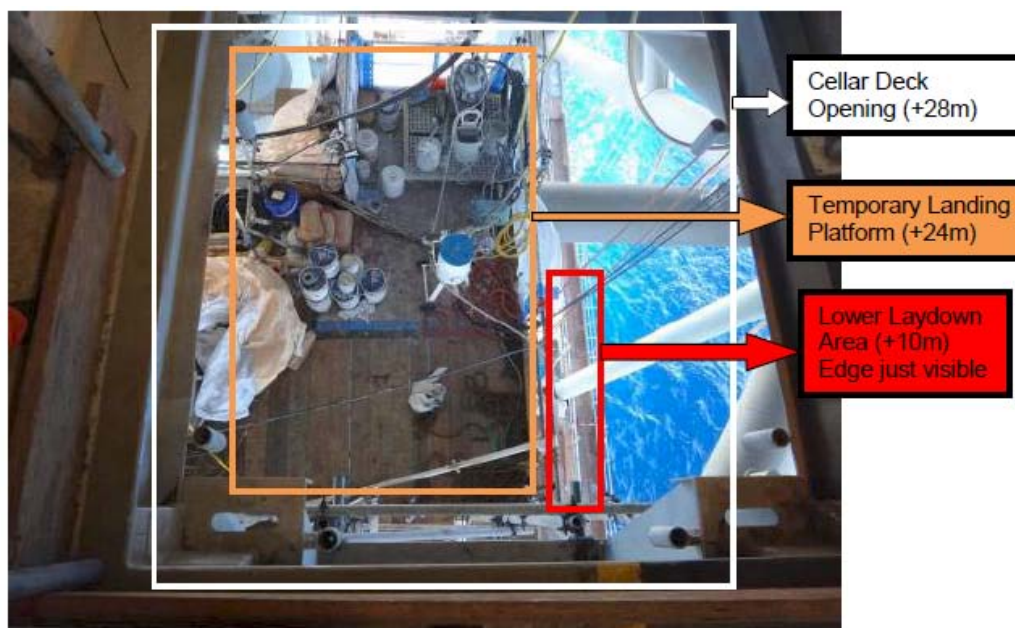
A member has reported an incident on an offshore platform in which three scaffold boards fell 4m from one deck to another. The incident occurred when the scaffold boards were being lowered in vertical bundles of three boards through a hatch opening on the cellar deck. The crew were using a timber hitch and a half hitch on a 19mm hemp rope fed through a shackle attached to a beam clamp. Whilst lifting the bundle of three boards over the handrail of the hatch, the knot holding the boards together contacted the handrail, causing it to loosen. This resulted in the three boards falling to the temporary deck (+24m level) four metres below. One of the boards then ricocheted off and fell a further 15 metres, landing in an area where two painters were working. The scaffold plank grazed one of the painters on the arm before coming to rest. The painter was assessed by the medic, but no treatment was required.

View through Cellar Deck Opening to +24m landing

- ◆ Work preparation and risk assessment was not adequate – the HIRA controls had been ‘ticked off’ and yet not followed, and the work method was inappropriate for the volume of scaffolding being moved;
- ◆ Improper rigging practices were used – the rope was rigged over a shackle rather than using a gin wheel;
- ◆ Three boards were being lowered at once – industry practice is for two boards at once as a maximum.

- ◆ Local scaffolding guidelines were updated to reflect industry practice of no more than two boards to be lowered at a time;
- ◆ Dropped object zones need to account for potential deflection.

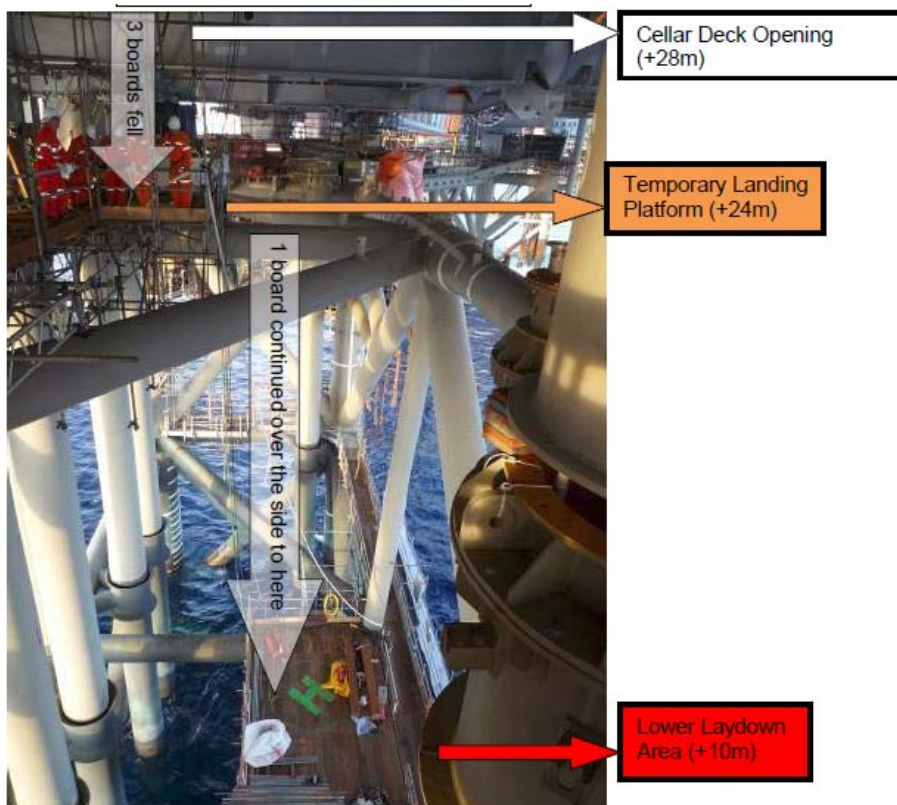
View from Sub Cellar deck +24 m level

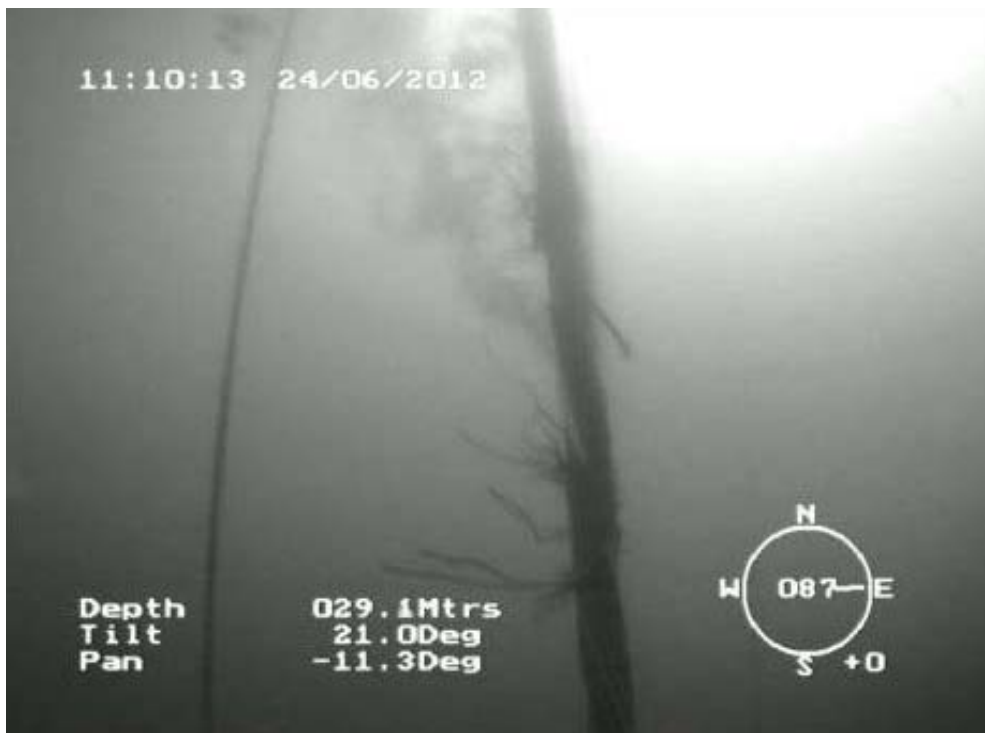
A slight leak was detected from damage observed to the umbilical outer sheath and a small amount of gas could be seen coming from one of the small pneumo-fathometer hoses. The divers secured the pneumo valves and the leak was stopped. The bell left 30m and internal pressure was maintained. The bell arrived on surface and was locked onto the system. All of the bell internal valves were closed and the system was bled down and the bell prepared for surfacing and sealed. All valves were secured inside the bell and the bell was recovered with the correct amount of tension on the umbilical for immediate transfer of the divers and assessment of the damage in the dry. There was no loss of integrity to the bell and the divers inside were unharmed.

View from ROV showing damaged umbilical leaking gas

- ◆ The immediate cause of the incident was found to be that the dive supervisor did not ensure sufficient tension on the bell umbilical to eliminate the risk of it bunching, trapping and being damaged during bell recovery operations;

- ◆ Re-termination of umbilical;
- ◆ Installation of an audible alarm onto the differential panel read-out on the hydraulic control panel, which will enhance pre-existing warning controls of differentials when recovering dive bells;
- ◆ Bell launch/recovery risk assessments reviewed and updated with incident findings and addition hazard control measures.
