1 Failure of ROV Lift Umbilical Winch Brake – Update

2 Hazard Potential from Equipment using Enclosed Rechargeable Batteries

3 ROV Winch Failure

4 Failure of Plastic Floatation Buoy

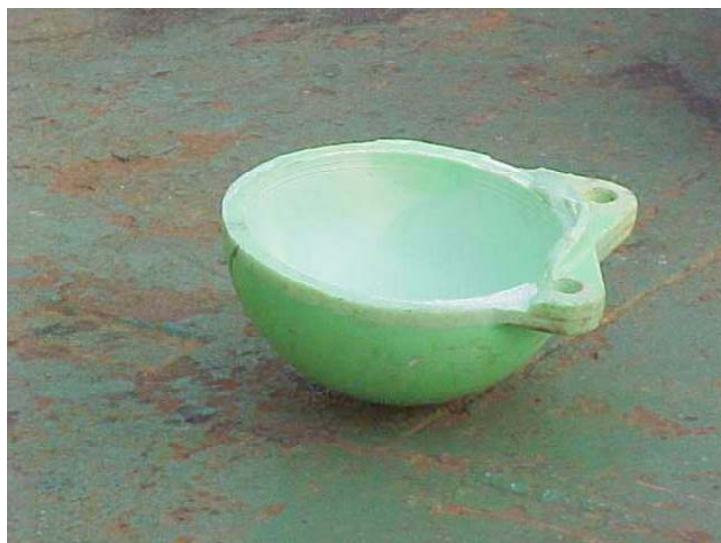
We have received the following information concerning a failure of a plastic floatation buoy. During deepwater operations on one of our member's vessels, a sling had been recovered to surface and riggers were in the process of removing a cluster of plastic floatation buoys. These buoys were rated for 150 bar external pressure and were hollow air filled types.

Without warning or any obvious signs of damage, one of the buoys exploded, resulting in two halves of the float flying apart with some force (see picture below). Fortunately no-one was injured, however this serious near miss serves to remind us, that such events are not unknown and for this reason, IMCA produced IMCA Guidance Note IMCA R 001 – *Plastic spherical air-filled fishing buoys* – concerning failures of this type of buoy giving recommendations on their use.

Whilst the floats being used were suitably pressure rated, the company concerned cannot be sure that either through manufacturing defects or due to rough handling that fissures in the seam of the floats allowed the internal void to be pressurised.

A number of IMCA member companies have a policy of not using plastic buoys.
