I Failure of Fall Wire – Update to Safety Flash 05/11

MAIB SAFETY BULLETIN 2/2011

Malfunction of a proximity switch, which resulted
in failure of a fall wire with the loss of one life
on the car carrier *Tombarra*

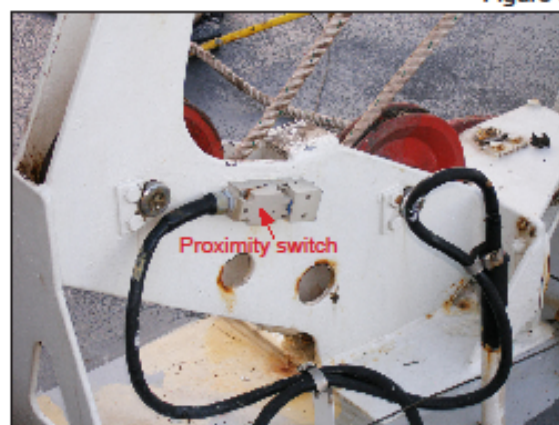
Figure 3

The winch was operated by a control panel sited forward of the davit. The boat was hoisted using the buttons on the control panel until the davit was near the stowed position. It was then intended that hoisting be completed manually by the use of a winch handle adjacent to the winch motor. To prevent the inadvertent operation of the winch when the rescue boat was in its stowed position, an inductive proximity sensor/switch (Telemecanique XS7-C40FP260) was fitted on the davit (Figure 3). The switch was intended to cut off power to the winch when the davit closed to within approximately 12mm of the sensor.

Proximity switch on davit

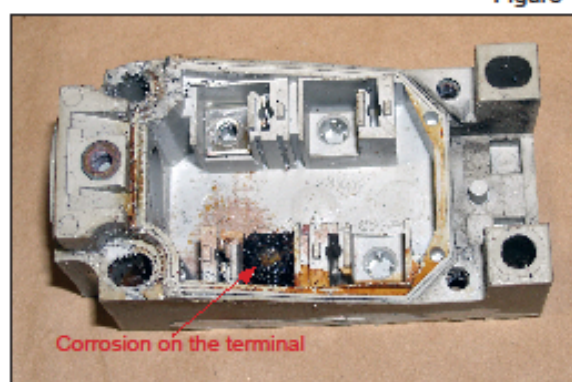
Figure 4

Water ingress into proximity switch

The switch was installed in 2006, and prior to the accident it was not tested before hoisting was commenced. Inspection identified that the switch body had been penetrated by water (Figure 4). However, detailed analysis highlighted that the switch malfunctioned due to an unrelated electronic fault. The MAIB is aware of both inductive proximity and mechanical limit switches fitted on other vessels that have also failed to operate correctly. However, none are known to have resulted in a similar accident.

- The fitting of the proximity switch was not compliant with its manufacturer's instructions. As a result, the gland and cable entry were higher than the switch body and its susceptibility to water ingress was increased.

Schat-Harding has issued a Product Awareness Notice (PAN) to its customers highlighting the need to test the proximity switches fitted on its SA 1.5 and SA 1.75 davits on each occasion before hoisting operations commence, and recommends that the proximity switch is replaced every 2 years; it also highlights the need for caution when using pressure washers on deck.

- In the case of vessels fitted with the Schat-Harding SA 1.5 and SA 1.75 davits, follow the advice contained in the PAN recently issued by the manufacturer or urgently contact Schat-Harding¹ if a PAN has not been received.
- Ensure that all devices (inductive or mechanical) fitted to boat davit systems to prevent overload are tested on each occasion before a boat is hoisted and that such devices are not relied upon during operation.
- Follow manufacturers' recommendations regarding the maintenance and periodic testing, examination and replacement of safety devices, seeking clarification from manufacturers where ambiguity exists.
- Verify the effectiveness of watertight seals on electrical equipment fitted to boat davit systems on weatherdecks.

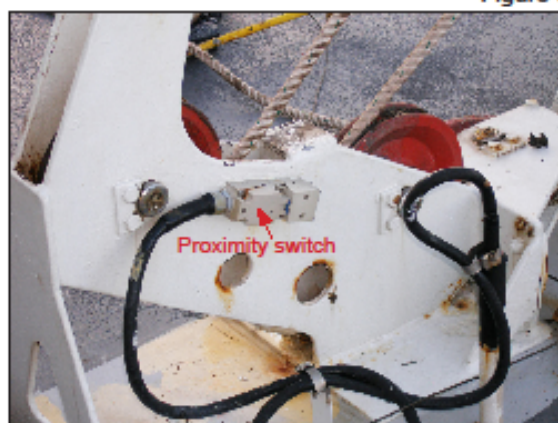
Figure 3

The winch was operated by a control panel sited forward of the davit. The boat was hoisted using the buttons on the control panel until the davit was near the stowed position. It was then intended that hoisting be completed manually by the use of a winch handle adjacent to the winch motor. To prevent the inadvertent operation of the winch when the rescue boat was in its stowed position, an inductive proximity sensor/switch (Telemecanique XS7-C40FP260) was fitted on the davit (Figure 3). The switch was intended to cut off power to the winch when the davit closed to within approximately 12mm of the sensor.

Proximity switch on davit

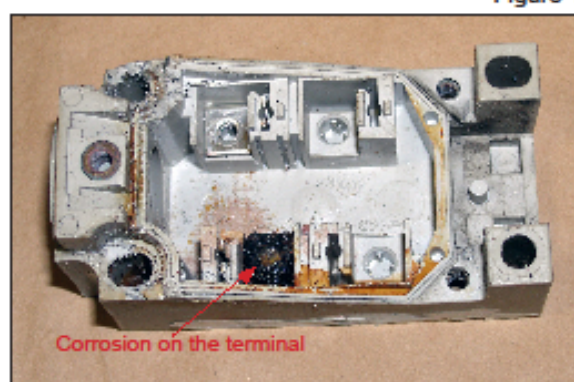
Figure 4

Water ingress into proximity switch

The switch was installed in 2006, and prior to the accident it was not tested before hoisting was commenced. Inspection identified that the switch body had been penetrated by water (Figure 4). However, detailed analysis highlighted that the switch malfunctioned due to an unrelated electronic fault. The MAIB is aware of both inductive proximity and mechanical limit switches fitted on other vessels that have also failed to operate correctly. However, none are known to have resulted in a similar accident.
