IMCA Safety Flash 09/12

September 2012

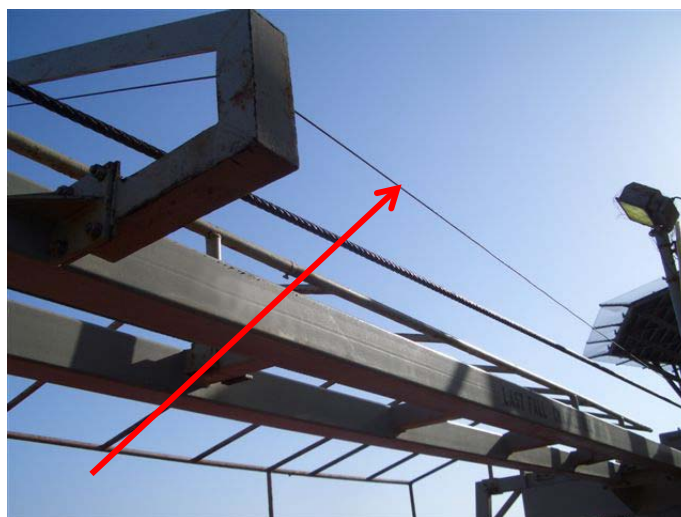
Cable release wire that was fouled by the tag line, pressure applied and caused de-activation of gravity brake

- ◆ The hazard created by the high wind was not fully recognised, and the opportunity to call a time out was not taken. The potential to snag the lifeboat release wire had not been recognised during the risk assessment;
- ◆ Although the taglines in use were of the tangle free type, the textile covering of the upper body of the line had become loose and retracted causing a snagging point to occur. This caught the release line and deactivated the brake;
- ◆ When the brake drum was opened for inspection, a large amount of oil residue was found on the brake lining, having seeped past the seals from the adjacent oil sump. The oil sump was overfilled beyond the manufacturers' recommendations. The oil on the brake linings reduced the efficiency of the brake to reset when the counterweight was reapplied.

- ◆ Deeper consideration of all conditions during risk assessment. For example, how did the controls to manage the steel plate introduce other hazards in this event?
- ◆ Inspection of tag lines to ensure they were fit for purpose, and holding of spares onboard;
- ◆ Review of lifeboat maintenance particularly with regard to the gravity brake;
- ◆ Checking oil levels were correct and that personnel understood the use of level plugs.

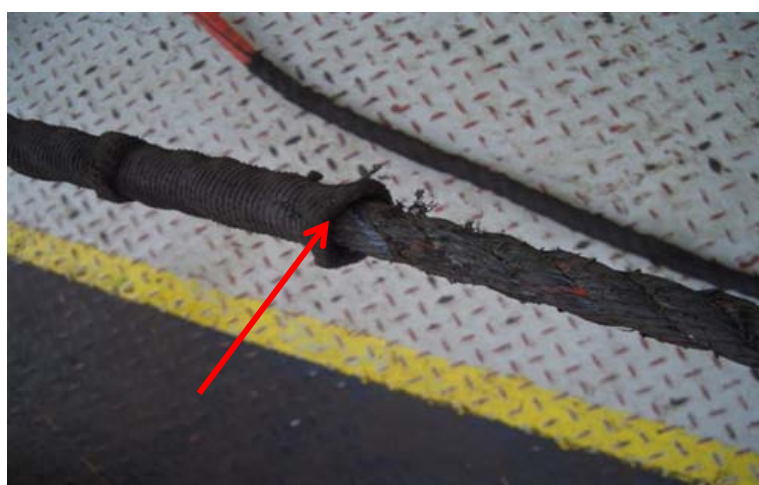
The outer sleeve of this tagline created a snagging hazard

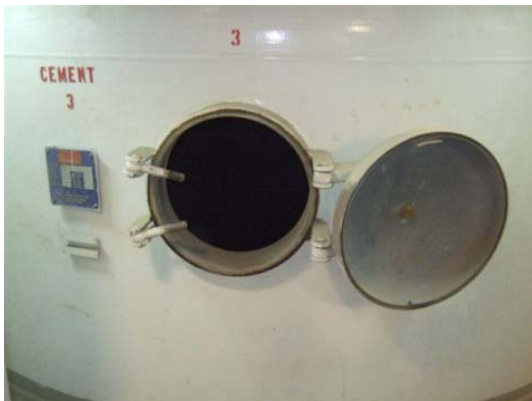
A member has reported an incident in which the hatch on a cement tank failed under pressure. The incident occurred when the cement tank was being pressurised to verify the integrity of the system prior to loading dry bulk during a forthcoming port call. Following the pressurisation of the cement tank to approximately 4 bar, a loud bang was heard and the cement tank pressure was rapidly lost.

Cement tank hatch

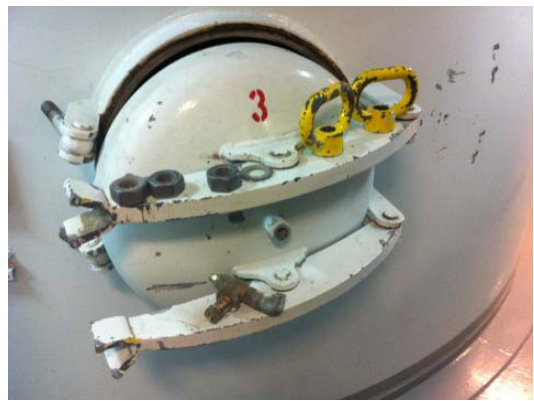
Nuts replacing dogs

- ◆ The original cement tank hatch securing dogs had been removed and replaced by nuts. When this replacement had taken place was not known;
- ◆ It was discovered that the most likely reason for the change of the securing dogs with nuts was to provide greater clearance for personnel access between the cement tank hatch and the pillar;
- ◆ Although the cement tank hatch thread bar was 27mm, the diameter of the nuts was 30mm and, although of a differing size, it was still possible to secure these 30mm nuts on the 27mm thread bar;
- ◆ The change had not been properly documented or dealt with through a "management of change" process;

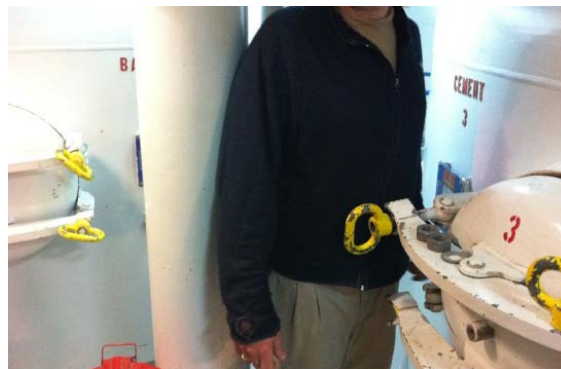
Showing personnel access restricted by dogs

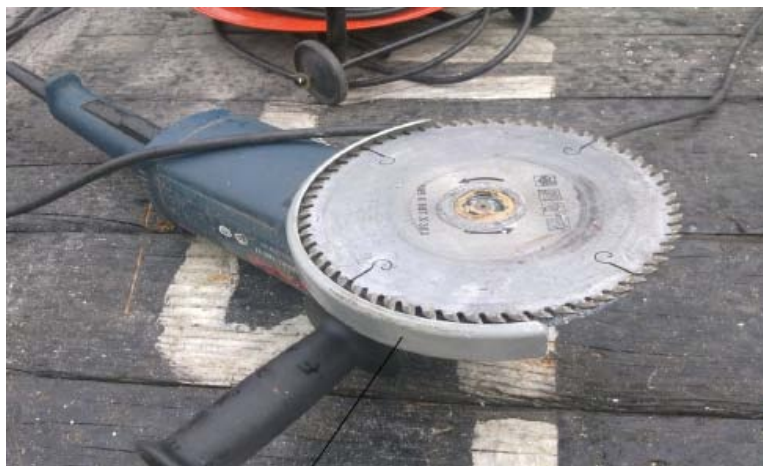
- ◆ The welder had been through job hazard analysis (JHA) training on the morning of the day of the incident;
- ◆ The welder was rushing to finish the job;
- ◆ The welder replaced the blade in his cutting machine but was distracted and failed to fix back in place the blade protective guard.

Cutting machine (with blade guard fitted)

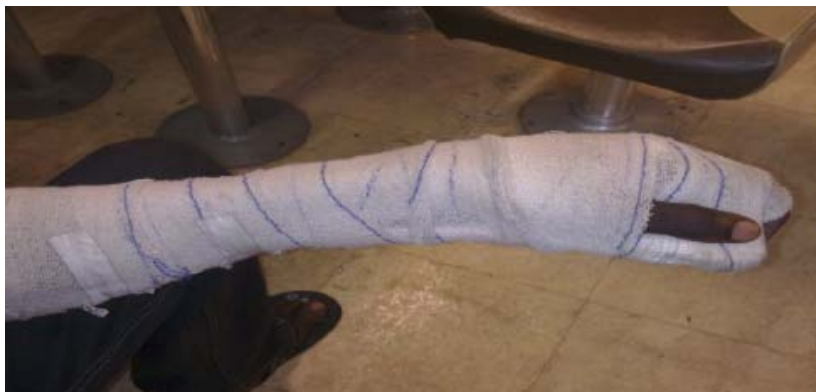
Hand/arm following treatment

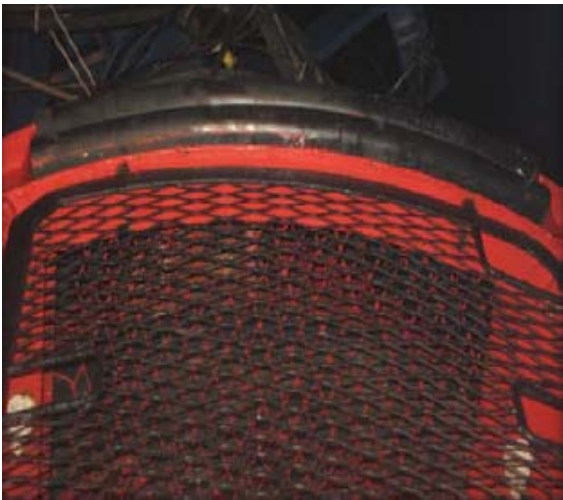
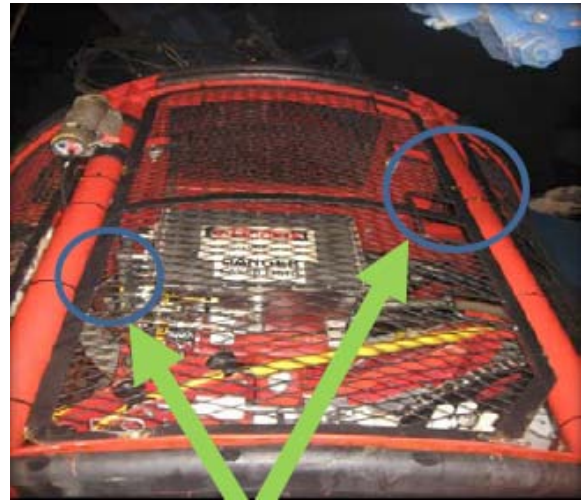
Further investigation revealed that when downward force was applied to the gates via the cut-outs, the gate became dislodged.

TMS protection gate showing "cut-outs" which are used as foot-holds.

Members are encouraged to make a careful check of this kind of TMS protection gate to ensure they are secured by the top pins. If they tend to come out while downward force applied, then the top pins should be changed immediately. The top pin which is secured to the gate can be modified such that it won't dislodge easily.

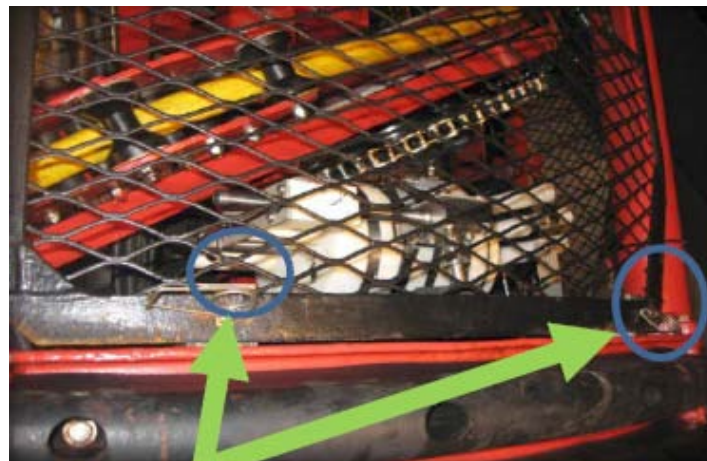
Bottom of TMS protection gate showing fixing brackets with bolts and 'R' clips which remained secured
