# IMCA Safety Flash 09/14

June 2014

## I Serious Dropped Object Incidents

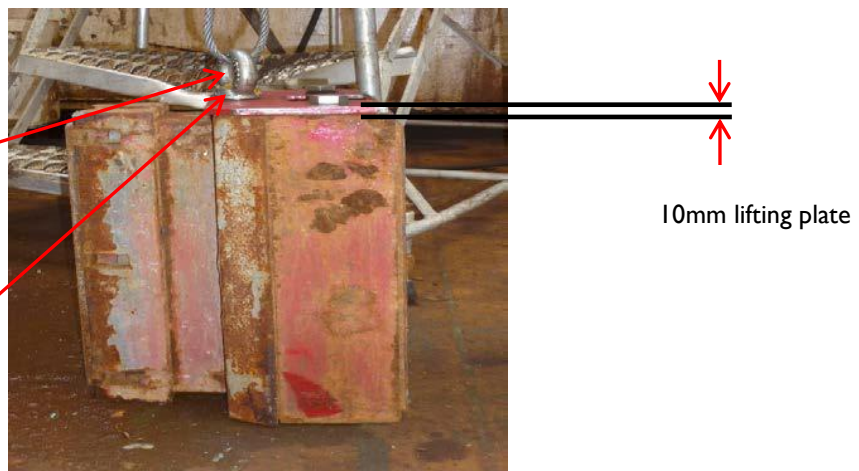
Figure 1: Showing HOM (hang-off module)

- ◆ The female thread in the HOM pad assembly was corroded;
- ◆ Due to its location the corrosion was not readily identifiable at the time the eye bolt was fitted;
- ◆ Owing to the eyebolt having to pass through a lifting bracket the effective thread was reduced by 10mm.

Eye-bolt through lifting plate reducing effective thread by 10mm

Thread inside the pad was found to be badly corroded

- ◆ Redesign of the lifting device – three threaded bolts now used to secure the lifting brackets in position;
- ◆ Weld type pad eyes will be fitted to all HOM pad lifting brackets;
- ◆ All tapped holes to be checked and re-drilled and tapped the next size up if found to be worn;
- ◆ Once all sizes are established, stainless steel grub screws will be purchased and will be greased and fitted to all tapped lifting holes on HOM pads to help eliminate corrosion.

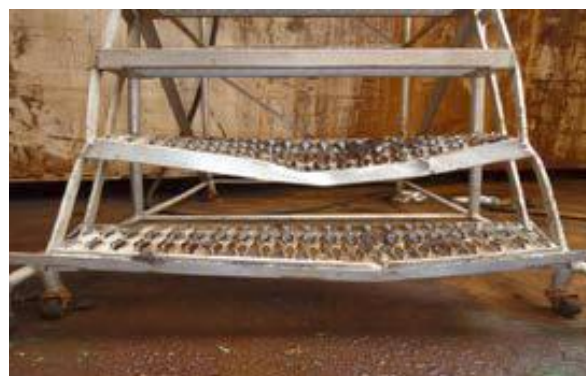
Figure 2: Showing damaged steps

During a routine change out of the HOM (Hang Off Module) pads, a pad weighing 100kg was dropped 2.4m. The pad landed on the portable access steps on which the operations technician was stood. The impact caused damage to the steps and caused the technician to lose his balance and fall over.

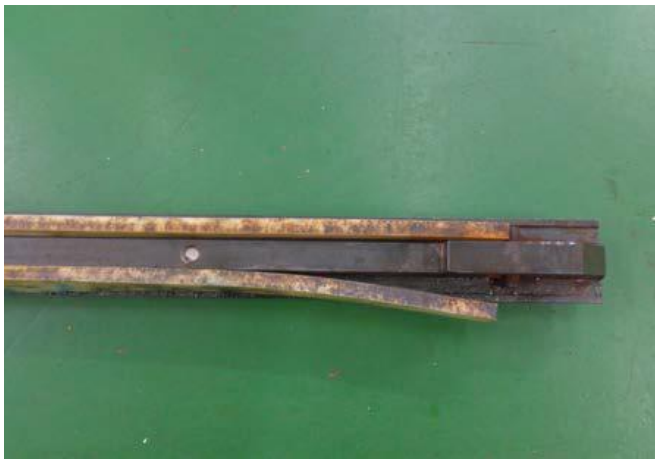
Figure 3: Side roller guide

On a pipelay vessel, a side roller guide for the track chains fell from the upper tensioner onto the protection roof of the lower workstation, before administering a glancing blow to a rigger, resulting in first aid treatment. The object weighed 15.3kg and fell 20m.

- ◆ The retaining bolts on the bearing rail had been sheared;
- ◆ The upper section had only one bolt in place.

- ◆ Corrosion;
- ◆ Insufficient security of bolts and tensioners.

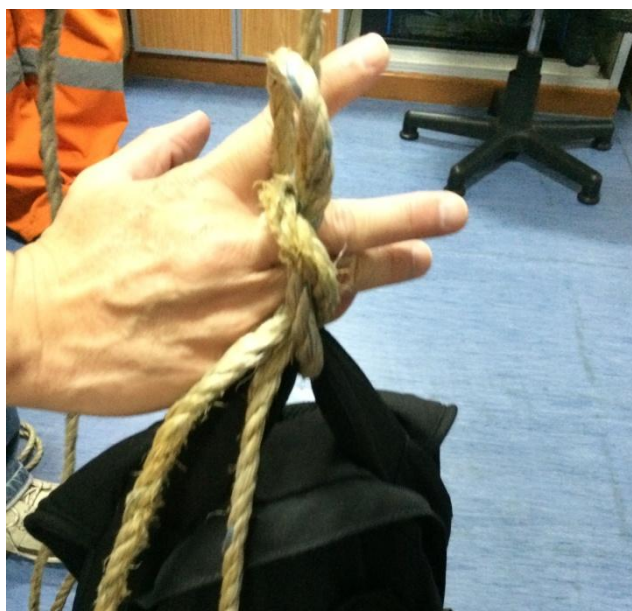
As the injured party was untying the line, the vessel took a sudden dip due to the high swells. He could not retract his left hand fast enough and three of his fingers were caught in the bight of the knot when the heaving line suddenly tensioned. The injured person pushed against the stern deck railing to prevent being pulled overboard. Subsequently the heaving line severed his little finger and lacerated the ring and middle fingers. The rope was finally cut and removed from his finger after crew fetched a knife from the accommodation.

Figure 5: Showing how fingers were caught in the bight (reconstruction)

- ◆ This was the first time this method of baggage transfer had been used by any of the crew. It was initiated on the spur of the moment, without any thought, risk assessment or planning – there was no Management of Change;
- ◆ The rope was secured to the platform in such a way that it could not easily be released or slackened;
- ◆ The platform crew were inexperienced at tying appropriate knots and tied excessive knots in the small diameter polypropylene rope which were difficult and time consuming to untie;
- ◆ To speed up the transfer process two bags were lowered on each end of the secured heaving line, dividing the attention of the deck crew.

- ◆ Always ensure operational risks are identified and assessed prior to starting operations;
- ◆ Don't be tolerant of unacceptable risk;
- ◆ Always be mindful of the impact of changing customary methods of routine operations;
- ◆ Always ensure operations are well planned, communicated and supervised;

- ◆ Don't give in to external pressure to work beyond safe working limits, always exercise your right to stop work.
