# IMCA Safety Flash 09/15

June 2015

## I “Routine” Task, Non-Routine Result: Batteries Stored Sideways Leak Battery Acid

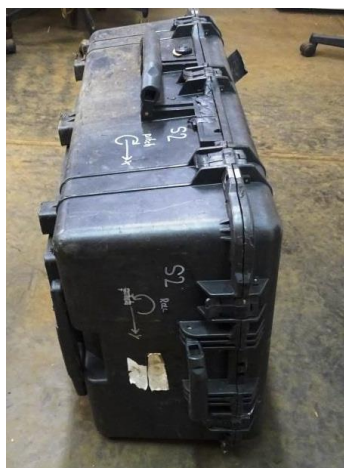
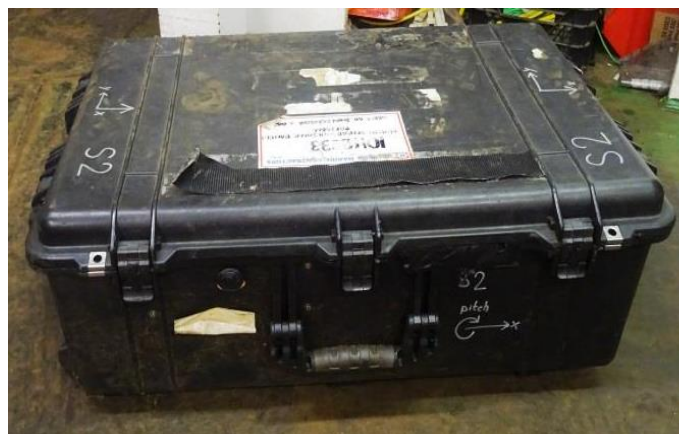
Figures above: No labelling on container indicating proper storage instruction or hazards of contents

- ◆ A wet cell battery with vents would permit leakage of the battery if stored improperly;
- ◆ The containers were stored on their sides; the electrician forgot that in doing this, the batteries might leak;
- ◆ The battery containers were not labelled to provide information regarding:
  - Which way up they should be stored
  - What was inside – the possible hazards of wet cell batteries.

- ◆ Boxes and containers should be clearly labelled so all crew know which way is up and any hazards relating to what is inside;
- ◆ This should particularly be the case for containers used for batteries;
- ◆ Consider replacement of the wet cell batteries with dry cell batteries – thus eliminating the hazard of an acid spill.

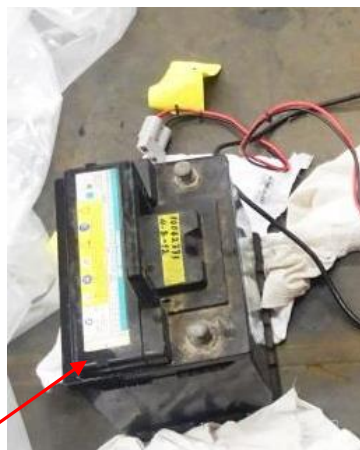
However, to limit the amount of floor space for storage the electrician placed the boxes on their sides, neglecting to remember that this improper orientation (batteries on their side) could allow the wet cell batteries to leak acid.

Figure: Location of vents permitting acid to leak out of battery when improperly stored

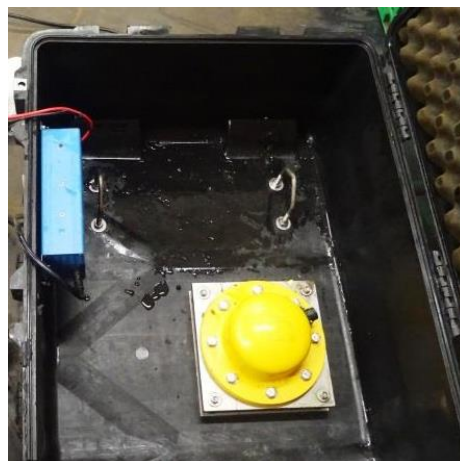
Crew on the following shift opened one case and noticed a smell, suggesting battery acid. Upon further inspection, the electricians noticed that battery acid had run out of the vents of the batteries in both plastic containers.

Figure: Extent of acid spill

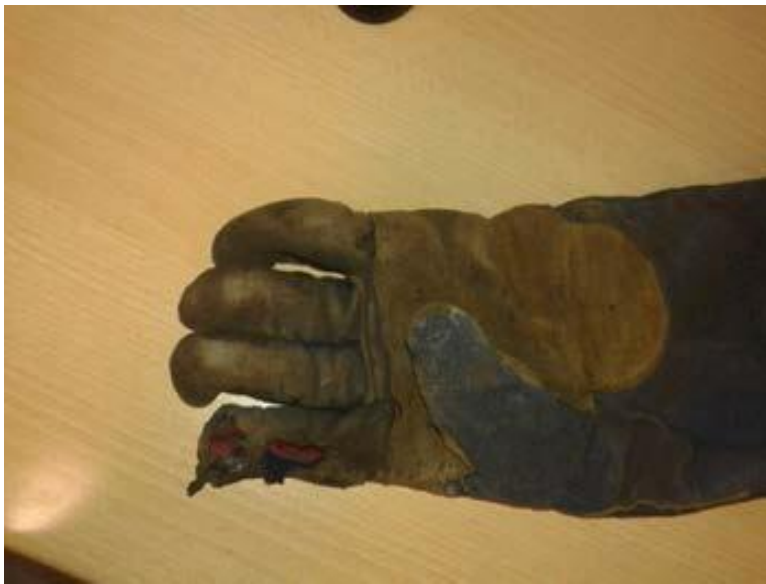
A member has reported an incident in which a welder injured his finger whilst at work. The welder was finishing cutting and noticed there was some loose slag built up from previous work. He swept this slag away with his hand and felt he had cut his left index finger. He inspected the welder's hot work gloves he was wearing and noticed there was a hole in the left index finger of the glove. He was unsure if the hole was caused by sweeping away the slag or if it was already present.

Figure: Injury to hand

- ◆ The welder should have used a broom for removing the loose slag;
- ◆ Gloves are personal protective equipment (PPE) and worn for protection, they are not sweeping tools;
- ◆ PPE should be regularly checked for damage. Perhaps most especially, helmets, safety glasses and gloves – **Change out and dispose of damaged PPE;**
- ◆ The incident was discussed at welder's pre-start meetings and use of brooms was reiterated. The risk assessment for welding was reassessed regarding proper use of tools, equipment and materials.
