## IMCA Safety Flash 10/12

October 2012

### I Diver Injured During Subsea Lifting Operations

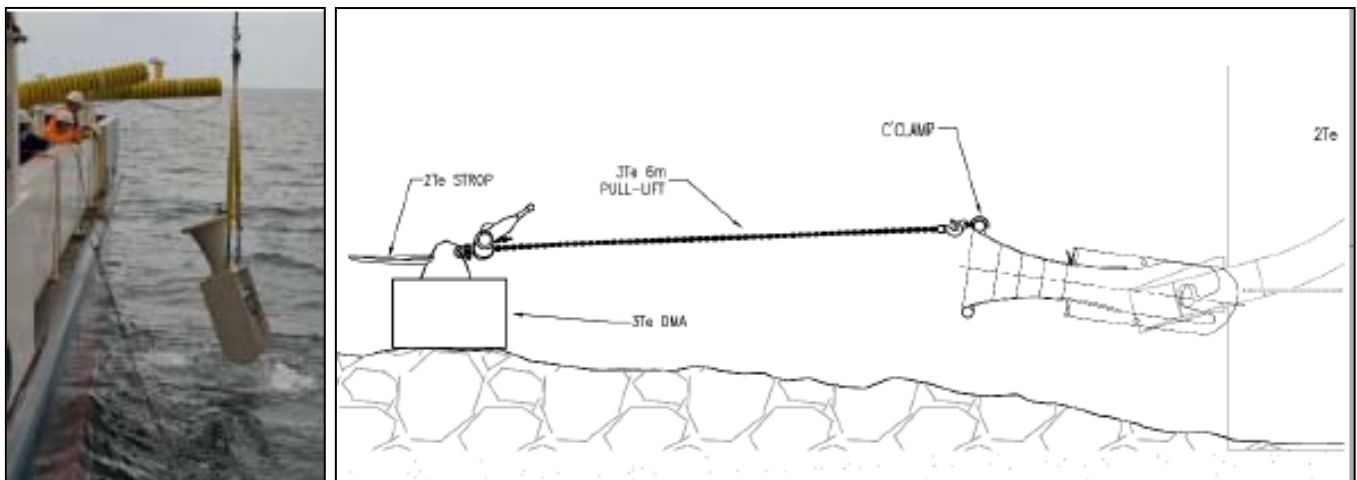
*Bell Mouth and Intended Underwater Arrangement*

- ◆ Lack of knowledge of the whereabouts and depth of the subsea load during its deployment through the water column;
- ◆ Over-rapid lowering of the load;
- ◆ The subsea load was lowered all the way to the seabed with no appropriate mid-water stop point;
- ◆ The diver was directly below the load as it was being lowered;
- ◆ Poor communication and co-operation between the diving supervisor and the divers;
- ◆ Owing to misunderstanding, diver 1 failed to follow the instructions of the diving supervisor;
- ◆ The diving supervisor failed to realise or notice that the diver had moved back into the danger zone.

- ◆ Inadequate hazard identification and risk assessment;
- ◆ No common toolbox talk held before the start of the operation;
- ◆ No lift plan or safe working procedure for deploying the load whilst divers were in the water;
- ◆ Reliance on the diver following instructions; failure to take sufficient account of human factors leading to errors (mistakes and violations);
- ◆ Complacency – the operation was perceived as being a simple, familiar and repetitive task, and personnel may have been operating within a “comfort zone”.

- ◆ All personnel (including divers) should attend toolbox talks to review the plan before the start of subsea lifting operations;
- ◆ Appropriate risk assessment should take place to cover the particular challenges of vessel lifting operations in support of diving operations;

- ◆ Lift plans prepared by competent persons should be in place before the start of subsea lifting operations;
- ◆ Ensure effective communications between all members of the lifting team;

- ◆ Personnel (including divers) should never work underneath loads;
- ◆ Divers should retreat to confirmed safe locations (e.g. the dive basket or bell clump weight) during the lowering or lifting of loads through the water column and remain there until they are alerted that the chosen stop point has been reached;

- ◆ Use of travel length indicators to stop loads at an agreed distance above seabed;
- ◆ Use of specific lift deployment speeds in lift plans/procedures;

- ◆ Loads should be lowered in a controlled manner at specific and agreed speeds, rather than in free fall;
- ◆ Equipment and procedures should be in place to enable the crane driver and diving supervisor to know the depth of loads as they are lowered through the water column;

- ◆ Use of suitable stop points in the water column so that loads are not deployed straight to the seabed (or lifted straight to the surface), allowing time for divers to retreat to a safe location.
