IMCA Safety Flash 10/18

April 2018

1 Incorrectly Selected Oxygen Welding Gas Hose Bursts & Catches Fire

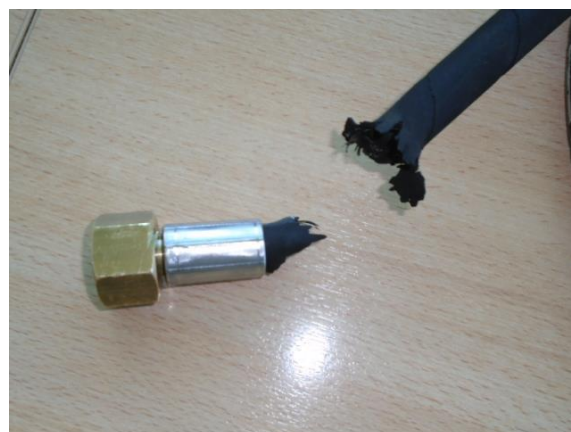
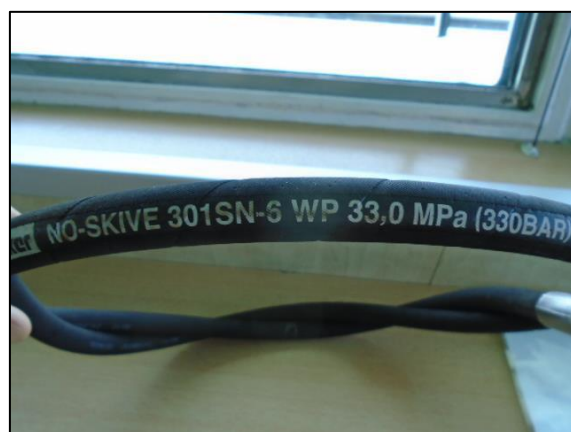
The ship's welder opened the Oxygen and Acetylene gas bottle valves in order to do a cutting job on deck. These gas bottles were attached to the vessel's integrated welding gas system. Opening the valve on the Oxygen bottle had the immediate effect of causing an explosion to a short, high pressure hose delivering oxygen from the bottle to the oxygen gas regulator. The end of the hose caught fire and was quickly extinguished by turning off the oxygen bottle. Nobody was injured and the only damage was to the hose that completely separated.

- ◆ The hose had been recently replaced, but the replacement hose was a hydraulic oil service hose with oxygen fittings. The replacement hose was not compliant with the ISO 14113 specification required by the manufacturer, although the pressure rating was suitable;
- ◆ The non-compliant hose was supplied from a non-preferred supplier (the required hose length was not available from original supplier);
- ◆ The onboard team did not adequately check that the hose was of the correct specification.

Based on detailed investigation into a similar incident, it was suggested that the cause of the incident was due to adiabatic compression heating within the hose which caused the inner lining to auto-ignite due to residual oil within the hose. Our member notes that there are numerous incidents recorded by industry due to this issue.

Welding hoses should be compliant with ISO 14113. For oxygen hoses, the material should have an auto-ignition temperature suitable for the service (typically > 400°), and cleaned for oxygen service.

- ◆ Do not assume that because a hose is sufficiently pressure rated it is fit for a specific purpose.

- ◆ Always ensure correct specification hoses are ordered and received.

- ◆ Use only original equipment and spares when handling/servicing oxygen equipment;
- ◆ Work clean – no oil or any other hydrocarbon impurities must contaminate the parts (your hands, tools etc.);
- ◆ Open oxygen cylinder top valves slowly.

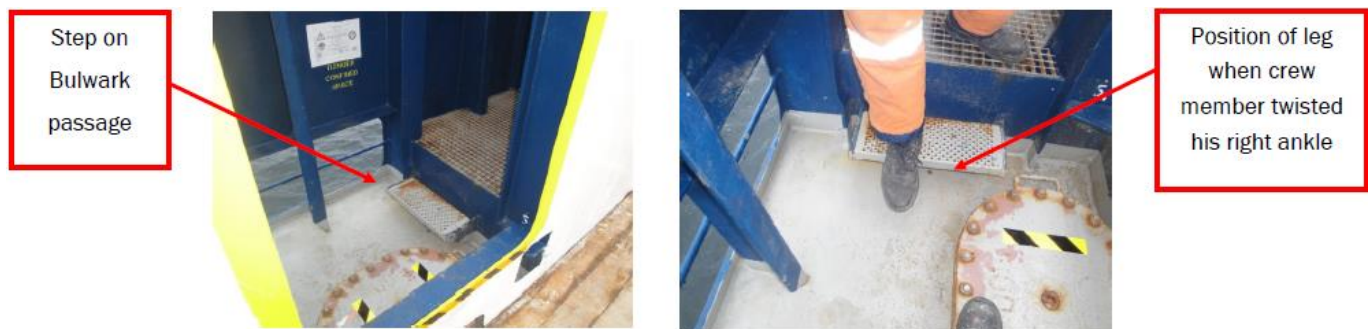
A crewman slipped on a step grating and twisted his ankle. The incident happened as he stepped through a hatch on his way to a job. Initially he did not feel any pain, so he did not report the incident and continued work. However, as time passed, the pain increased and after three hours he reported the event to the officer on watch (OOW). The OOW contacted the client's medical service, who provided an ambulance and evacuated the injured person from the vessel to the clinic. The injured person was assessed at the clinic in the middle of the night, and the vessel informed the office the next morning. Investigation highlighted the fact that client's medics reported the incident to the company before the vessel.

- ◆ With regard to reporting:
 - the injured person did not follow company procedures and immediately report the incident to the OOW
 - the vessel management did not inform the designated person ashore when the incident occurred – again, not following company procedures;
- ◆ With regard to the slip/trip:
 - lack of hazard identification will have been a contributing factor
 - the incident is still under investigation.

- ◆ Discuss the lessons learnt with all crew members, particularly the requirement to report incidents immediately;
- ◆ Consider efforts to identify the need to mark steps, especially when there is no colour contrast;
- ◆ The company has a permanent “Edges and Ledges” campaign to identify all edges and ledges and mark all hazards.

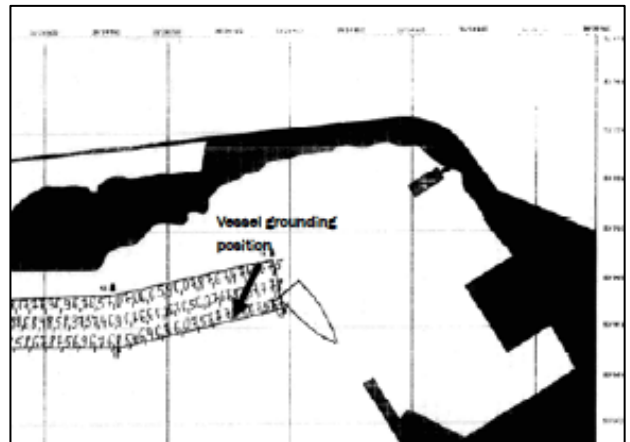
A vessel ran aground whilst leaving a channel on the approach to a port. The vessel was making around 4.5 knots, and grounded by the stern in the right side of the channel. At the moment of grounding, the echo sounder was indicating a depth of 3.5 metres. Whilst leaving the channel, the vessel caught a small sand hill that had not been charted.

During the investigation process, the channel navigational chart was carefully checked and errors were found. There were also indications that a buoy had shifted 5m due to the length of the chain anchoring the buoy.

- ◆ Closer control of the water depth indication and echo-sounder information was required. Officers need to be more aware of the location and accuracy of the vessel's fitted echo-sounder and its limitations in shallow water;
- ◆ Suspected errors in navigational marks should be reported to Port Authorities, and any changes reported should be marked on charts.

- ◆ Management were to approach the appropriate authorities with the findings from the company investigation and communicate updates to relevant vessels. The responsible authorities were to update the channel navigation chart and consider adjusting the length of the chain on the buoy;
- ◆ Ensure that deck officers are fully aware of the importance of constantly monitoring the vessel's draft and echo sounder whilst passing through a channel;
- ◆ Passage planning should be from berth to berth. When making any passage plan, it is of absolute necessity to ensure there is safe navigable water throughout the route to be taken. Any areas of concern should be indicated on the chart so that all officers of the watch are aware of any potential issues.

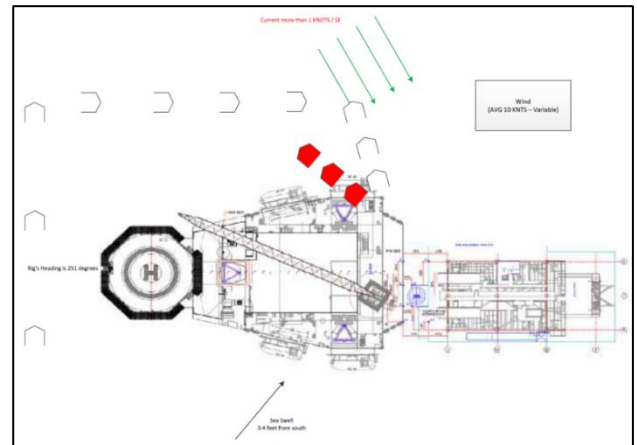
A vessel came into contact with the legs of a rig – however, there was no damage to the vessel. The incident occurred when the vessel was moving astern down the prevailing current, to approach the starboard side of the rig. Because the cargo was located on the vessel's forward deck, the vessel had to approach within two meters of the rig in order to allow the hook to reach the load. When the vessel reached her offload/snatch position below the crane's hook, the vessel's bow turned slightly to port, which allowed the current to catch the vessel's starboard side. The Master observed the vessel drifting towards the rig's starboard side aft leg and he immediately decided to abort the operation. The vessel was manoeuvred forward with both engines to escape; unfortunately, the port quarter slightly touched the rig's starboard side aft leg.

- ♦ The Master permitted the operation to take place on the starboard or weather side of the rig and did not request to have the work done from the rig's port or lee side;
- ♦ The effect of wind and current played a vital role in vessel's approach to and hitting the rig's leg;
- ♦ The Master's decision to approach was not properly risk assessed – he misjudged the direction and effect of the current during manoeuvring;
- ♦ It was not evident that the lifting operation was covered in a specific risk assessment for that particular project;
- ♦ The Master had no robust plan for escape manoeuvring and did not plan when to abort manoeuvring.

- ♦ A better understanding was needed of the risks and hazards of manoeuvring against the current;
- ♦ A more detailed prior agreement should have been made between the vessel Master and the offshore installation manager (OIM) with regard to cargo and lifting operations;
- ♦ Escape routes and plans should be considered before starting any critical manoeuvring;
- ♦ The vessel Master – rather than the OIM or the client – has the overriding authority to accept or reject the operation based on judgment about the weather limitations and circumstances.
