## IMCA Safety Flash 10/19

May 2019

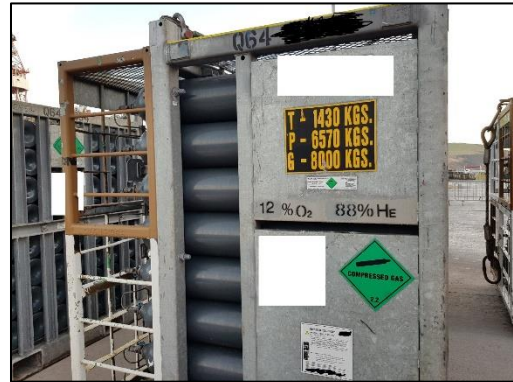
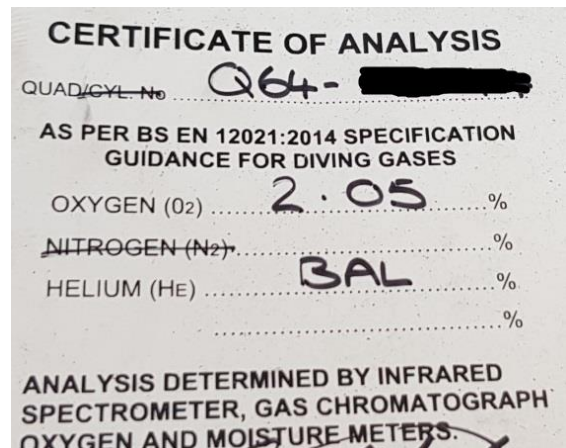
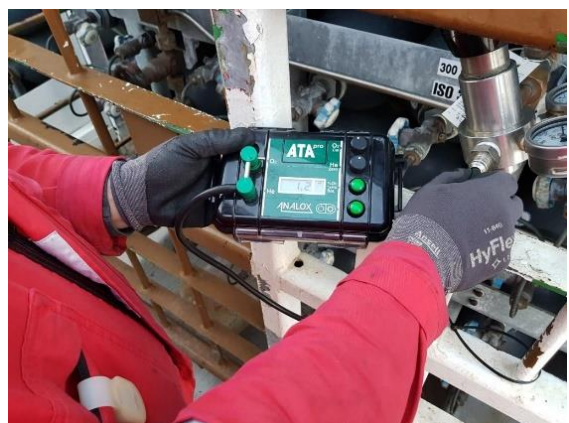
During a planned mobilisation of five Helium gas quads (2% O<sub>2</sub>, 98% He), one of the gas quads was found to differ from the others. All of the quads were labelled and certified as being 2.05% O<sub>2</sub>. One quad, however, was stencilled as 12% O<sub>2</sub> and 88% He.

When the gas man began his analysis of the quad, the first quadrant indicated 1.21% O<sub>2</sub>. Each quadrant was subsequently analysed and provided the readings below:

- ♦ 1) 1.21%
- ♦ 2) 1.40%
- ♦ 3) 3.73%
- ♦ 4) 1.84%

It was established that there was a human error.

- ♦ Poor production checks resulted in the incorrect stencilling;
- ♦ Poor mixing of gasses before filling.

- ♦ Always make sure that the contents match with the quad markings, the paperwork supplied and is tested on site;
- ♦ When the manufacture recharges 64-cylinder quads, they may fill the four quarters separately (16 cylinders) of the unit, accounting for the variations.

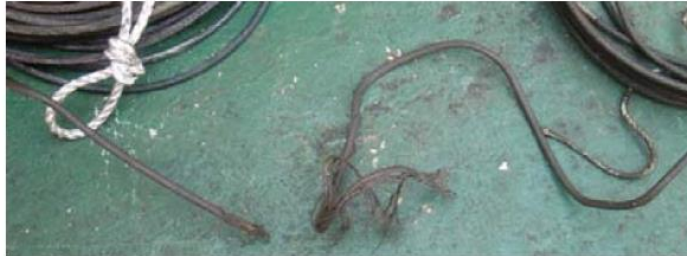
300KG Guide/Clump Weight

Before launch of an Air Diving Launch and Recovery System (LARS) from a third-party DSV, the winch wire for the clump weight/guide weight became lodged between the winch body and the winch drum wall. As the winch operator paid out on the clump weight, the winch wire tightened on the winch hub and parted. This resulted in the 300kg clump weight falling to the seabed and narrowly missing a saturation diving bell and divers already deployed near the seabed. There were no injuries or damage to equipment.

- ◆ Consider additional engineering controls, where there is a possibility for winch wire loose wrap movement off the winch drum;
- ◆ Ensure adequate equipment pre-use checks are conducted;
- ◆ Maintain line of sight to the winch drum during spooling;
- ◆ In operations that involve equipment being deployed overboard, consider dropped objects and ensure that adequate 'drop-zones' are identified.

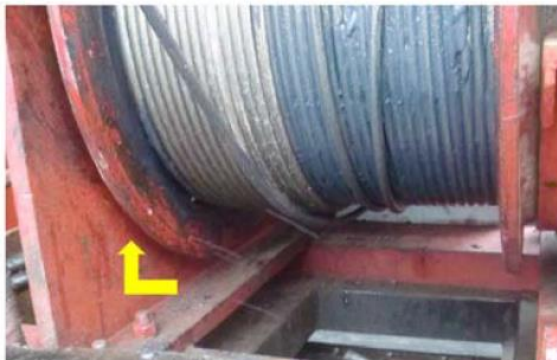
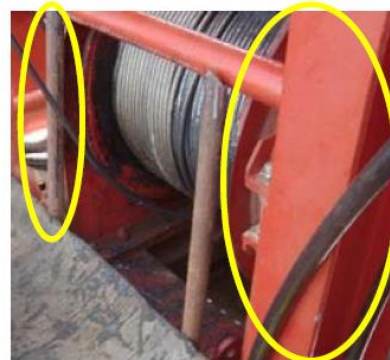
Parted Winch Wire

- ◆ It was not standard operating procedure to inspect the clump weight wire or winch, before launch of the Air Diving LARS;
- ◆ There was no pre-use check program in place for operating the LARS;
- ◆ The winch operator's position did not allow a clear line of sight to the winch drum;
- ◆ The LARS design enabled a loose wire when the A-frame is in stored position, i.e. a loose wrap became lodged between the winch housing and the winch drum wall.
