## 1 Engine Room Fires – Appropriate Use of Insulating Material on Hot Surfaces – Feedback following IMCA Safety Flash 10/05 item 2

## 2 Near-Miss During Diving Operations

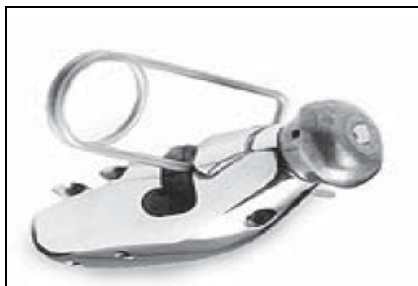
Figure 2

During debriefing, the diver stated that he had one hand on the down-line and the other held a cloth measuring tape. The diver was proceeding down the down-line head first and the cam lock apparently made incidental contact with the down-line, causing the cam lock to dislodge.

- ◆ the use of a safety pin or other secondary safety device on Kirby 17A/B helmets (see figures 2 and 3);
- ◆ the importance of remaining up-to-date on safety alerts from manufacturers of dive equipment;
- ◆ divers should not descend to the work site carrying tools or equipment.

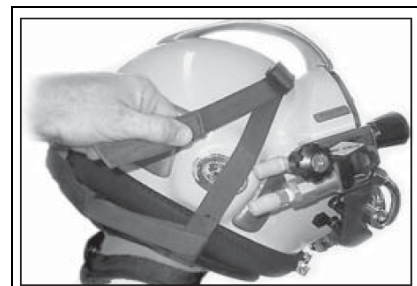
Figure 3

If used, the yoke strap (168) is now placed over the top of the helmet (but under the handle) and secured in place. The yoke strap is standard on all 17 A/B helmets shipping after January 2004. It's use is strongly recommended.

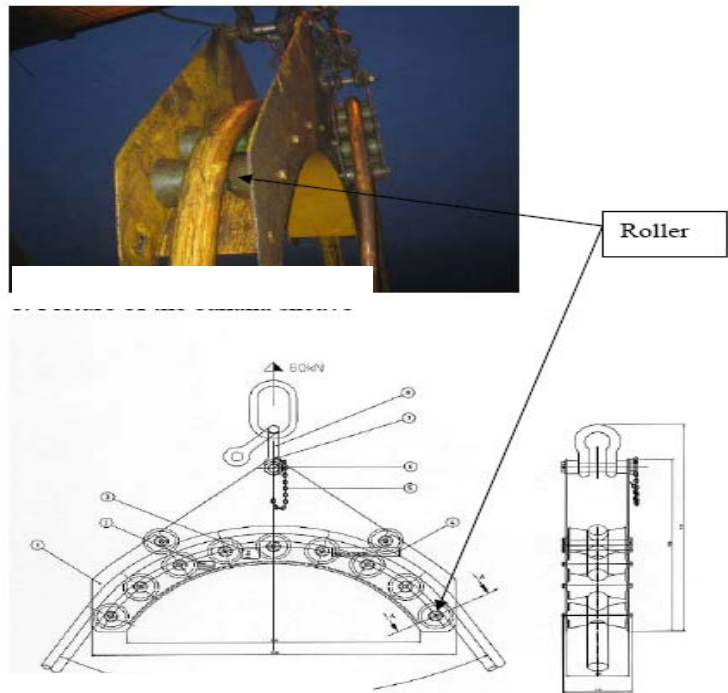
2. Drawing of the banana sheave

IMCA has received a report of an incident wherein a 'banana sheave' roller weighing 4.5kg came loose during operations. It fell some 24 metres from the derrick and hit the drill floor. Nobody was injured.

The immediate cause of the accident was identified as being that the bolts which attached the rollers to the sheave had loosened.

- ◆ insufficient design;
- ◆ insufficient maintenance;
- ◆ lack of documentation and drawings describing that the sheaves should be function tested;
- ◆ insufficient description of responsibility for involved personnel;
- ◆ insufficient maintenance management and follow-up relating to lifting equipment.

- ◆ Lifting equipment should be examined and valid certificates for equipment in use should be presented;
- ◆ Inspection and maintenance should be performed on all sheaves that are in operation, with nuts and bolts inspected;
- ◆ All bolts on rollers should be fitted with protective pins to stop the bolt from loosening;

The contractor's planned maintenance management system in place is to be reviewed accordingly.

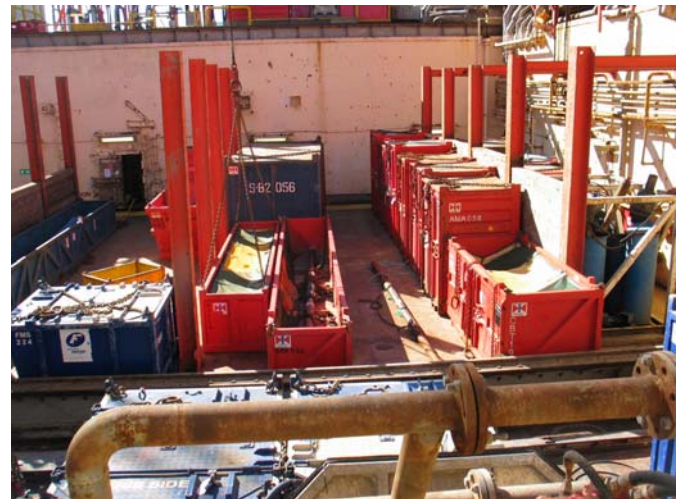
We have received reports of a near-miss wherein a worker was nearly caught between a load and a fixed structure.

The immediate cause of the near-miss was crane creep, which was compensated for automatically with an upward movement of the load, almost trapping the worker on the deck.

- ◆ insufficient management engagement;
- ◆ responsibility for operation and maintenance of crane not being properly understood;
- ◆ inadequate knowledge of crane operational routines and condition;
- ◆ maintenance routines not being specific enough.

- ◆ ensuring that responsibility and reporting routines in connection with crane operation and maintenance are clearly understood by all involved;
- ◆ ensuring appropriate competence and training for all personnel with crane functions;
- ◆ checking and updating of maintenance routines, with daily follow-up for all cranes;
- ◆ replacement of the existing 'creep compensator'
- ◆ review of the company's crane manuals and training material to ensure that they are appropriate and up-to-date.
