I Catastrophic Failure of Vessel Main Crane Wire

2 Incorrect Lifting Equipment Used

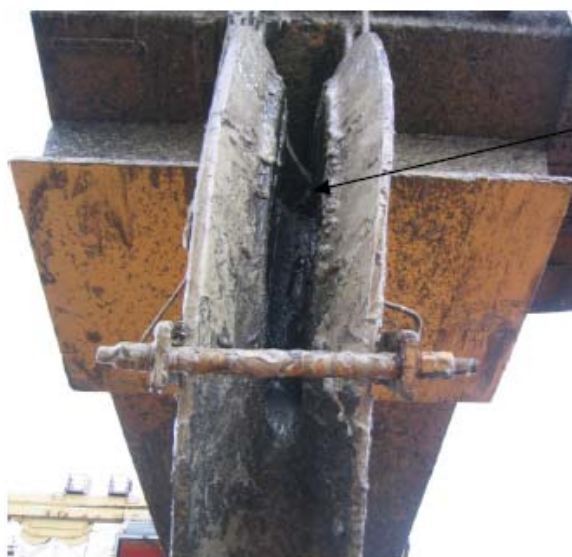
Immediate investigation identified the failure point of the wire rope to have been at the second sheave of the knuckle boom. Subsequent inspection of the sheave has identified significant damage that would be consistent with the sheave failing to rotate during the operation of the crane, and the resultant wear on the wire rope is potentially the cause of the rope failing.

Photograph shows the wear in the crane sheave that has potentially caused the wire rope to fail

It is recommended that members operating vessels with cranes of this type carry out regular inspection of crane sheaves to identify any signs of wear that would indicate a potential failure of the sheaves to operate as designed. Members operating cranes with active heave compensation are recommended to check sheave integrity and visibly check rotation of all sheaves.

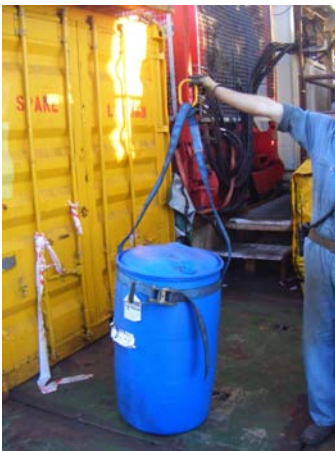
- ◆ Poor choice of drum lifting device – a barrel span set lifting strop designed for lifting metal drums was used to lift a plastic one with sides that curved in slightly towards the lid which allowed the drum to slip out of the strop;
- ◆ There was a change in the lift plan without a reassessment of hazards;
- ◆ Lack of knowledge of the correct applications for this type of drum lifting gear.

Plastic drum with curved sides with barrel span set lifting strop – poor choice as intended for metal drums

Members are recommended to ensure that personnel are fully capable of identifying and using the correct drum lifting equipment.

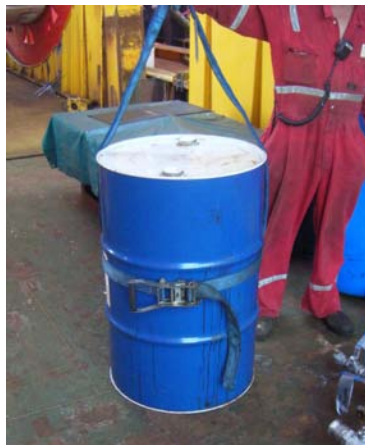
Metal drum showing intended use of barrel span set lifting strop

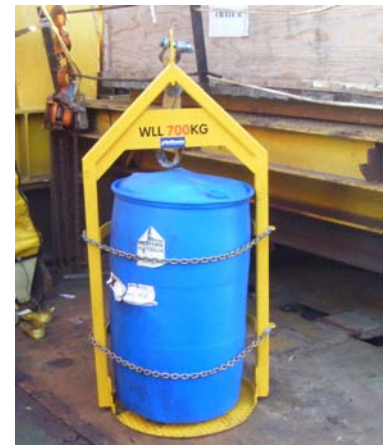
Plastic drum with curved sides held securely in appropriate lifting equipment
