## I Failure of Pressure Washer

## 2 Equipment Damage – Dropped ROV/Tether Management System (TMS)

### 3 Grinding Disc with Defects

## 8 Pilot Ladder Failure

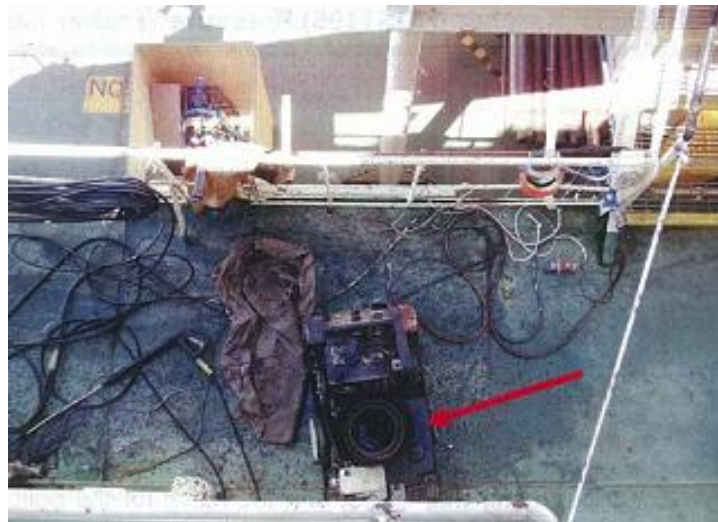
A member has reported an incident in which a Karcher HDS1195 pressure washer failed when a technician was conducting a test run after maintenance. The model involved was a portable unit designed for domestic and industrial use, and was three years old. A technician had completed the replacement of an electrical switch, and was checking that the switch was working correctly. On successful completion of the tests, the unit was powered up to ensure it was fully operational. The technician saw water emerging from the nozzle of the cleaning gun, and proceeded to shut down power to the washer. As this was done, there was a loud bang and the hatch for the boiler was blown off into the air. The technician received two small cuts to the face and minor droplet burns to the right arm.

- ◆ A pressure relief valve, designed to prevent system overpressure, was found to be corroded and unserviceable;
- ◆ A switch, designed to regulate the boiler, was also found to be defective. As a result, overpressure within the system caused the heating coil to rupture, and the escaping water and steam blew the hatch off the boiler unit and into the air.

*Pressure washer with boiler hatch missing*

- ◆ A thorough inspection of similar portable pressure washing devices, particularly those using a heating system, would be beneficial;
- ◆ Portable pressure washing devices should be part of the planned maintenance schedule.

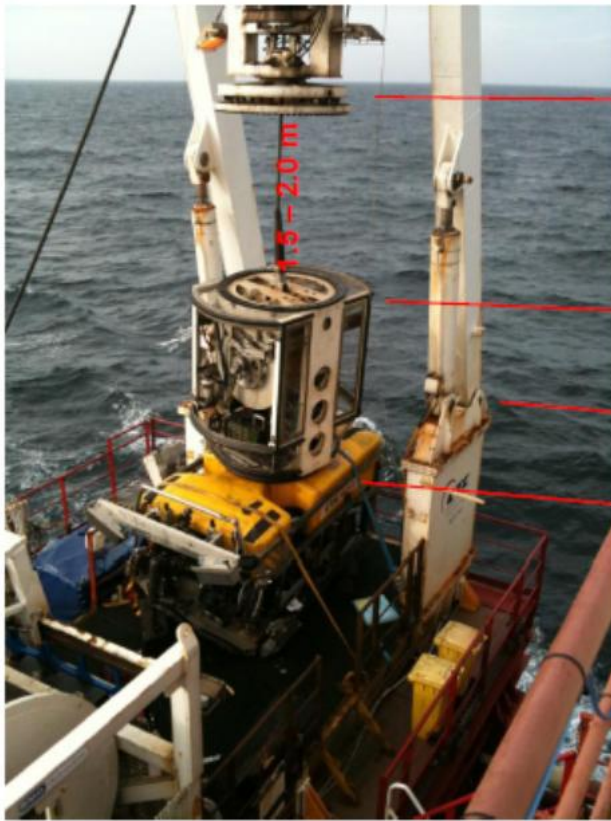
A member has reported an incident in which an ROV was dropped to the deck from between 1.5m (metres) and 2.0m, resulting in significant damage. The work-class ROV was being launched via the launch and recovery system (LARS) A-frame when the LARS operator failed to recognise that both latches were not engaged. Visual inspection had only been conducted on the aft latch. The umbilical was not managed effectively resulting in unnecessary slack which allowed the system to fall the 1.5-2m to deck.

### Latching System:

Comprises of two pins that fix the TMS in place during lifting operations.

- ◆ As an interim measure, an audible alarm indicator was installed to confirm and notify that the latch mechanism has been engaged. This alarm sounds for 7 seconds;
- ◆ Markers were painted on each latch to clearly identify the latch position;
- ◆ Cameras were installed to view the latch position;
- ◆ Additional communication checks were implemented and recorded;
- ◆ Task job safety analysis (JSA) was updated to reflect additional control requirements.

- ◆ An engineering review of this particular system to include development of an interlock system that would prevent overboarding or recovery of ROV unless the latch mechanism was engaged;
- ◆ An engineering review of all ROV LARS operations within the company to identify opportunity for improvement and potential hazard impacts.

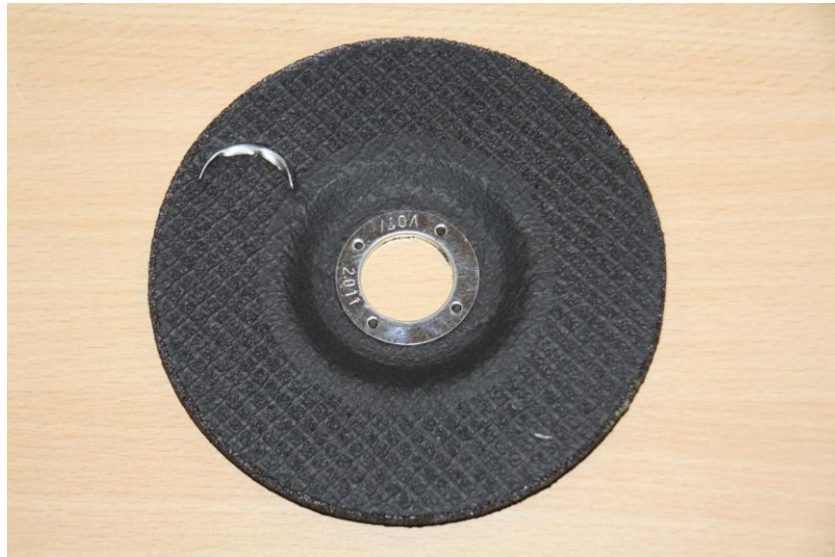
A member has reported an incident in which a welder discovered a defect in a new grinding disc. When grinding, the defect could have resulted in the disc cracking leading to possible serious injury or damage. The defect seemed to be a disc steel inner ring that had melted into the disc during fabrication.

*Iron ring melted into the disc*

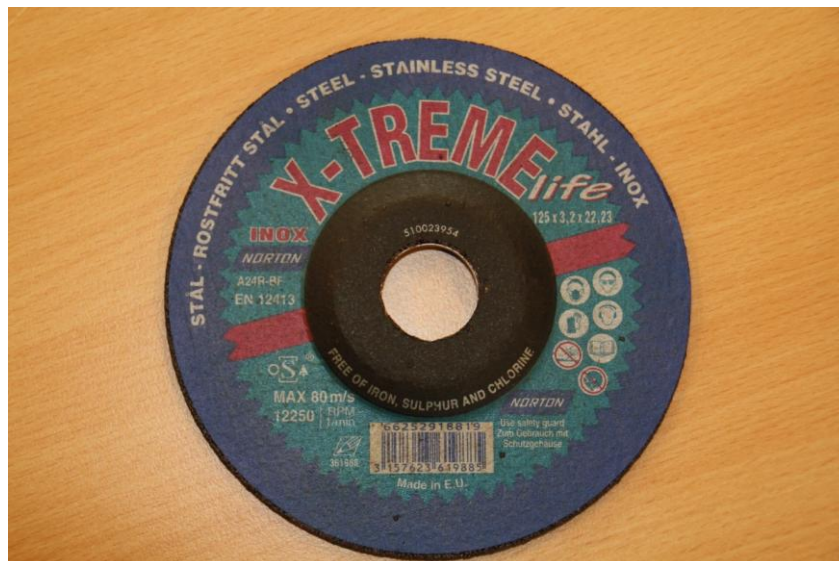
*Top side of grinding disc with no marks of defect*

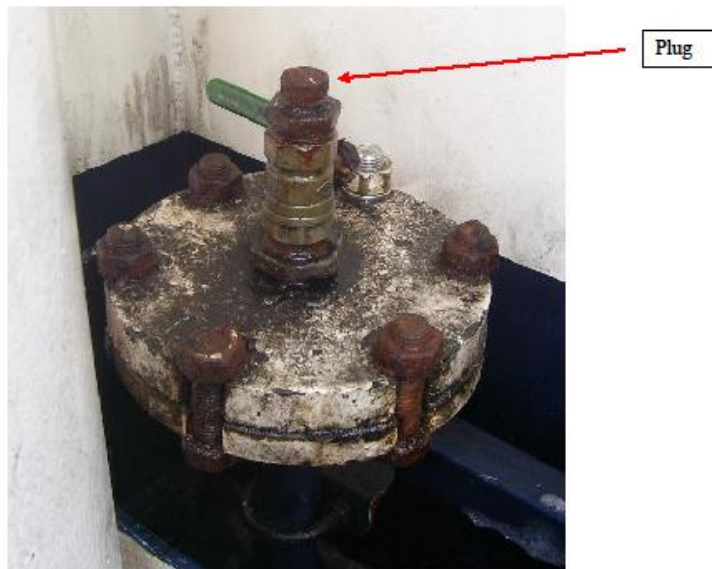
Starboard Waste Oil Connection

- At 0940 hrs the 2<sup>nd</sup> Engineer checked with the barge if it was ok to resume pumping and the pump was restarted.
- At 0955 hrs the Motor man heard a noise from the starboard side and noticed waste oil spraying out from the starboard connection. The motor man immediately stopped the pump using the Emergency Stop.
- Approximately 20 litres was spilt on the vessels deck with one litre going over the side into the water.

- No check list was in use prior to commencing discharge of waste oil
- During the handover all the relevant information was not passed on.
- The joining crew did not use a check list before resuming operations.
- The scupper plug under the waste oil saveall was not in place
- The unused (stbd.) connection was not properly capped with the valve closed.
- A secondary check of the lines after resuming discharge of waste oil would have indicated the starboard connection was leaking
- Company procedures were not adhered to.
- Poor Communication
- No evidence of a checklist being used for waste oil discharge since early 2010.

All personnel are reminded to ensure that Company Procedures are followed at all times. The use of a checklist would have prevented this incident from occurring. This incident also highlights the importance of a proper handover whether during crew change or change of watch.

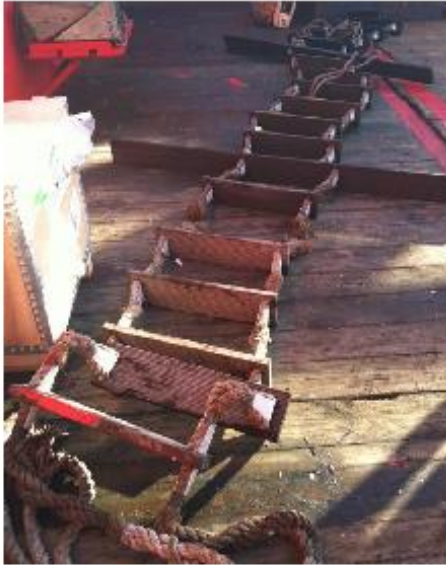
- The pilot ladder was in poor condition and the pilot ladder ropes were worn by contact with the sheerstrake.
- There were no measures in place to reduce the effect of the sharp edge of the vessel's sheerstrake on the pilot ladder ropes.
- The wear on the pilot ladder ropes from contact with the sheerstrake was not considered as the company risk assessment process was not effectively implemented on board.
- Experience Transfer highlighting the potential hazard from the deployment of a pilot ladder over the sheerstrake was not yet issued to the fleet.
- The pilot ladder was stowed on the open deck by the pilot boarding station and was not covered and suffered deterioration from the weather.

**Damaged Pilot Ladder**

1. Any sharp edges with the potential to affect pilot ladders to be removed
2. A new and unused spare pilot ladder to be provided
3. Gratings to be installed to raise pilot ladders from deck (if not stored in a dry and clean environment)

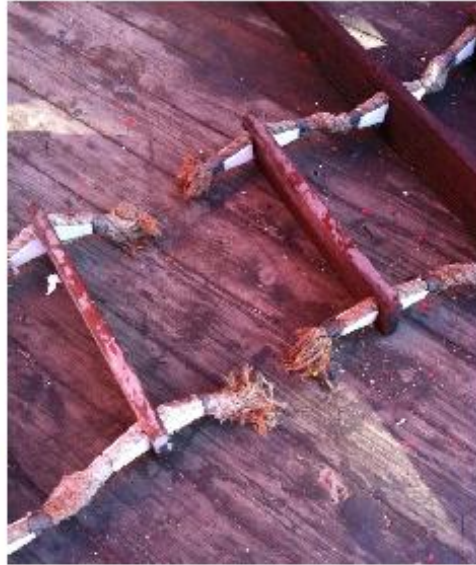
**Pilot Ladder Where Parting Occurred**

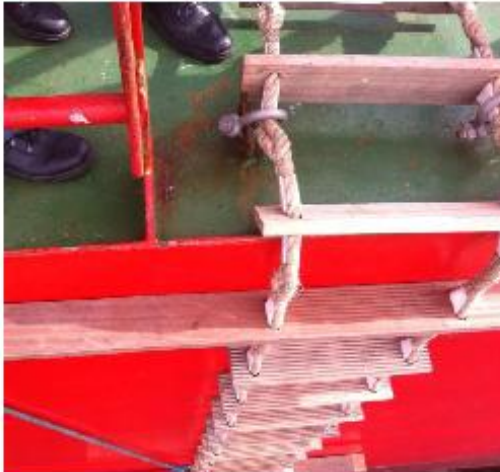
**Pilot Ladder Deployed Over Sheerstrake**

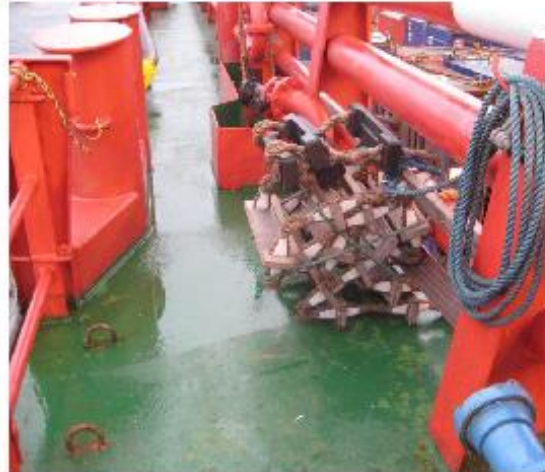
**Pilot Ladder In Stowed Position**

4. Weather proof covers to be provided for pilot ladders (if not stored in a dry and clean environment)
5. Regular inspections of pilot ladders to be carried out by a competent person on board
