IMCA Safety Flash 11/12

October 2012

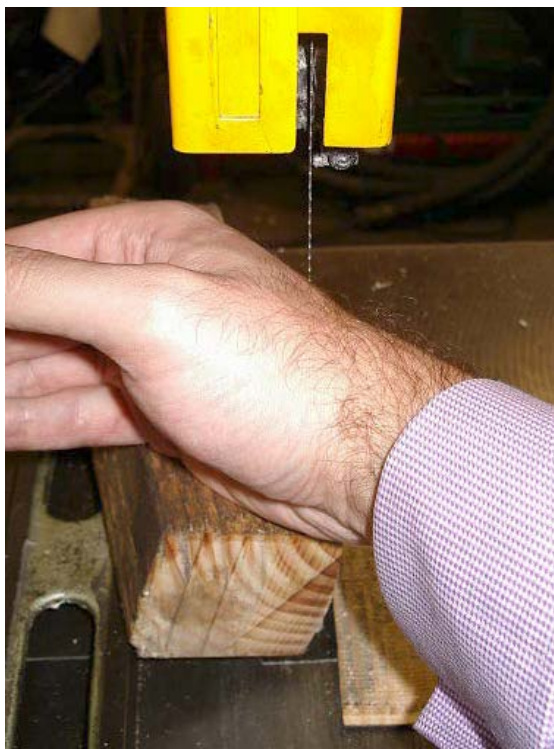
A member has reported an incident in which a worker sustained a serious injury to his right hand. The incident occurred in an onshore mechanical workshop. The injured person was attempting to cut a small block of wood down to size to use as a spacer. Whilst using the mechanical workshop vertical band-saw his hand came into contact with the moving blade, causing a serious laceration to the back of the hand and resulting in tendon damage.

Position of hand and wood during incident

- ◆ Immediate causes:
 - The wood split during cutting due to the application of excessive force to the wood, which was caused by excessive wear on the blade and the incorrect positioning of the wood;
 - A "Push stick" was not used;
 - An adjustable guard was not used.
- ◆ Root causes:
 - Lack of hazard awareness/complacency – the injured person did not identify using the machine as a hazard and did not use the available safety guards and processes whilst operating the saw;
 - Uncondoned behaviour/violation – the injured person identified a fault with the saw but continued to operate it without reporting the fault.

- ◆ Workshop/Yard Induction form to be reviewed and updated to include specific mention of Safety Observation Card requirements, Stop the Job requirements and section relating to machinery operation and competence;
- ◆ Review of induction frequency requirements and inclusion into site management procedures;
- ◆ Prepare and issue pre-use checklists for each machine with requirements for inspection prior to use, following use and reporting requirements where faults have been identified;
- ◆ Implement locking e-stop system with controlled key access to prevent unauthorised use;
- ◆ Update risk assessment with lessons learned from incident investigation where pertinent.

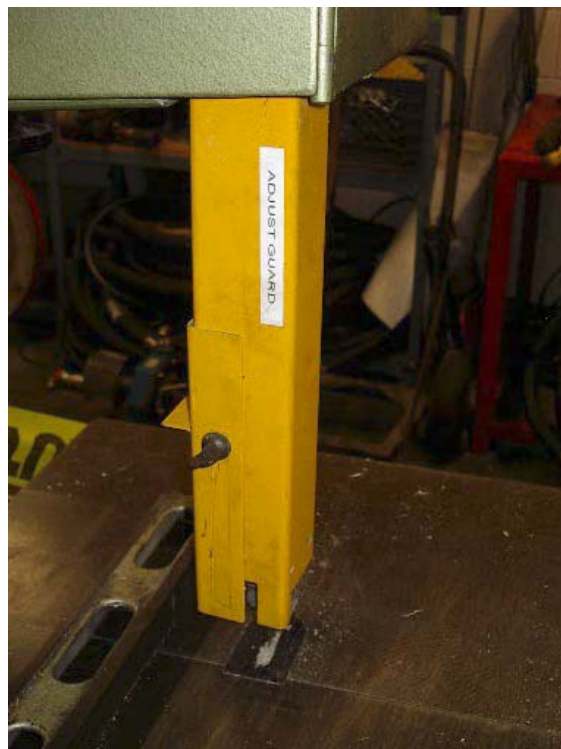
Band-saw with guard set to lowest position

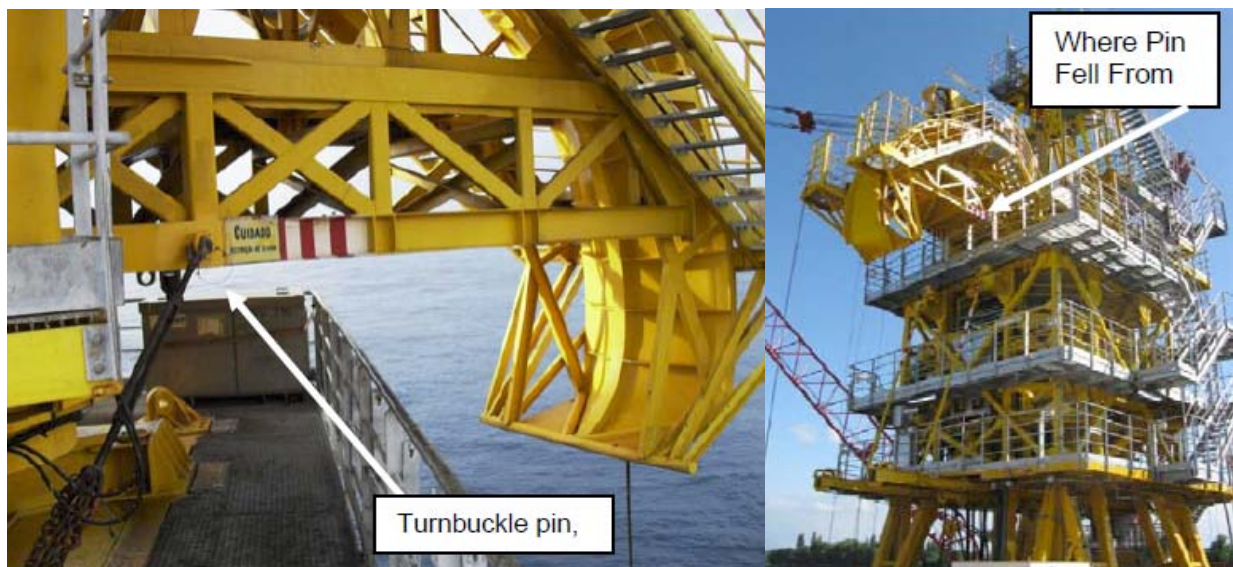
A member has reported a near miss incident in which a turnbuckle pin weighing approximately 2kg fell more than 12m to deck. The incident occurred on a third party construction support vessel used for pipe laying. The vessel has a gutter to guide the flexible pipe into the vertical tensioner. It is able to slew left and right to allow the flexible pipe to approach from various angles. This gutter was to be held in place using a combination of turnbuckle, chain and shackles (see photographs below.) Whilst installing the turnbuckle securing arrangement, the retaining pin of the turnbuckle was dropped more than 12m to deck. There were no injuries.

Using the DROPS Calculator as a benchmark in the classification of the potential consequences of a dropped object, our member determined that the outcome of dropping the turnbuckle pin could have resulted in a fatality

Location of turnbuckle pin (L) and where the turnbuckle pin fell from (R)

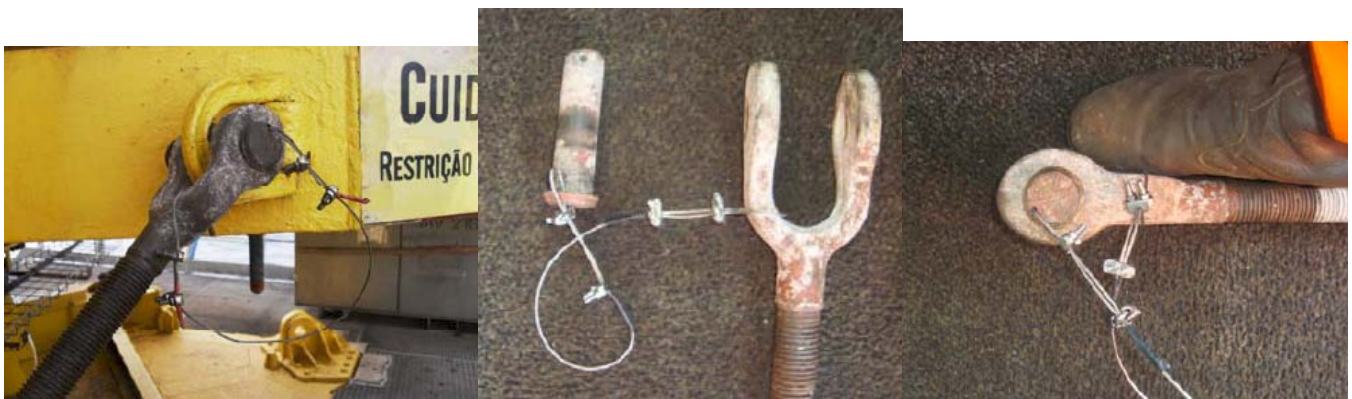
Securing of shackle pins used at height with wire

Our member investigated the incident and as a result implemented a simple secondary securing method to prevent dropped objects.

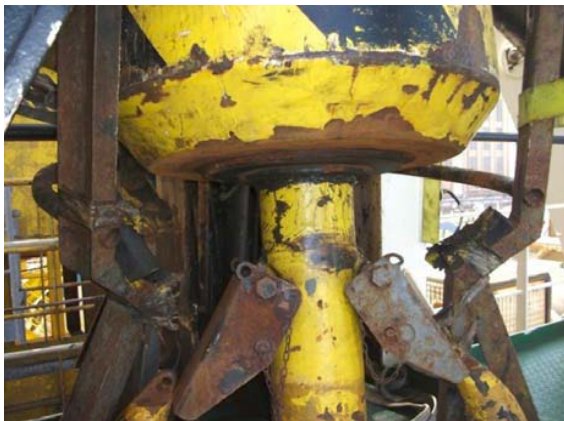
A member has reported an incident in which a crew member broke his arm. The incident occurred as the vessel was approaching port when a crew member released the securings for the main crane block. The block started to move and inflicted a crush injury resulting in a broken arm and subsequent medical evacuation.

The vessel was rolling due to the sea conditions and vessel manoeuvring. The injured person went to the crane pedestal to remove the sea fastenings from the main block in preparation for crane operations in port. As the injured person loosened the sea fastenings, the ship rolled causing the block to move clear of the bucket, and his right arm was caught between the swinging block and a steel upright. The impact caused lacerations to the inside and back of the upper right arm resulting in bleeding and fracture to the humerus (forearm) bone.

Crane block

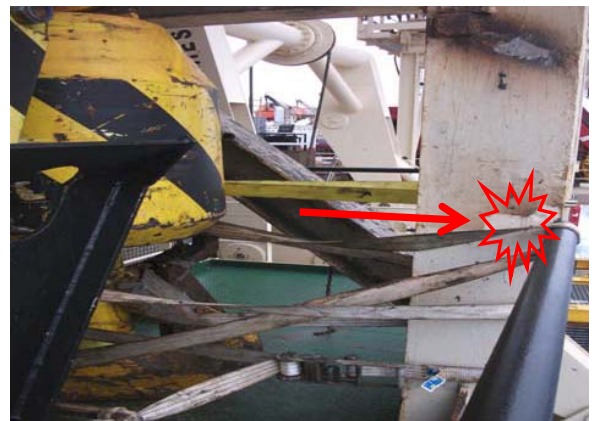
Crane block and upright showing how crane block moved

- ◆ The movement of the block which caused the injury was directly caused by the removal of sea fastenings too soon before the vessel had actually arrived in port. This allowed the main block to move as the vessel rolled. The main block had been securely fastened up to this time and throughout the vessel transit;
- ◆ The main block bucket had been altered with a section having been removed to house a slightly larger block, this resulted in the block requiring cargo straps to secure it in position;
- ◆ The injured person was working alone at the time of the incident and had neither been requested, nor sought permission to carry out this task.

- ◆ To review lone working policy on vessels to ensure all personnel are aware of the dangers and responsibilities of lone working, and to inform others when potentially working alone around the vessel;
- ◆ Ensure active supervision to prevent personnel undertaking tasks without prior notification;
- ◆ To undertake learning and information campaigns to help raise hazard awareness: if personnel can correctly identify hazards then they can take the correct actions to mitigate risks;

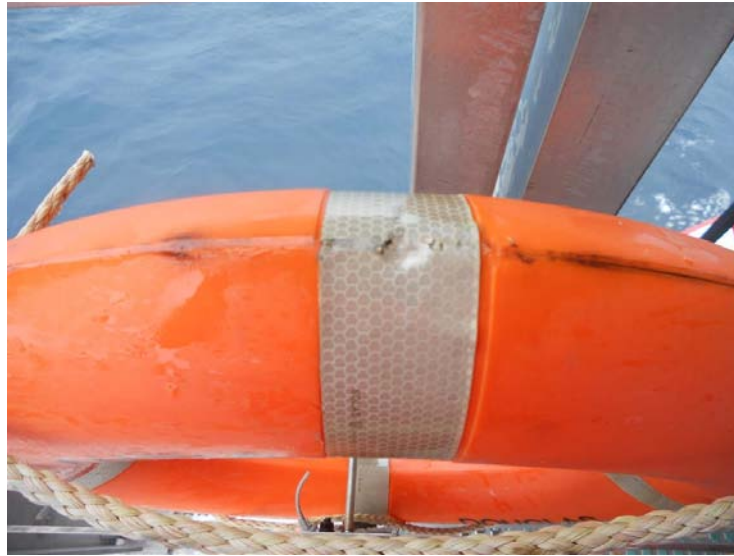
A member has reported an incident in which defects were discovered on several lifebuoys aboard a company-owned vessel. During routine life-saving appliance checks, it was noted the plug/stopper on one of the lifebuoys was missing. The position where the plug/stopper should have been is shown in the photographs below. These should have been put in place by the manufacturer. In this instance, the lack of the plug had resulted in one lifebuoy being full of water with a resultant loss of buoyancy. A further four lifebuoys were found to have the plugs missing.

Lifebuoy Plug/stopper insert location covered by retro-reflective tape

Members are recommended to conduct a visual check and, where necessary, a weight check on all lifebuoys onboard for this potential issue. It is recommended to amend onboard planned maintenance schedules such that that they include quality control checks and inspection of lifebuoys.

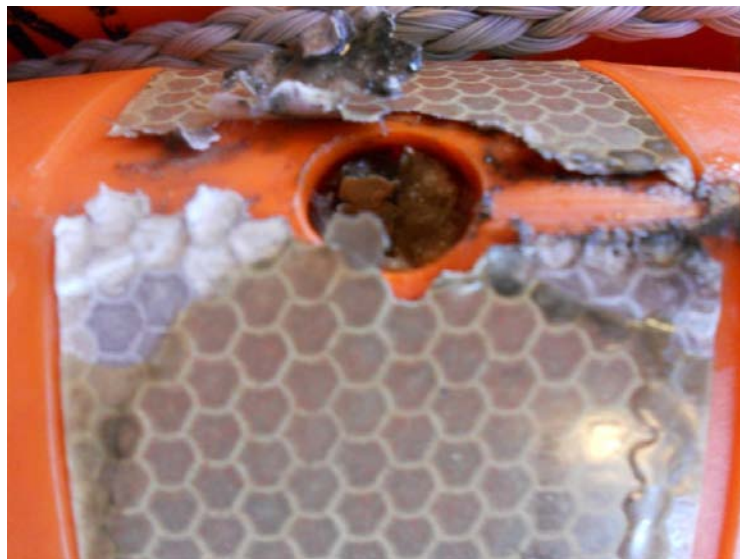
Lifebuoy Plug/stopper insert location showing lack of plug when tape removed
