## I Failure of High Pressure Fitting

## 2 Lifting Fatality

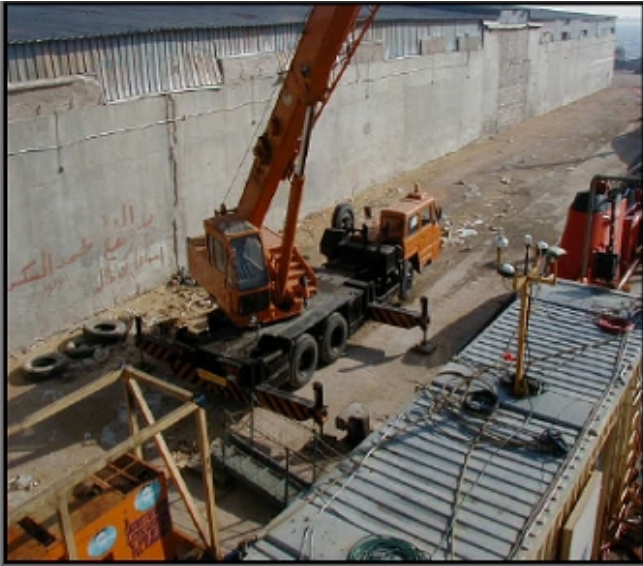
Photo 1: Accident Scene Pan 1 :

Whilst attempting to position the replacement generator, the crane was required to 'jib-out'. As a result of the combined boom extension and excessive load, the mobile crane's outriggers lifted off the quayside. This compromised the stability of the crane, causing the load to move unexpectedly downwards and across the deck simultaneously at considerable speed. The two tagline operators were unable to control this sudden movement. One crane worker was unable to get clear in time and was struck by the load, suffering severe crush injuries to his right leg and torso. He was transferred immediately to hospital but was pronounced dead on arrival.

- ◆ Safety management system procedures should be followed at all times.
- ◆ Efficient and effective supply chain management is particularly important for safety-critical suppliers
- ◆ Ensure lifting procedures are up to date and followed, including
  - lifting risk assessment
  - lift plans
  - lifting toolbox talks
  - lifting checklists
  - management of change procedures
- ◆ Re-assess roles and responsibilities of supervisory staff at mobilizations and during lifting operations
- ◆ Identify through audit specialist lifting companies and establish an 'approved vendors list' for safety-critical suppliers.
