IMCA Safety Flash 13/14

July 2014

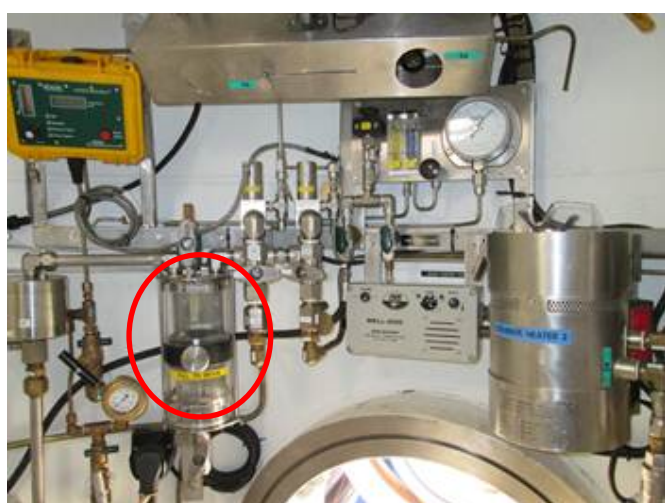
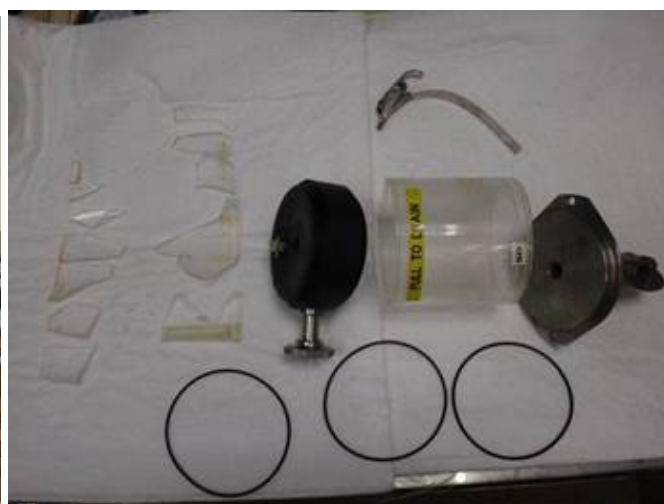
Showing reclaim before and after failure

The root cause of the incident was determined to be that the check valve was incorrectly installed (inverted). A contributing factor was that the planned maintenance regime did not include increased frequency of filter change since the refurbishment; the reclaim compressor was started remotely.

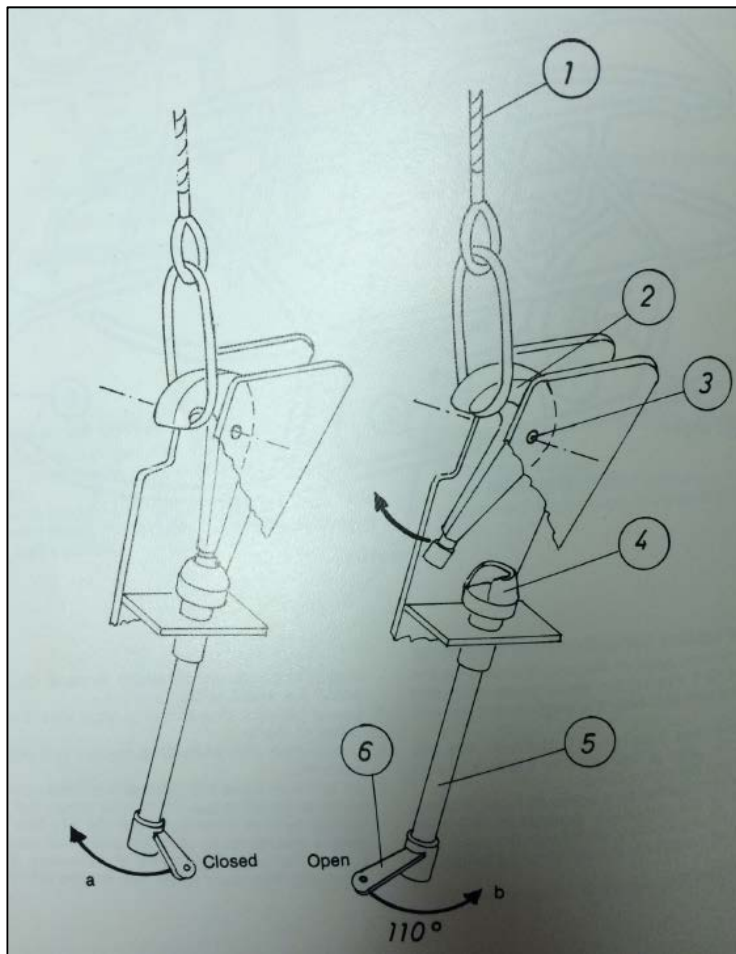
Figure 1: Lifeboat hook release mechanism

The current design of the system does not give the operator direct indication that the forward hook is correctly locked. A single indicator serves both the Master (aft) and Slave (forward) locking systems, but only the position of the aft hook is positively indicated.

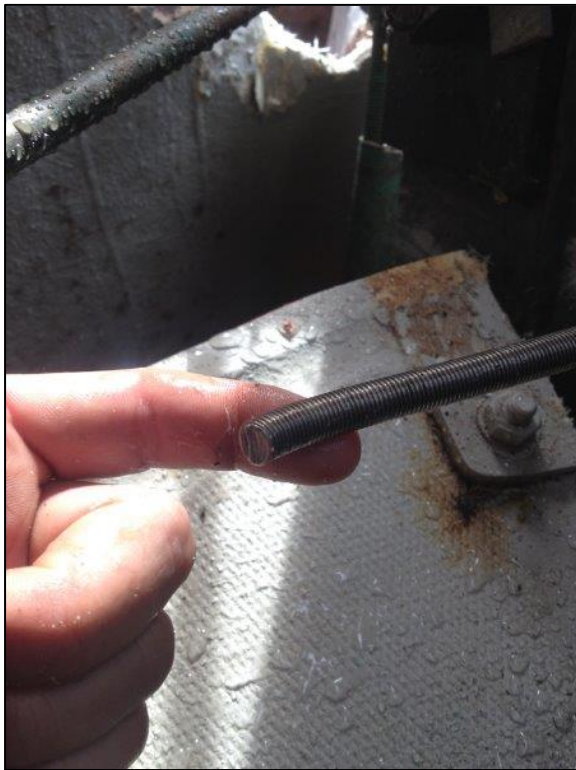
Figure 2: Showing sheared hook release mechanism from the lifeboat that dropped

- ◆ The hook release mechanism linkage was found to have failed (sheared) - see Figure 2 - at the forward end of the lifeboat. This is likely (pending final report) to have been caused by misalignment of the hook during re-attachment and/or fragile design of the hook release mechanism linkage;
- ◆ Further inspection onboard found that the forward release mechanism linkage was severely bent (See Figure 3) in one of the other three lifeboats;
- ◆ As a result of the above noted damage, a total of two of four lifeboats were found to have release hooks that were not fully engaged.

This photograph shows the linkage rod that sheared on the forward release hook mechanism on the failed lifeboat. With the linkage sheared, the lifeboat release hook was not fully engaged, resulting in the hook releasing.

- ◆ Immediate inspection of all lifeboat release hook mechanisms, irrespective of design with the following pointers:
 - Check for integrity and potential damage
 - Ensure that the latching mechanism is fully engaged;
- ◆ Ensure that there are routine checks that all hooks are engaged prior to launch, on completion of recovery and during routine lifeboat inspections.

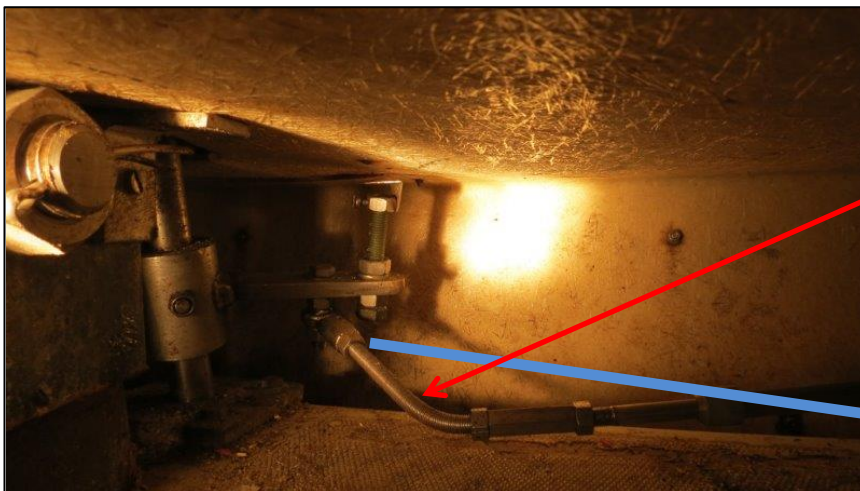
Figure 3: Damaged hook release mechanism linkage on other lifeboats onboard

This photograph shows the release hook mechanism linkage at the forward locking mechanism.

The arrow indicates the area of severe deformation of the linkage rod, caused by the misalignment of the hook and/or fragile design.

The blue line represents the correct alignment of the linkage rod. In this condition, the lifeboat hooks are not fully engaged.
